# FACILITY CONDITION ASSESSMENT

*119663.16R000-020.017*

*December 21, 2016*

**PALOS VERDES PENINSULA UNIFIED SCHOOL DISTRICT  
CAMPO VERDE**

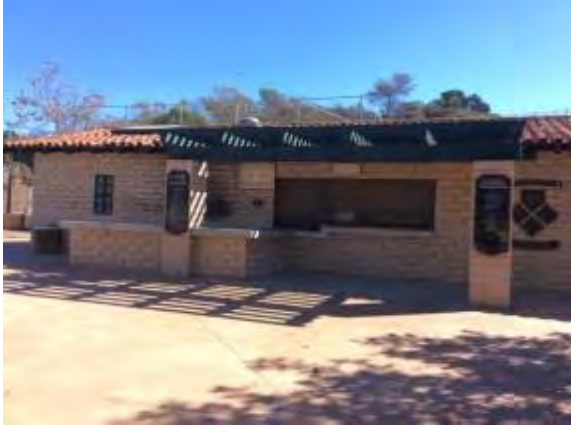
Photo #1: Front view of main building

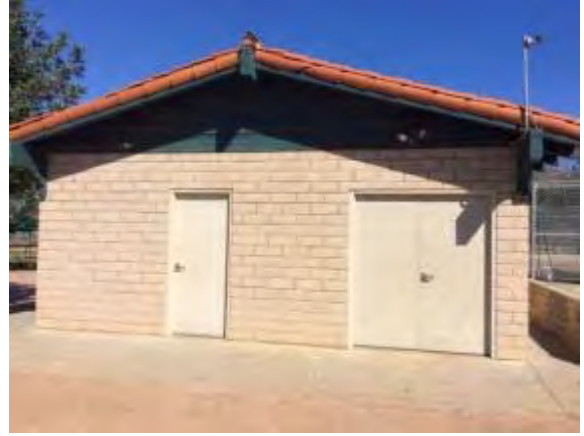
Photo #2: Side view of main building

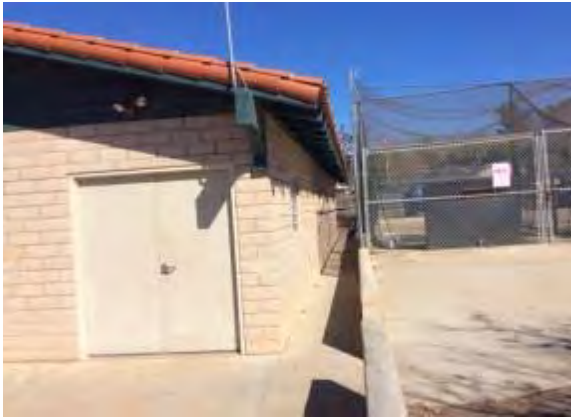
Photo #3: Partial side view and rear elevation

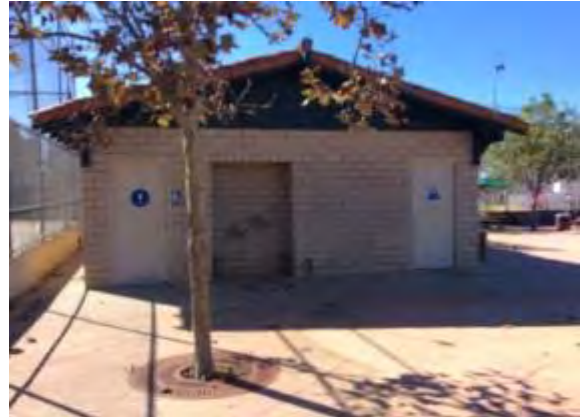
Photo #4: Side view of main building

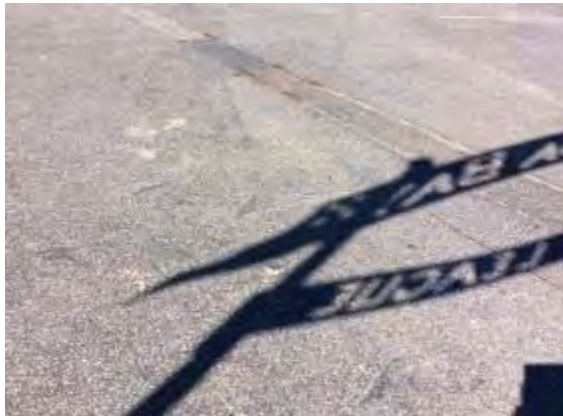
Photo #5: Asphalt pavement

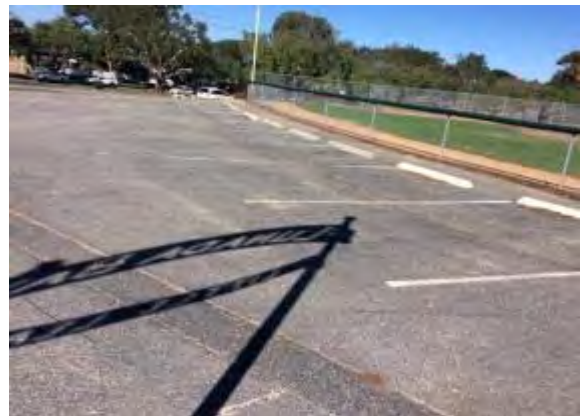
Photo #6: Parking lot

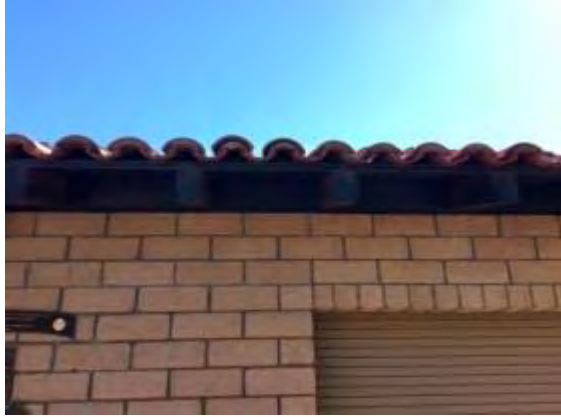
Photo #7: Partial view of roofing

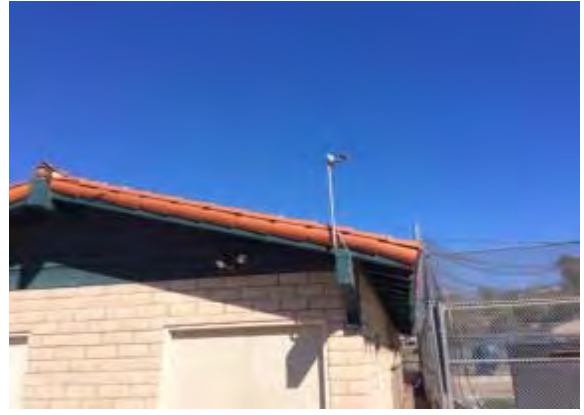
Photo #8: Partial view roofing

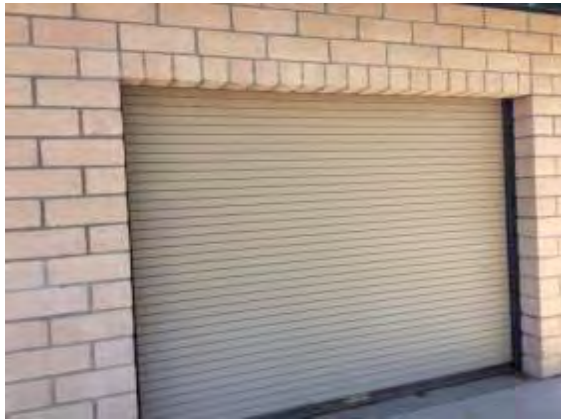
Photo #9: Overhead door

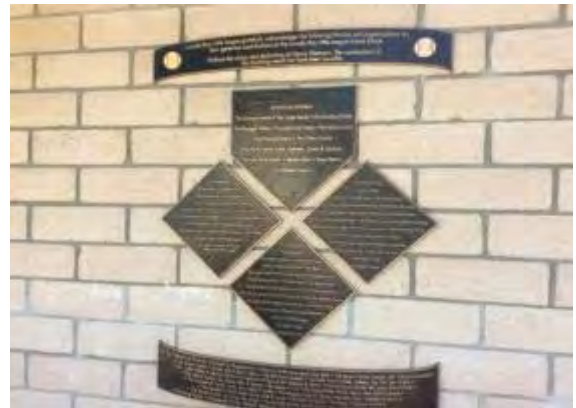
Photo #10: Exterior veneer brick wall

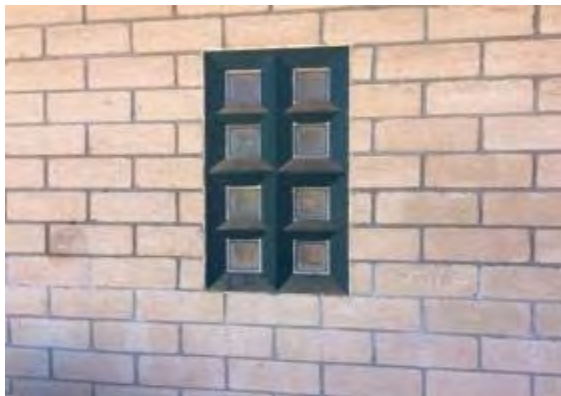
- The screens at the service counter are frayed and loose. These must be replaced for functionality and appearance purposes.
- On-going periodic maintenance is highly recommended. Future lifecycle replacements of the component listed above will be required

Photo #11: Window

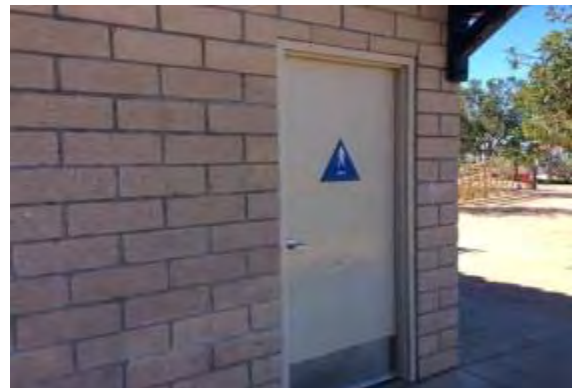
Photo #12: Hollow metal exterior door

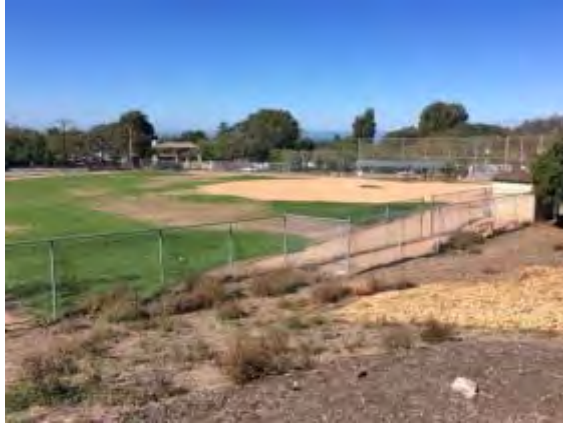
Photo #13: Baseball field

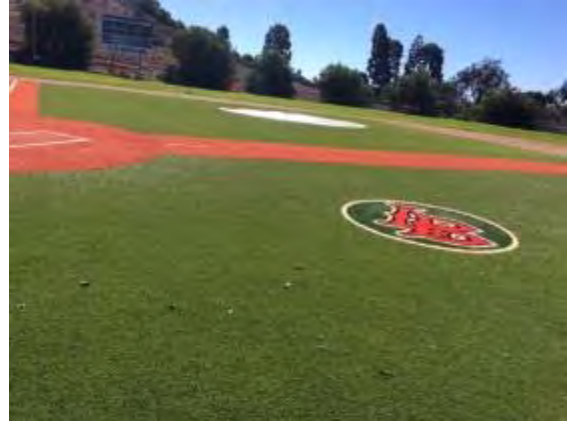
Photo #14: Baseball field

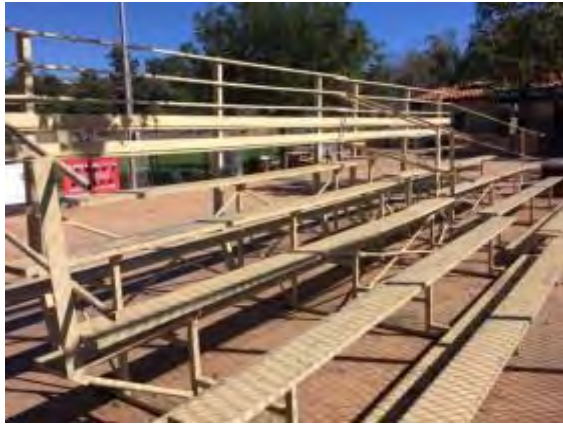
Photo #15: Bleachers

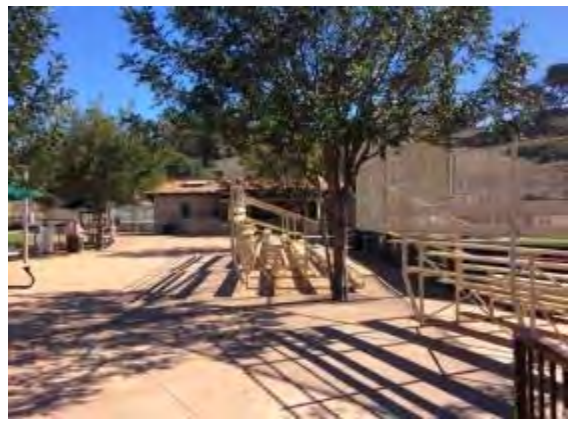
Photo #16: Site view with bleachers
