# FACILITY CONDITION ASSESSMENT

**PEDREGAL/CORNERSTONE ELEMENTARY**

**6069 GROVEOAK PLACE**

*December 14, 2016*

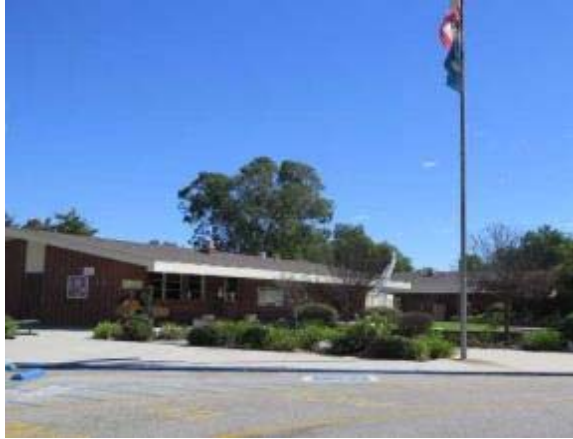
Photo  
#1: School entrance

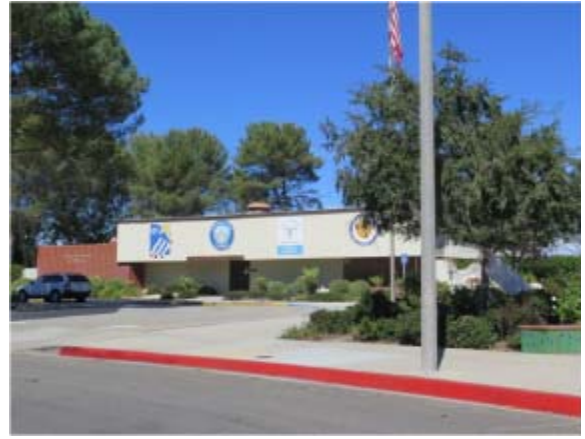
Photo  
#2: MPR building

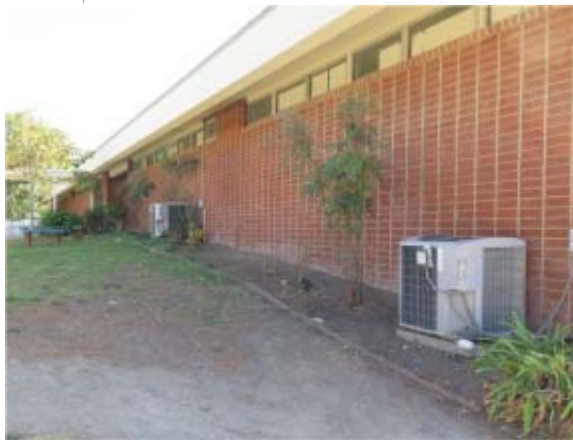
Photo  
#3: Rear of classroom building

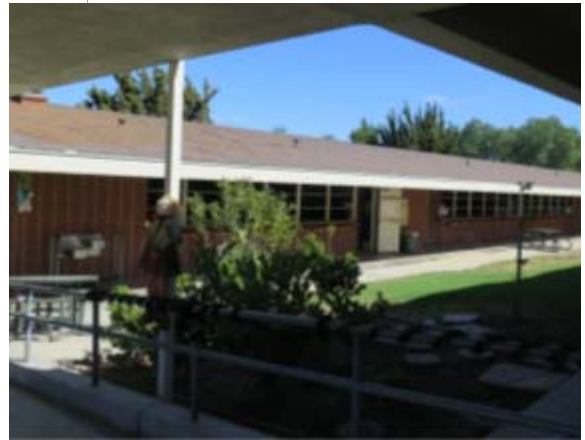
Photo  
#4: Front of classroom building

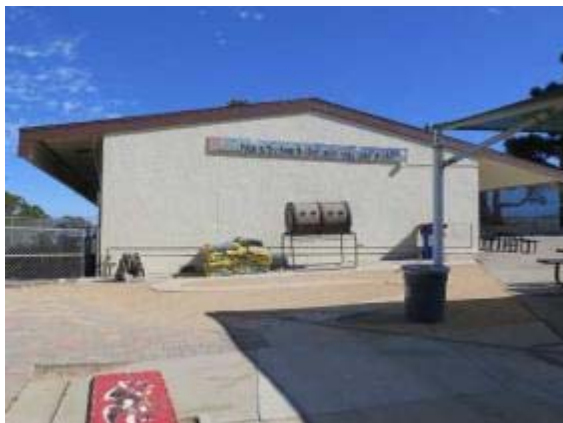
Photo  
#5: Side of classroom building

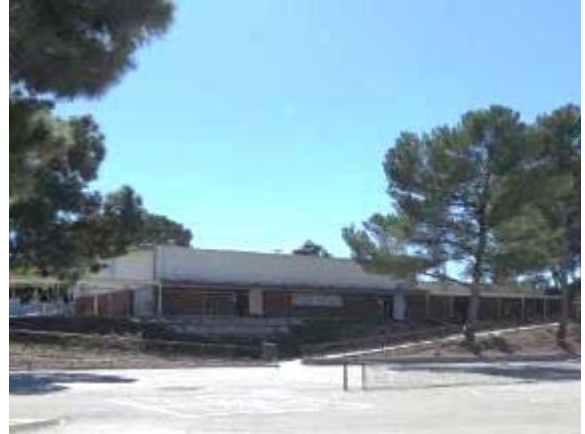
Photo  
#6: Rear of MPR and ramp to playground

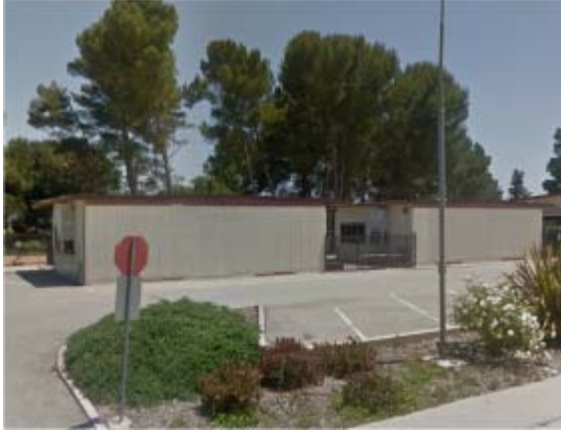
Photo #7: Side of Portable Classrooms

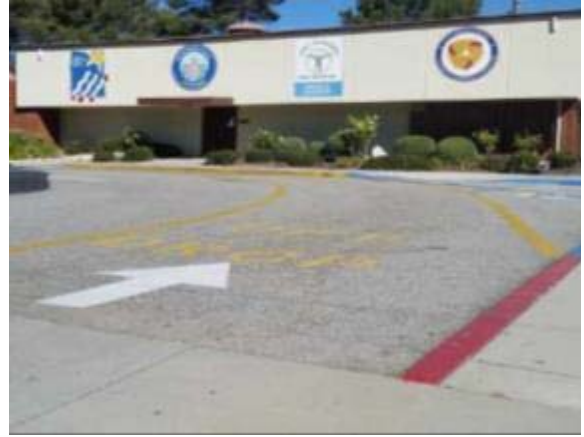
Photo #8: Parking lot entrance pavement

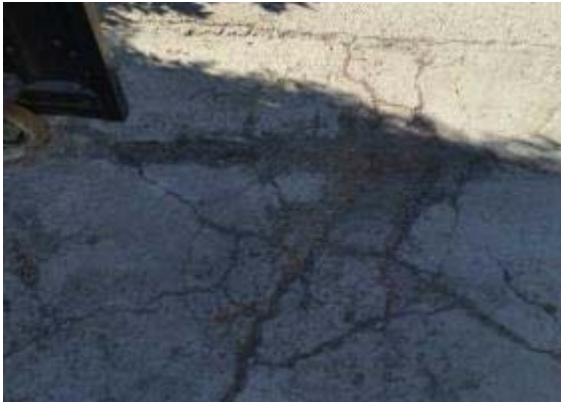
Photo #9: Pavement in service area

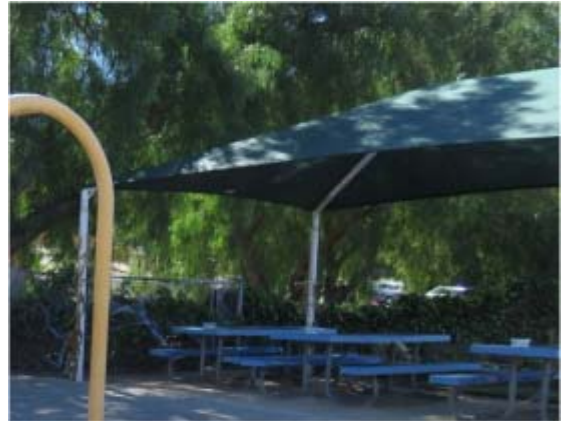
Photo #10: Lunch shade canopy

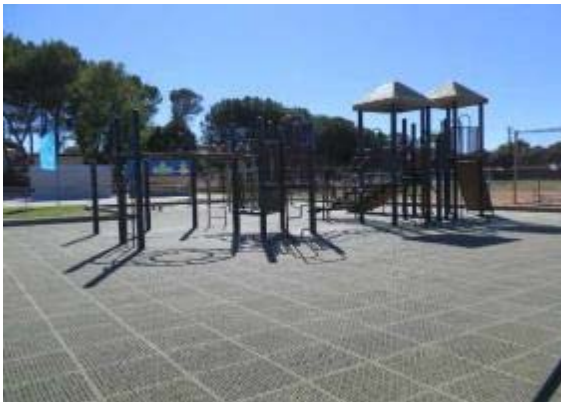
Photo #11: Playground equipment

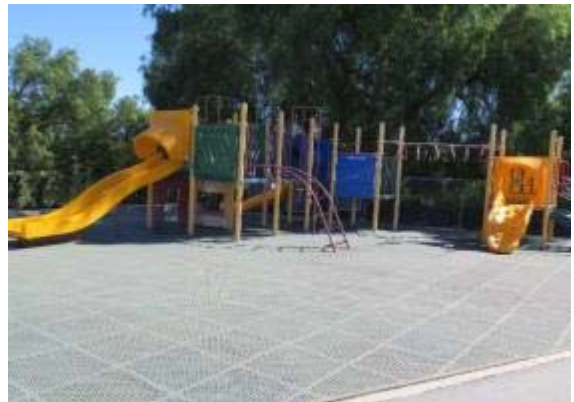
Photo #12: Playground equipment

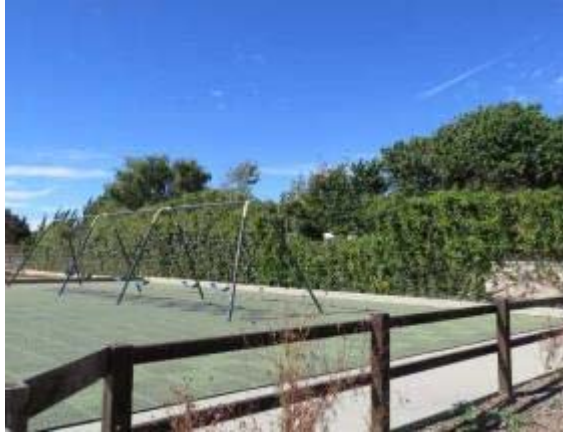
Photo #13: Playground equipment

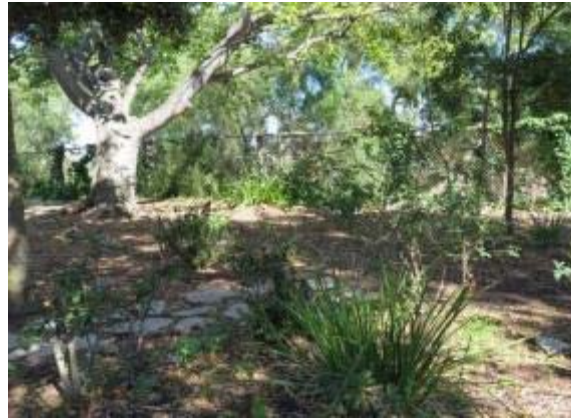
Photo #14: Landscape

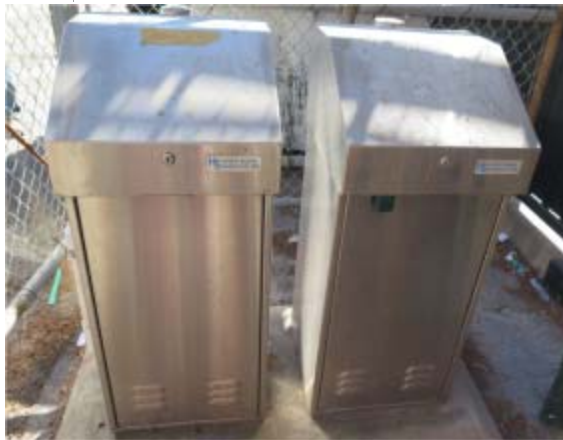
Photo #15: Irrigation controls

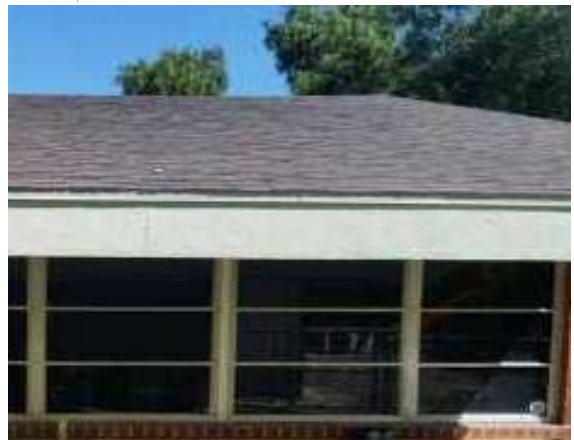
Photo #16: Composite shingle roof

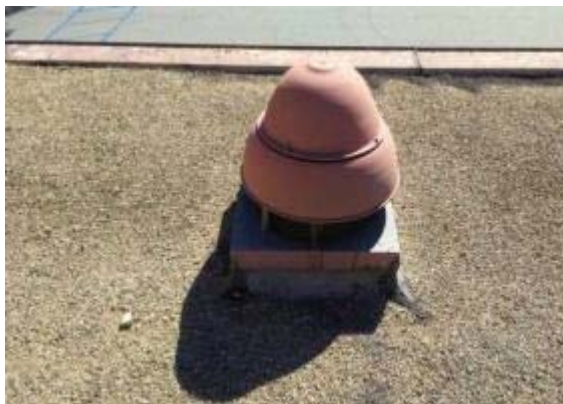
Photo #17: Built-up membrane roof

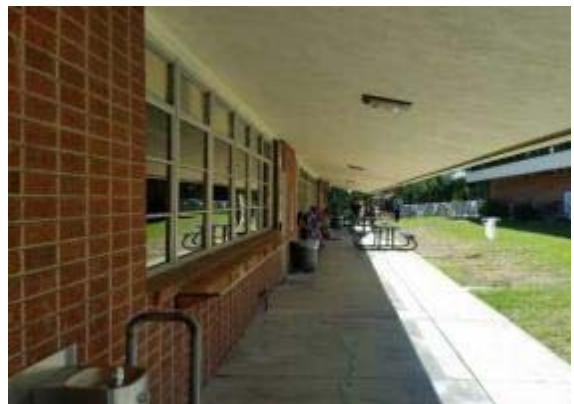
Photo #18: Enclosed soffit

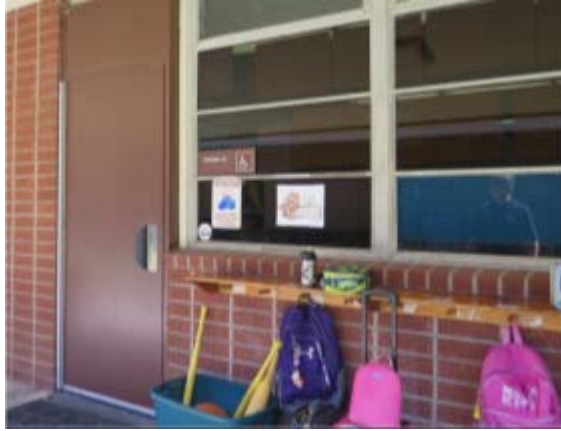
Photo #19: Classroom door and windows

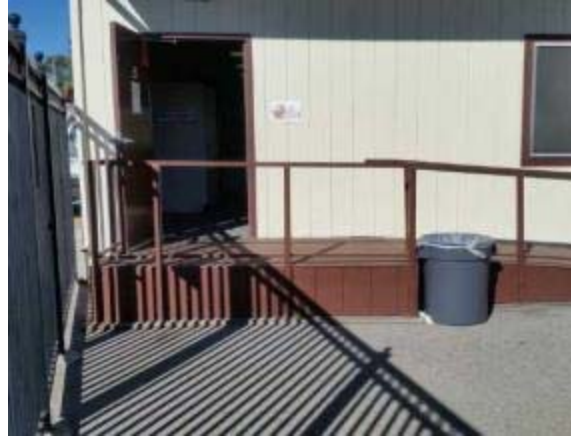
Photo #20: Portable classroom siding and ramp

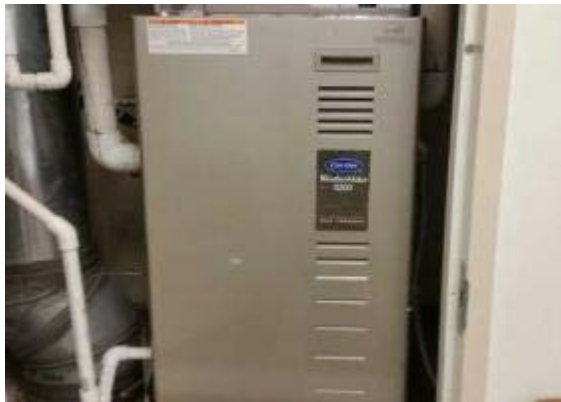
Photo #21: Classroom furnace

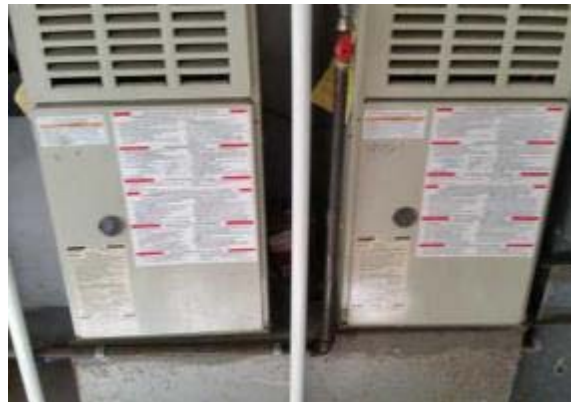
Photo #22: Administrative office furnaces

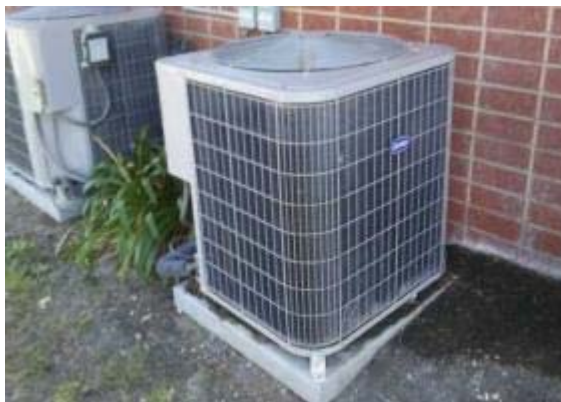
Photo #23: Condenser units

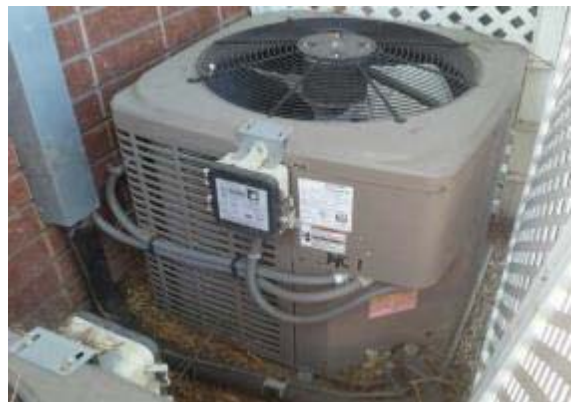
Photo #24: Condenser unit

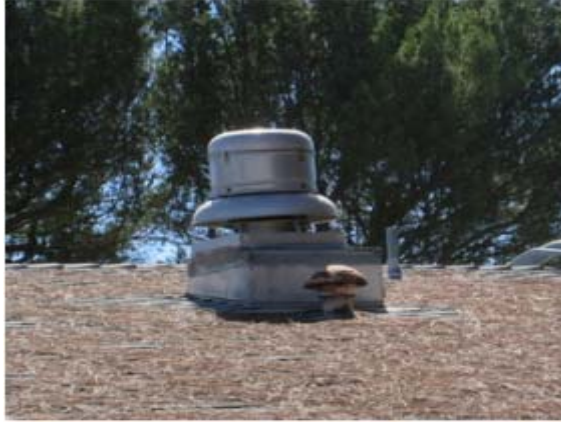
Photo #25: Exhaust fan

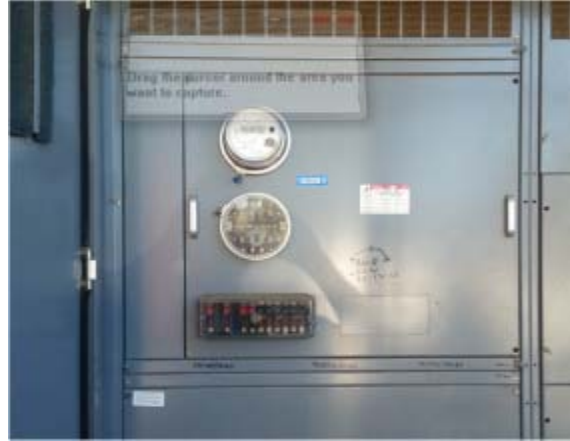
Photo #26: Main 2000 amp electrical service

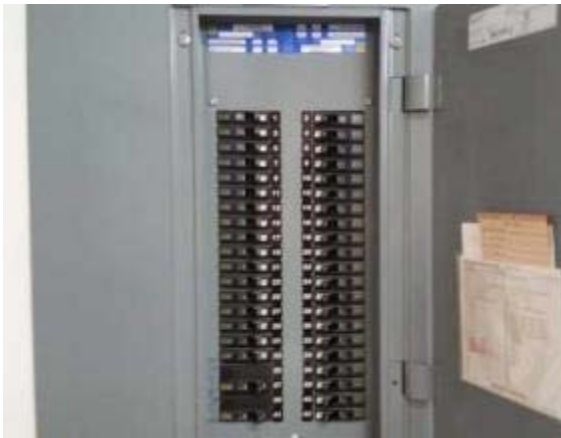
Photo #27: Electrical distribution panel

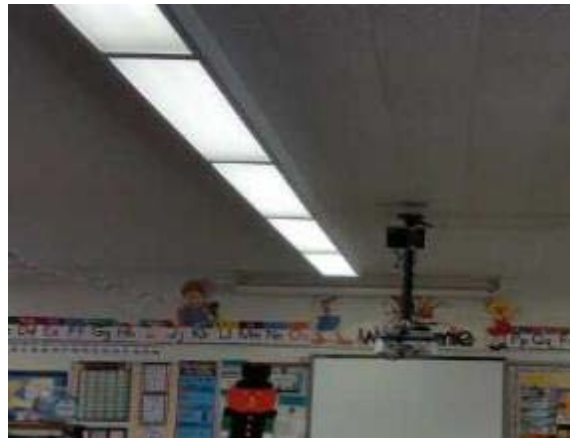
Photo #28: Classroom lighting

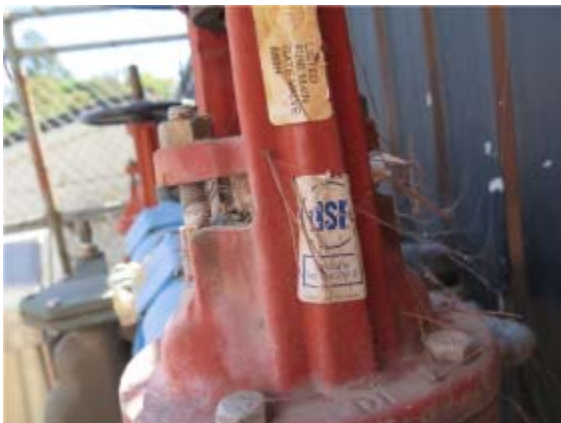
Photo #29: Water service backflow device

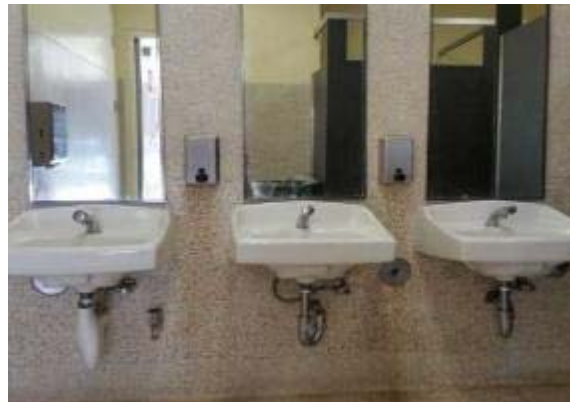
Photo #30: Lavatory sinks

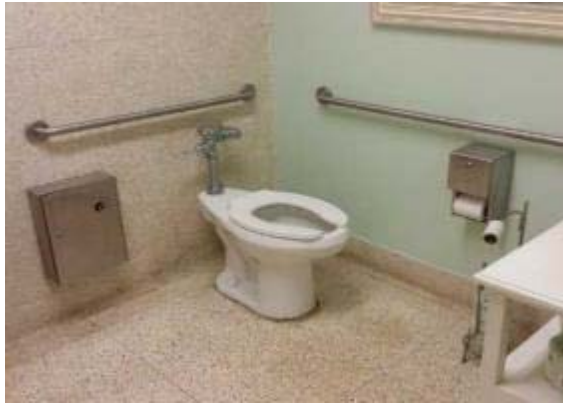
Photo #31: Restroom toilet

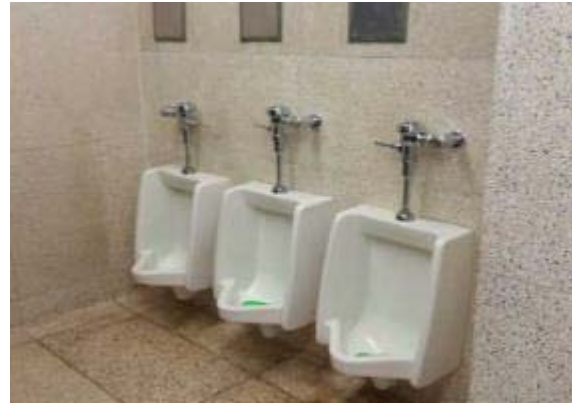
Photo #32: Restroom urinals

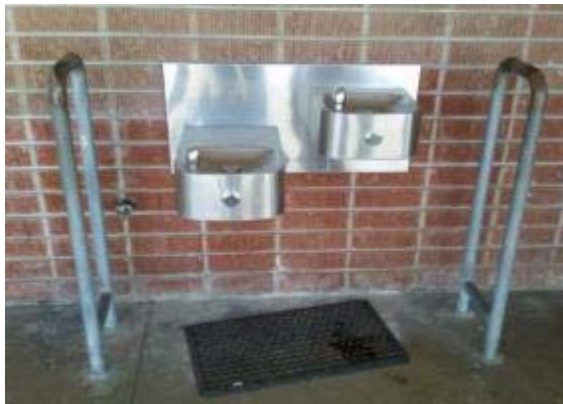
Photo #33: Drinking fountain

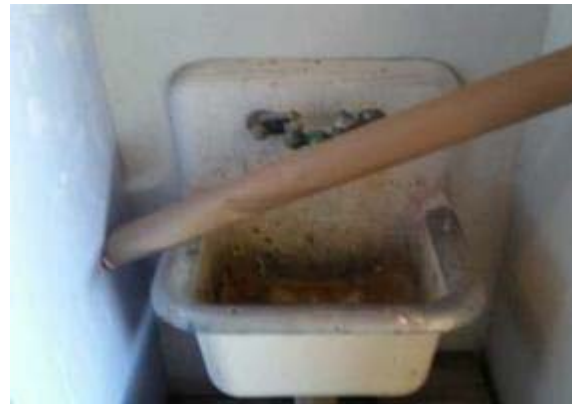
Photo #34: Mop sink

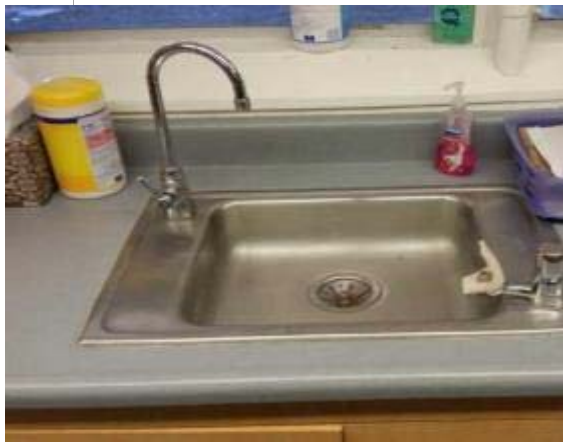
Photo #35: Classroom sink

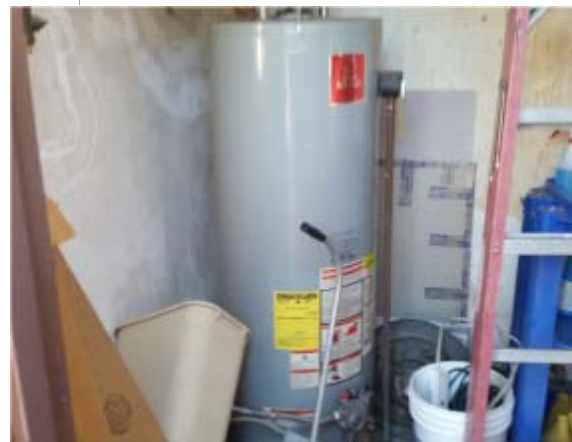
Photo #36: Water heater

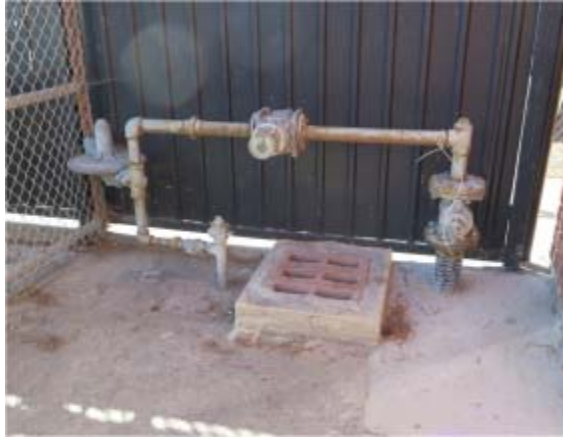
Photo #37: Natural gas service

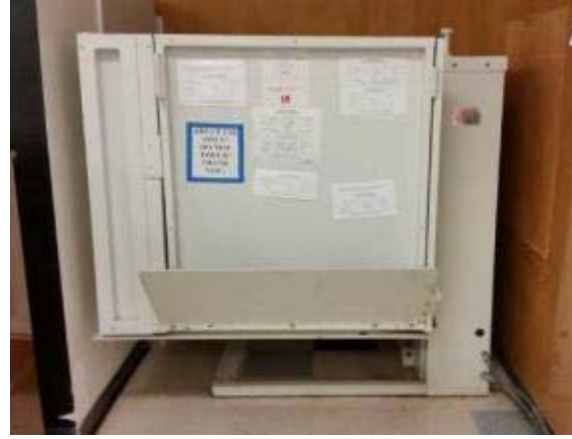
Photo #38: Wheelchair lift

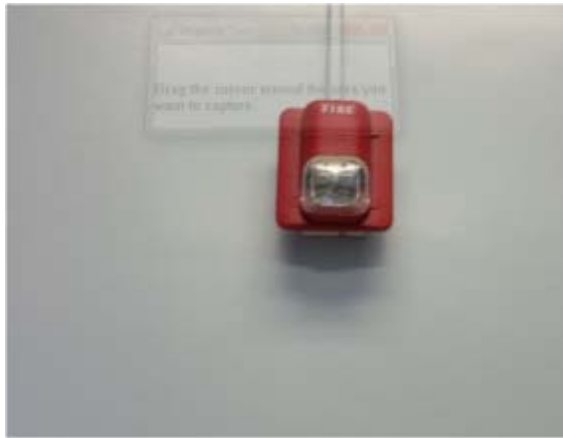
Photo #39: Fire alarm strobe

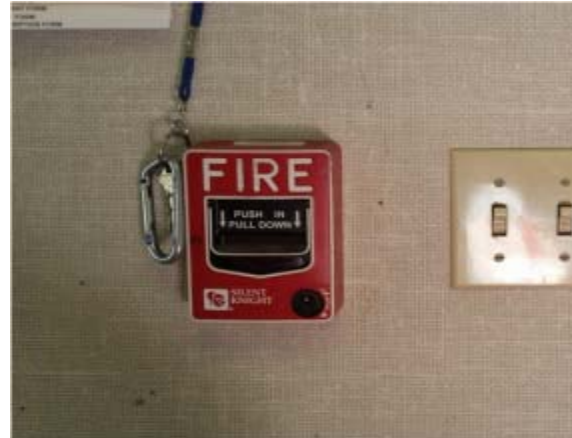
Photo #40: Fire alarm pull station

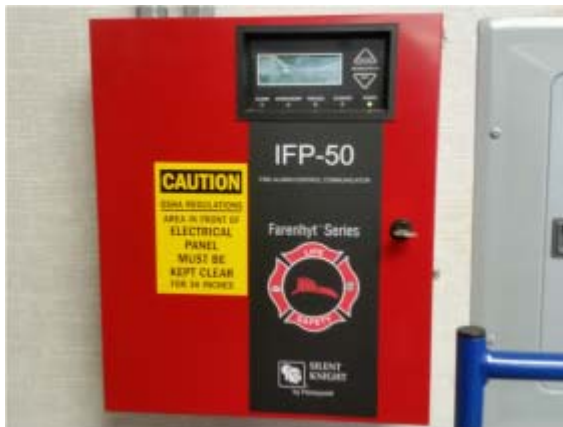
Photo #41: Fire alarm panel

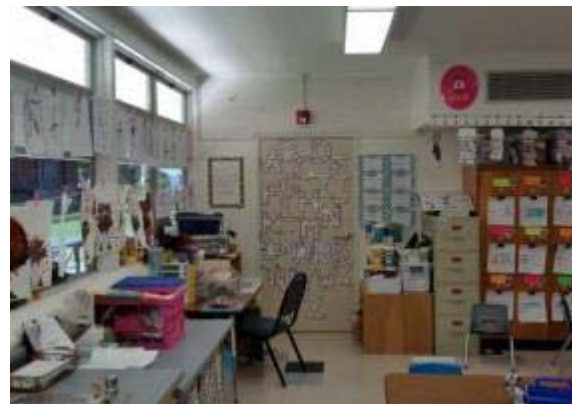
Photo #42: Classroom

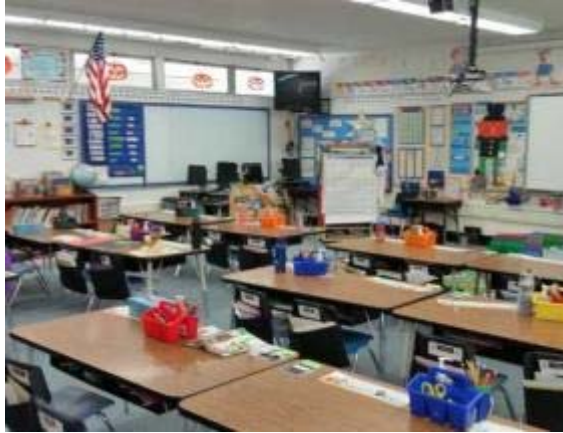
Photo #43: Classroom

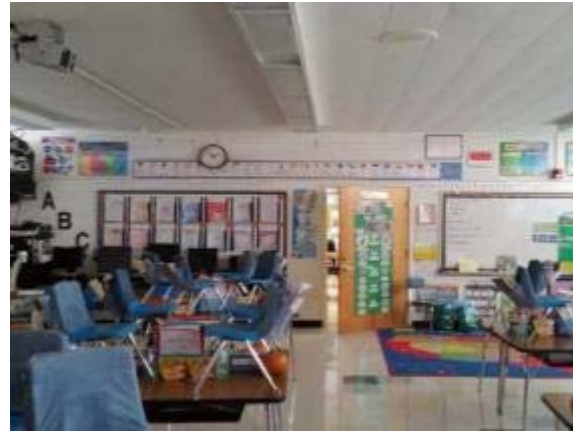
Photo #44: Classroom

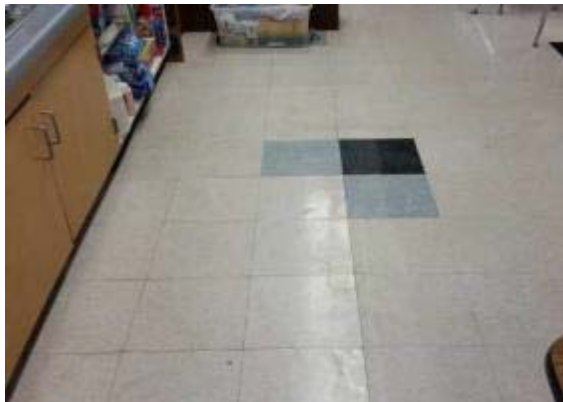
Photo #45: MPR flooring

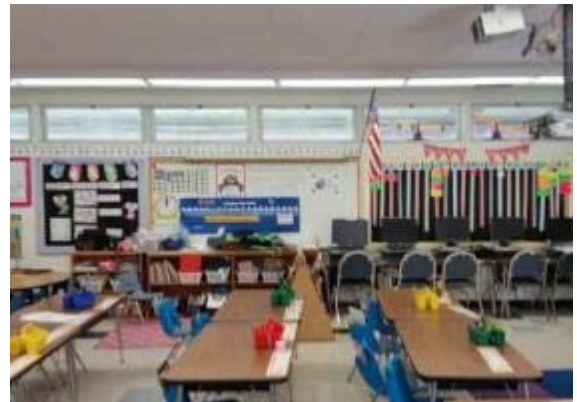
Photo #46: Classroom

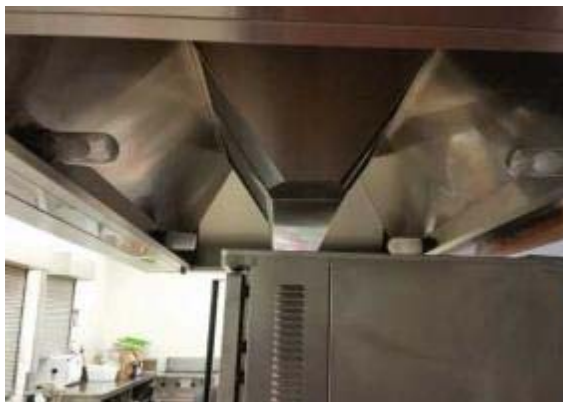
Photo #47: Kitchen hood

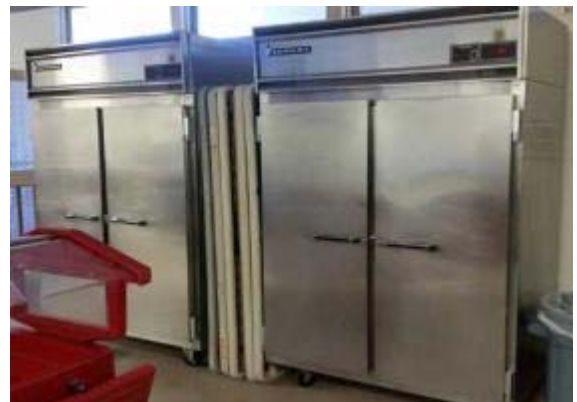
Photo #48: Kitchen commercial refrigerators

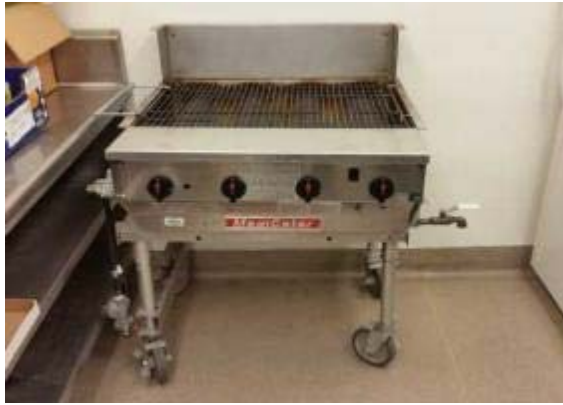
Photo #49: Kitchen commercial griddle

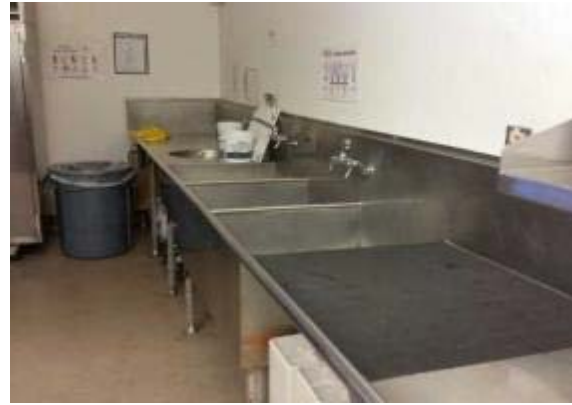
Photo #50: Kitchen commercial sink

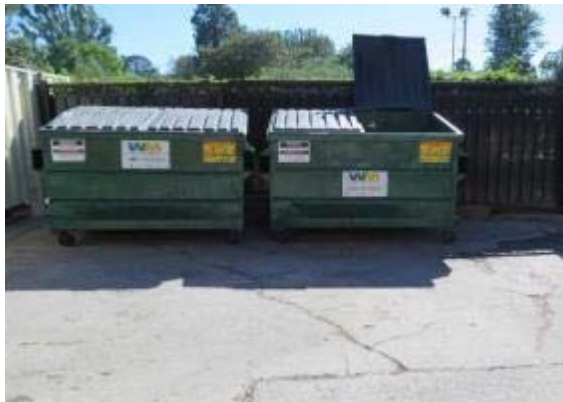
Photo #51: Trash containers

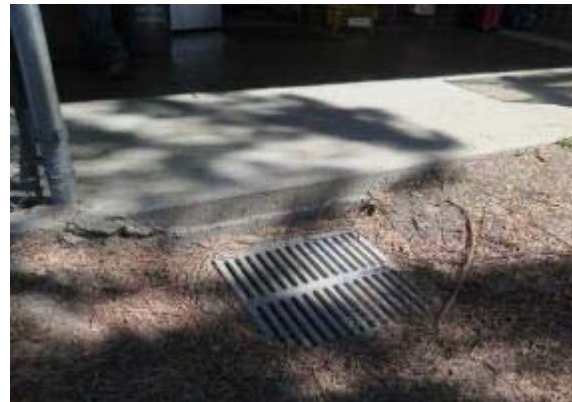
Photo #52: Trip hazard at landscape area drain

5.3	7 locations where drain below sidewalk	490975	Exterior Stairs & Ramps, Handrails, Metal, Replace	25	25	* 0	21	LF	\$65.91	\$1,384	\$1,384																			\$1,384

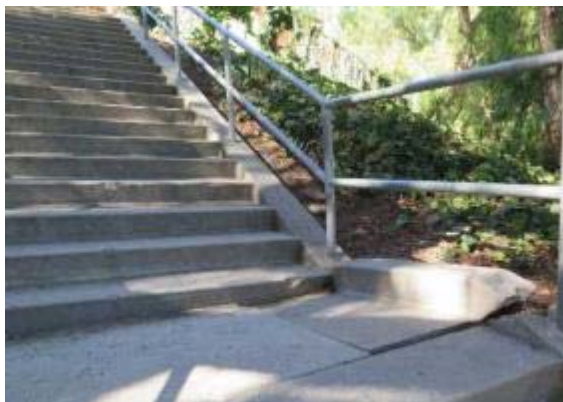
- The foundations and footings at the northeast classroom building, the stair at the eastern side of the site, and the drainage swale at the northern side of the site are showing signs of ground movement. A professional engineer must be retained to analyze the existing condition, provide recommendations and, if necessary, estimate the scope and cost of any required repairs. The cost of this study is included in the cost tables. The cost to repair is not included in the cost tables.

Photo #53: East stair settlement

5.2	Eastern site access	490575	Exterior Stairs & Ramps, Handrails, Metal, Replace	25	25	* 0	120	LF	\$45.91	\$5,509	\$5,509																			\$5,509
5.2	Eastern site access	490553	Exterior Stairs & Ramps, Concrete (per LF of Nosing), Replace	25	25	* 0	200	LF	\$38.43	\$7,686	\$7,686																			\$7,686

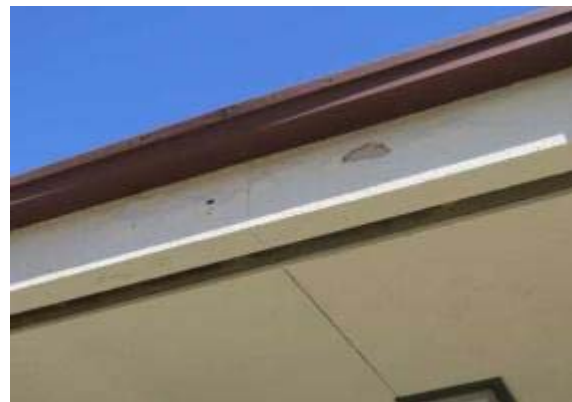
Photo #54: Paint spalling
