FACILITY CONDITION ASSESSMENT

PALOS VERDES PENINSULA UNIFIED SCHOOL DISTRICT

DAPPLEGRAY ELEMENTARY

November 30, 2016

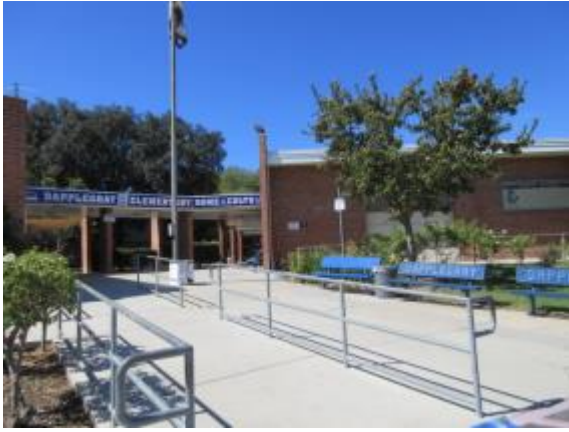
Photo #1: Main entrance

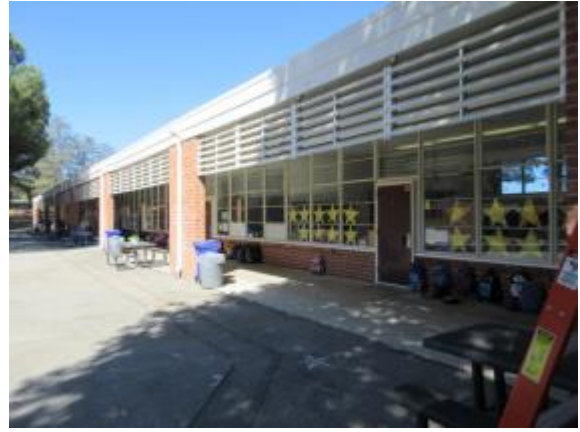
Photo #2: Front elevation

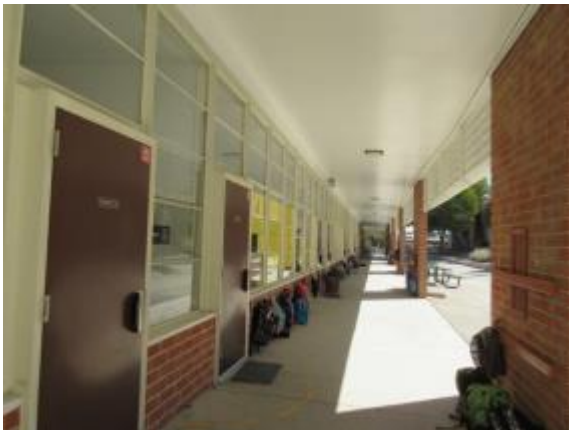
Photo #3: Front elevation

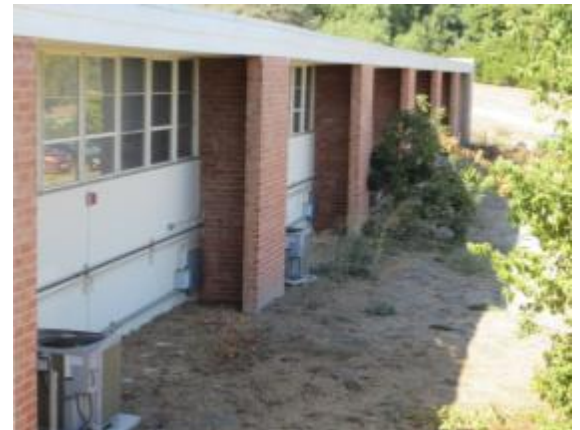
Photo #4: Back elevation

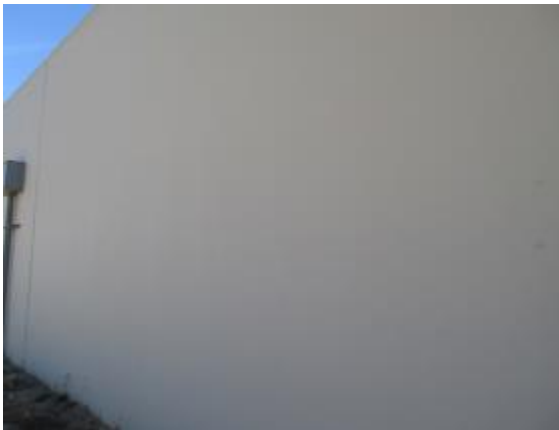
Photo #5: Side elevation

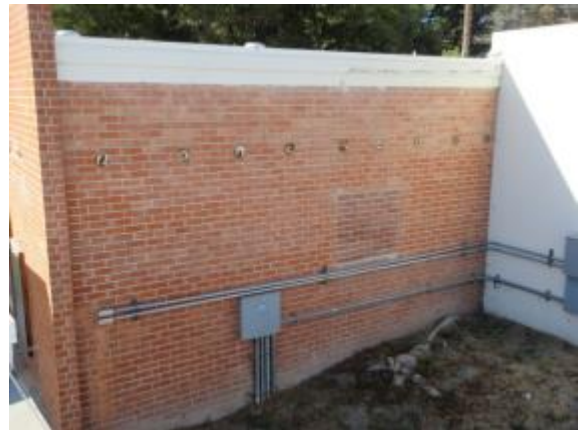
Photo #6: Side elevation

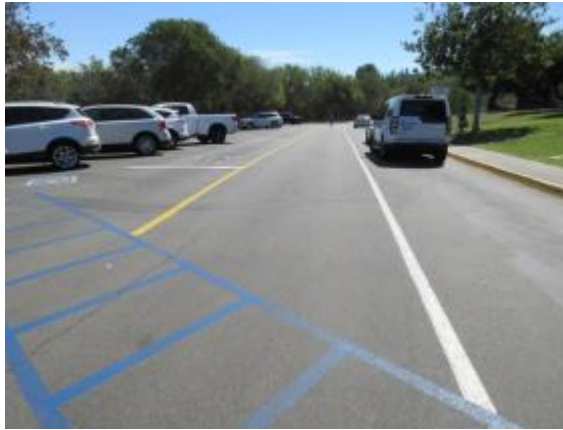
- The asphalt pavement exhibits significant isolated areas of failure and deterioration, such as alligator cracking and transverse cracking at the northeast section of the parking lot. The most severely damaged areas of paving must be cut and patched in order to maintain the integrity of the overall pavement system.
- No additional significant actions are identified at the present time. On-going periodic maintenance is highly recommended. Future lifecycle replacements of the components listed above will be required.

Photo #7: Parking lot

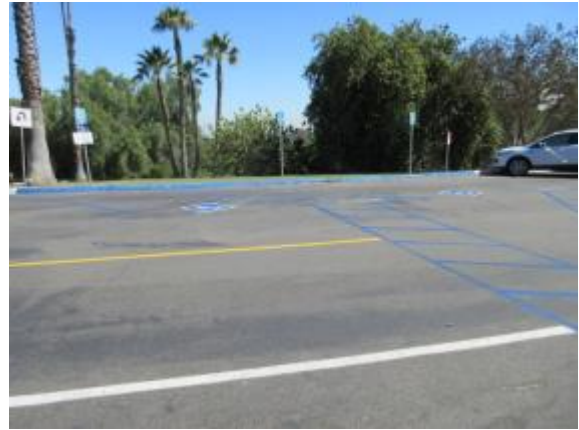
Photo #8: Accessible parking spaces

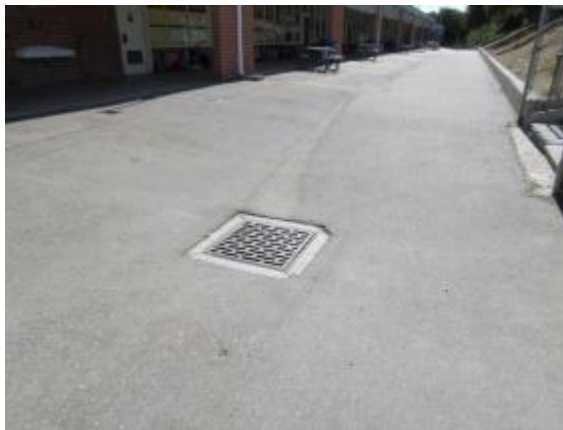
Photo #9: Storm drain

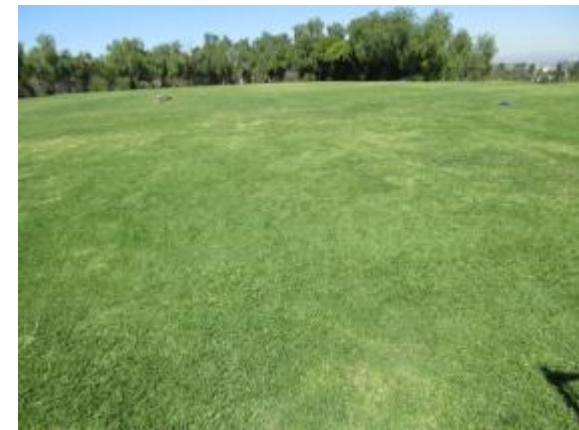
Photo #10: Soccer field

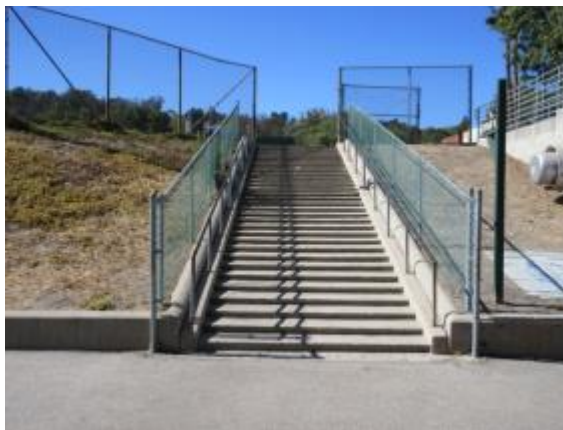
Photo #11: Site stairs

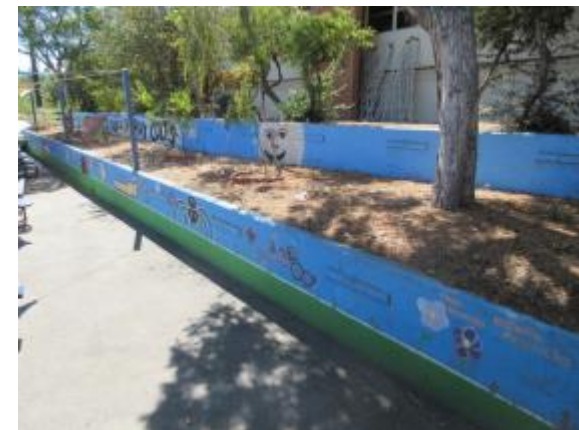
Photo #12: Retaining walls

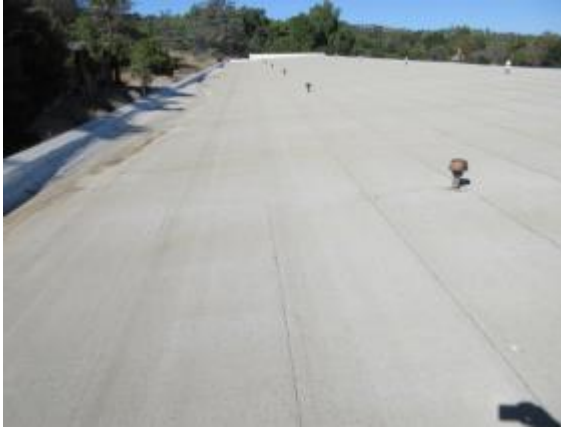
Photo #13: Roof

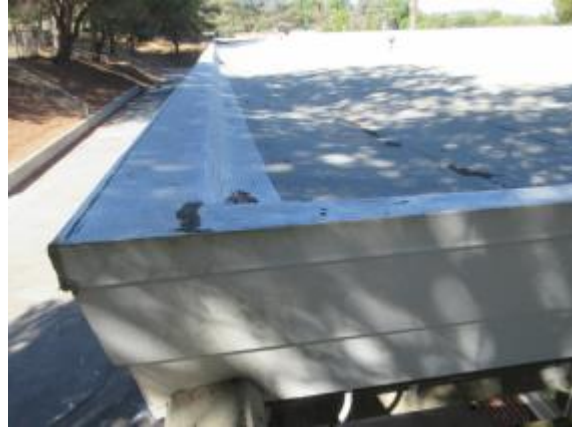
Photo #14: Roof flashing

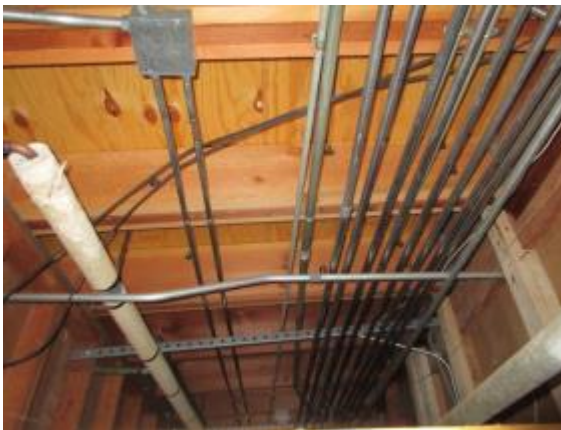
Photo #15: Roof structure

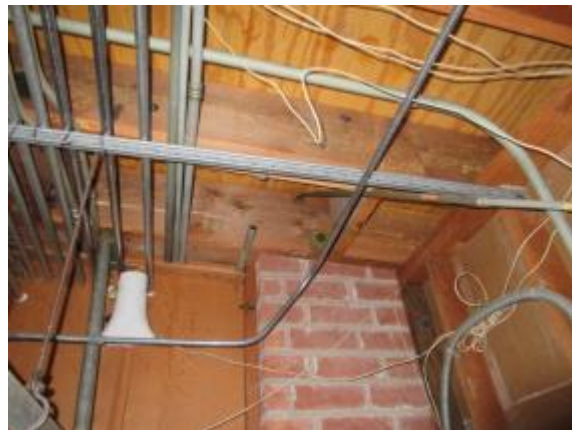
Photo #16: Roof structure

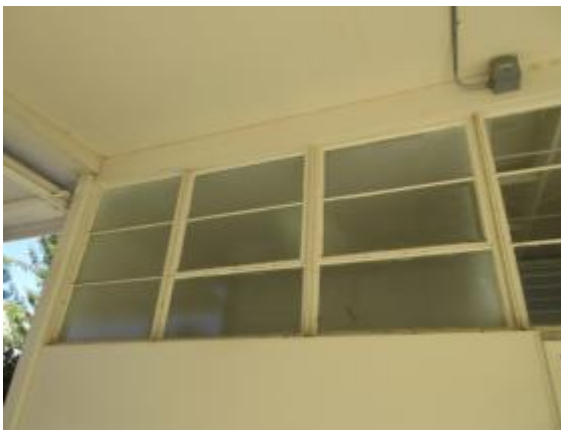
Photo #17: Classroom windows

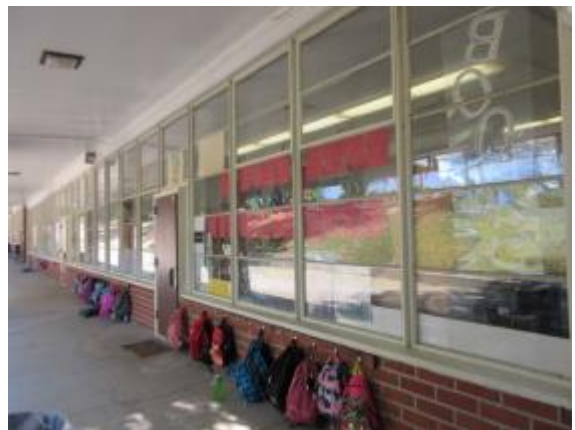
Photo #18: Classroom windows

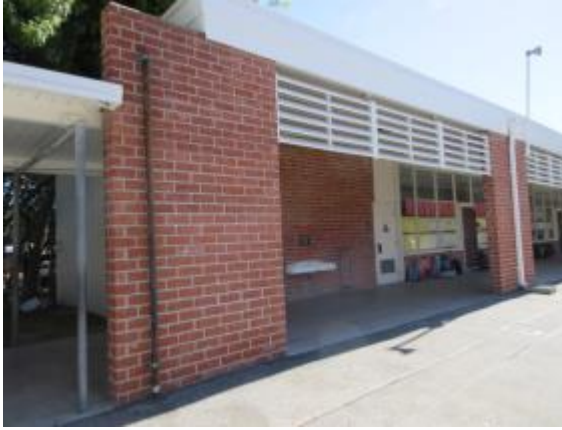
Photo #19: Overhang structure

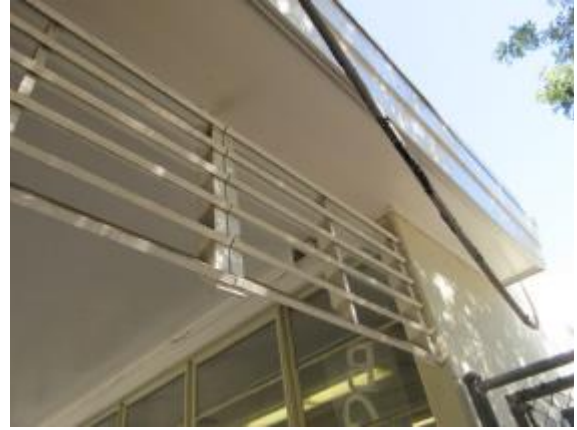
Photo #20: Overhangs

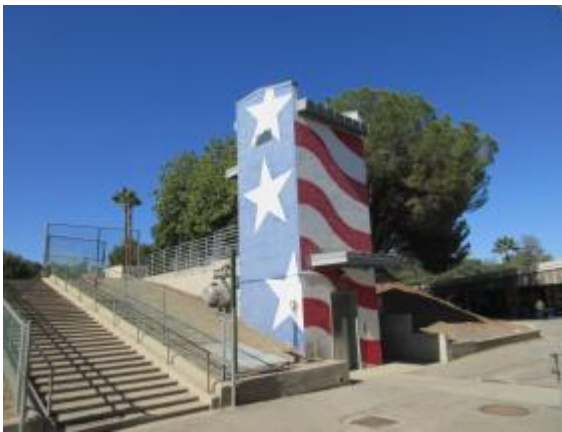
Photo #21: Elevator

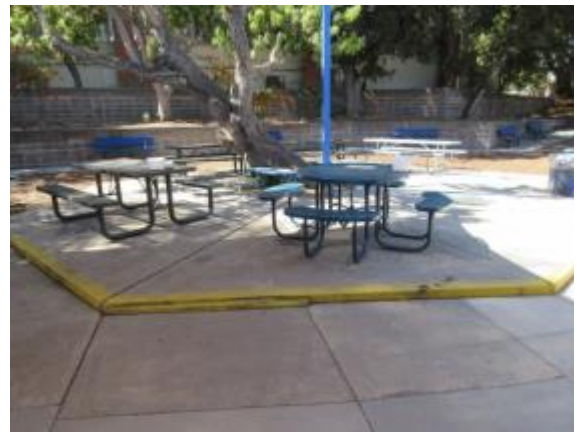
Photo #22: Lunch area

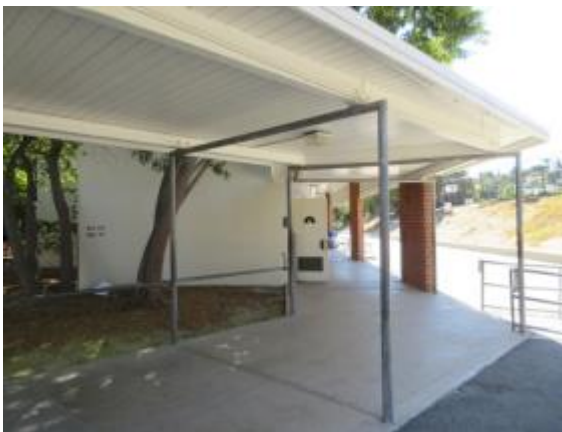
Photo #23: Walkway shade structure

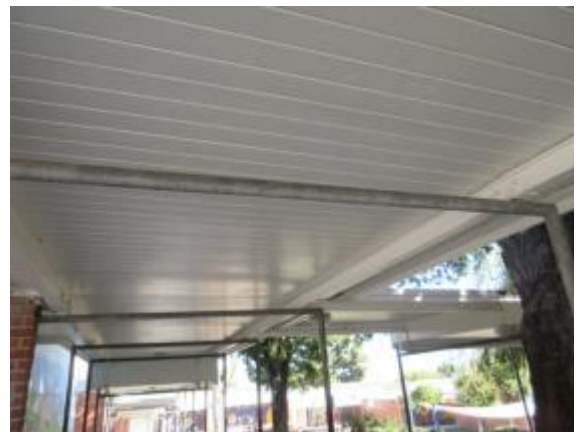
Photo #24: Walkway shade structure

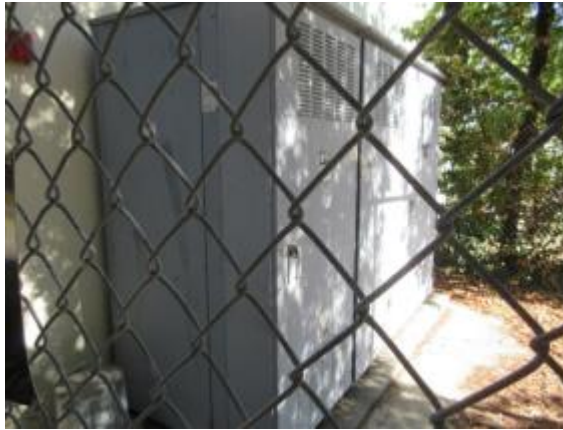
Photo #25: Main switchgear

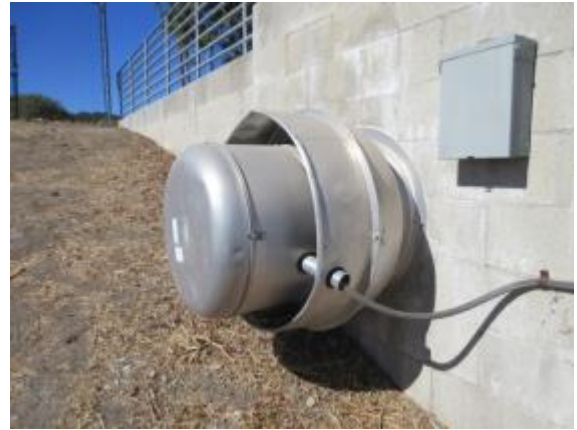
Photo #26: Elevator equipment room exhaust fan

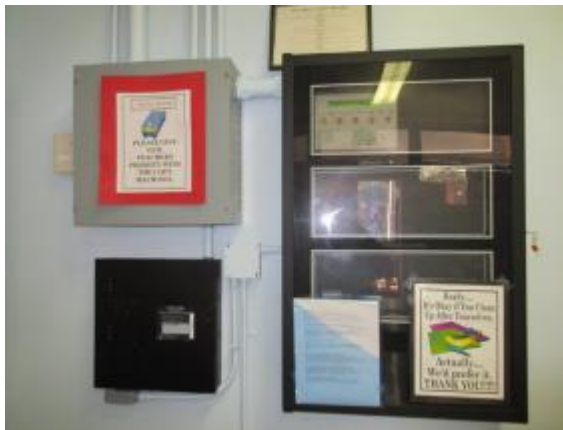
Photo #27: Fire alarm

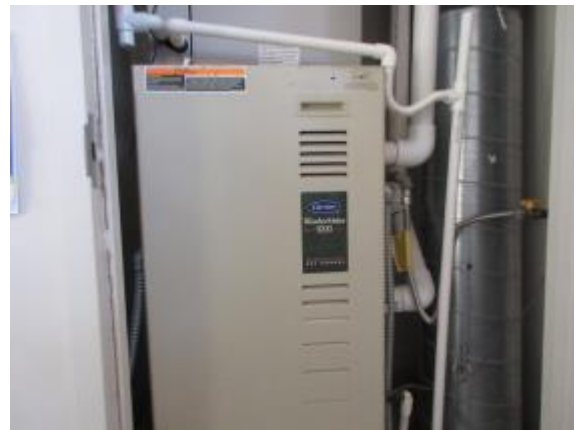
Photo #28: Gas furnace

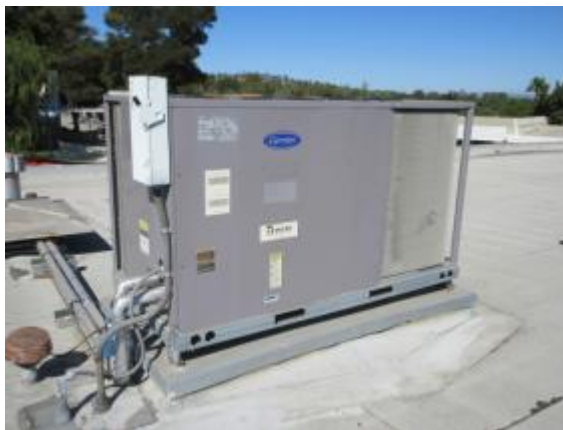
Photo #29: MPR condensing unit

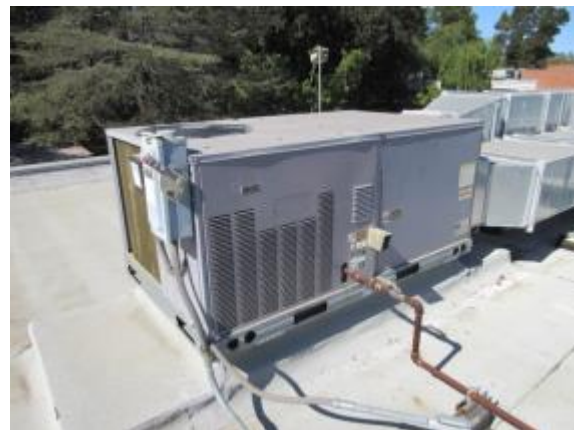
Photo #30: Rooftop package unit

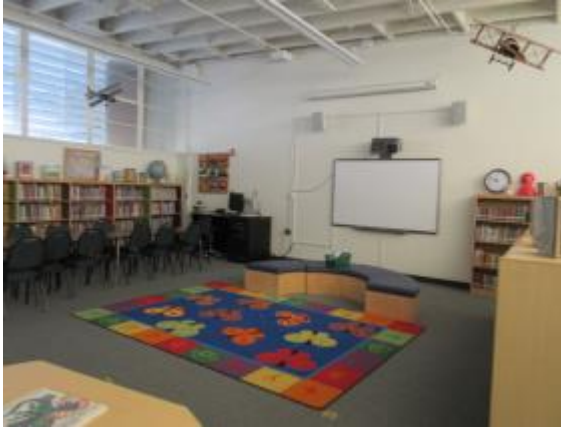
Photo #31: Literacy room

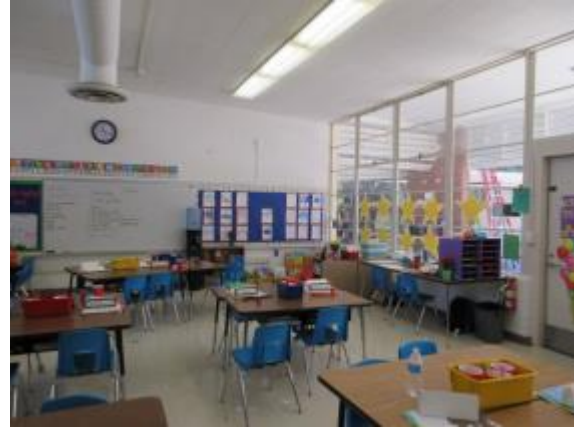
Photo #32: Classroom

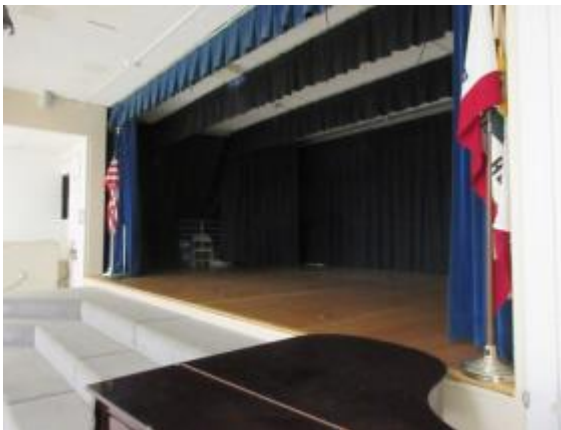
Photo #33: MPR stage

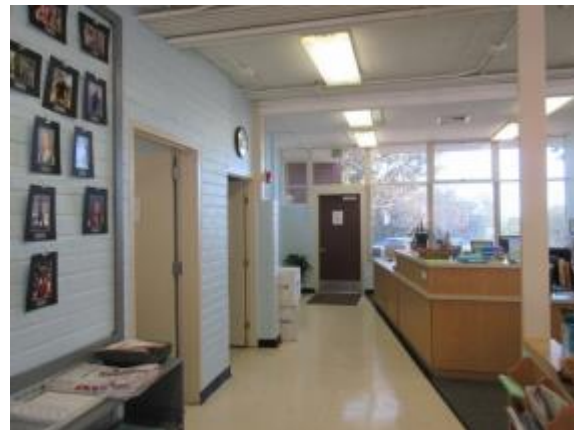
Photo #34: Main lobby

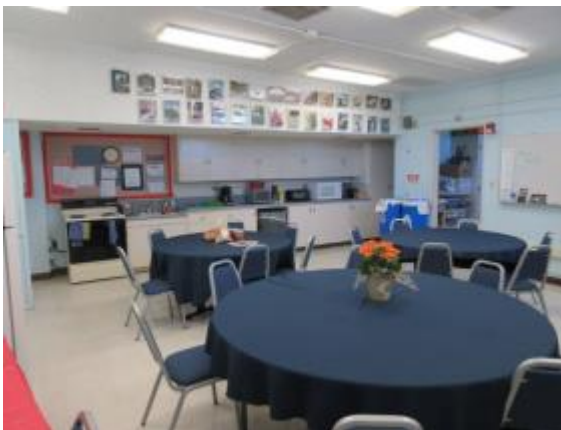
Photo #35: Breakroom

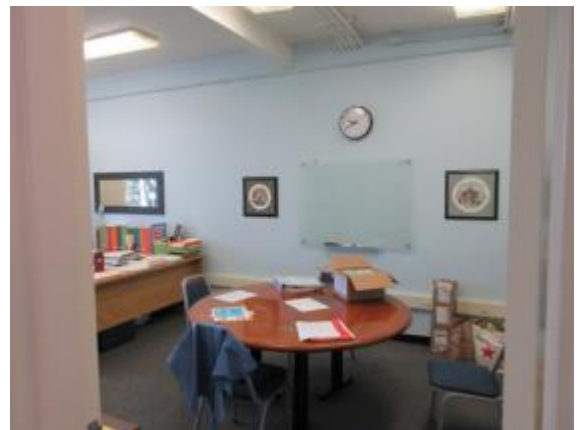
Photo #36: Office area

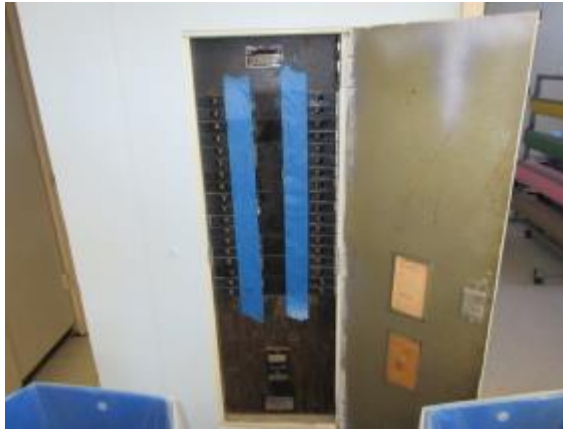
Photo #37: Abandoned in place electrical panel

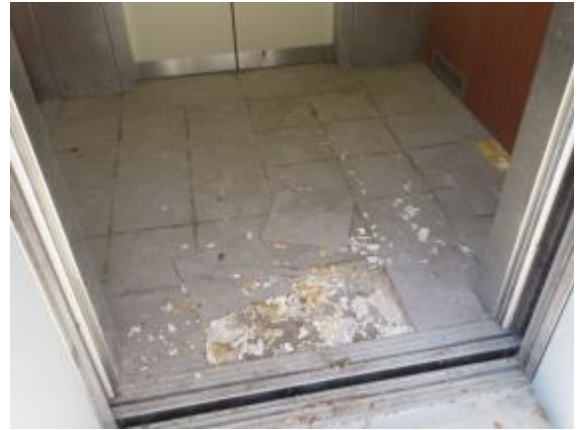
Photo #38: Damaged floor tiles at elevator cab

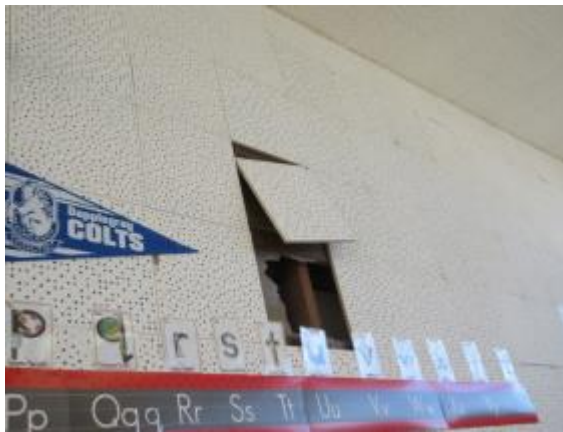
Photo #39: Missing wall (clerestory) tiles

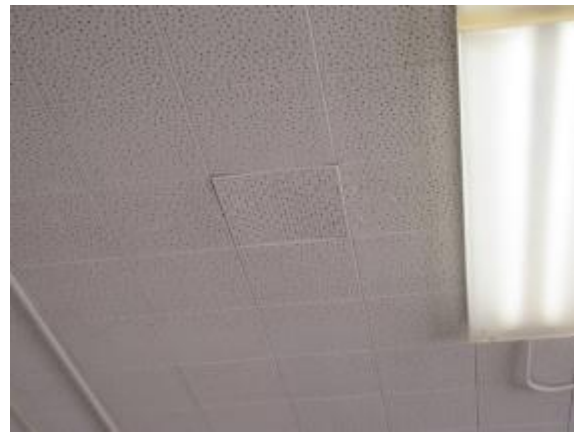
Photo #40: Loose ceiling tiles

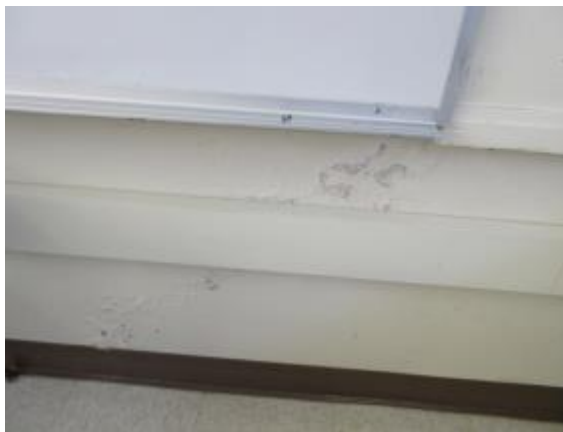
Photo #41: Water damage at Classroom 21

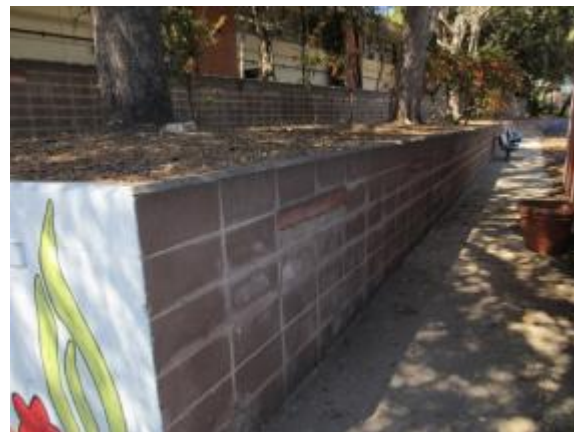
- The CMU retaining walls have isolated areas of efflorescence near the exterior lunch area. The affected areas of CMU masonry must be cleaned and an efflorescence-checking coating must also be applied to the CMU masonry.
- The topography and adjacent uses do not appear to present conditions detrimental to the property. There are no significant areas of erosion.

Photo #42: Efflorescence at retaining wall
