FACILITY CONDITION ASSESSMENT

**PALOS VERDES PENINSULA UNIFIED SCHOOL DISTRICT
PVPUSD / MALAGA COVE**

375 VIA ALMAR

November 29, 2016

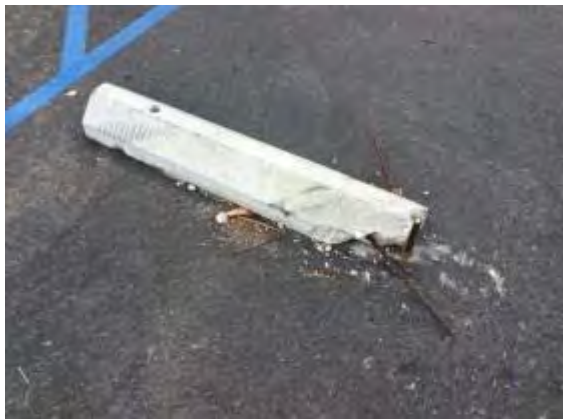
Photo #15: Damaged wheel stop at lower parking lot

5.2	482580	Parking Lots Wheel Stop, Wheel Stop, Concrete, Replace	20	20	0	1	EA	\$237.96	\$238	\$238																		\$238							
	5.5	481747	Basketball Courts - Seal & Stripe, Asphalt, Seal & Stripe	5	3	2	6000	SF	\$0.38	\$2,283			\$2,283			\$2,283					\$2,283					\$2,283			\$9,132

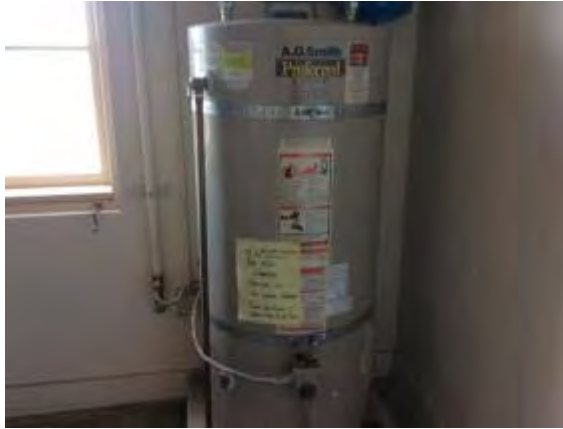
Photo #43: Water heater

7.2	589991	Backflow Preventer, Domestic Water Supply, Replace	15	13	2	1	EA	\$6,001.42	\$6,001			\$6,001													\$6,001			\$12,003							
	7.2	482952	Water Heater, 30 GAL, Replace	10	10	0	1	EA	\$2,349.48	\$2,349	\$2,349								\$2,349										\$4,699

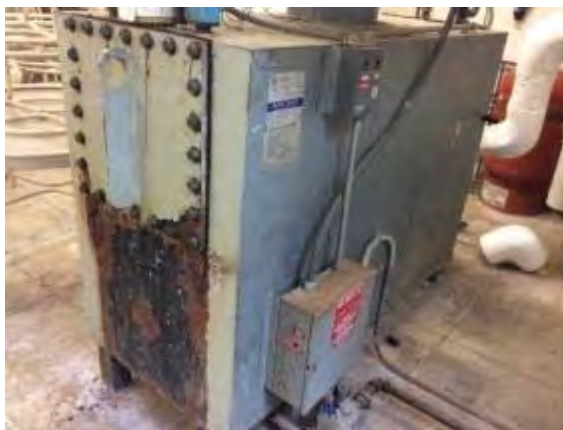
Photo #47: Boiler

7.1	482473	Boiler, 750 MBH, Install	25	24	1	1	EA	\$23,840.87	\$23,841		\$23,841																	\$23,841							
	7.1	482472	Boiler, 750 MBH, Replace	25	24	1	1	EA	\$23,840.87	\$23,841		\$23,841																	\$23,841
