# FACILITY CONDITION ASSESSMENT

PALOS VERDES PENINSULA UNIFIED SCHOOL DISTRICT

LUNADA BAY ELEMENTARY

November 30, 2016

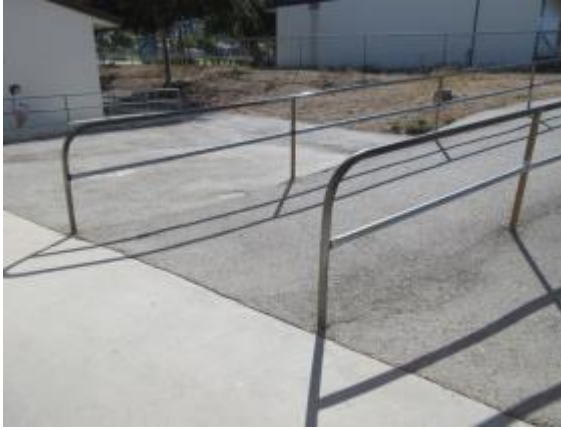
Photo #55: Non-compliant handrails

Report Section	Location Description	ID	Cost Description	Quantity	Unit	Unit Cost	Subtotal	Deficiency Repair Estimate *
3.1	Throughout Property	486672	ADA, Miscellaneous, Ramp/Stairs, Handrails, Modify	8	EA	\$316.25	\$2,530	<b>\$2,530</b>

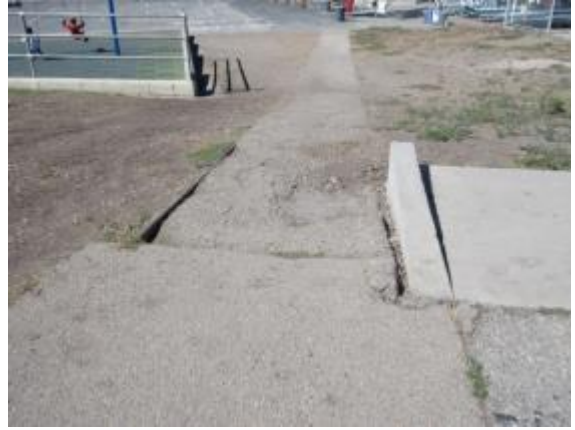
Photo #56: Pedestrian sidewalk in poor condition

5.2	East Part of the Property	486714	Pedestrian Pavement, Sidewalk, Asphalt, Replace	300	SF	\$2.60	\$781	<b>\$781</b>
5.3	Upper Parking Lot	588320	Storm Water Drainage, Drainage Piping, Replace	102	LF	\$98.45	\$10,042	<b>\$10,042</b>

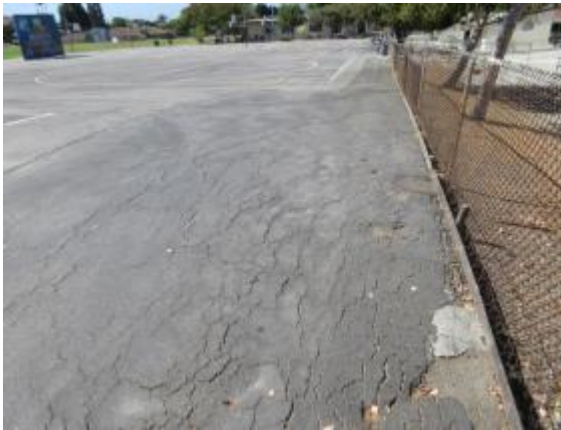
Photo #57: Playground asphalt in poor condition

5.5	Throughout Property	486734	Fences & Gates, Chain Link, 8' High, Replace	30	17	13	1628	LF	\$53.90	\$87,749														\$87,749								\$87,749
5.5	Northeast Playground and Southeast Basketball Courts	486720	Play Surfaces & Sports Courts, Asphalt, Cut and Patch	25	25	0	800	SF	\$5.90	\$4,720	\$4,720																					\$4,720

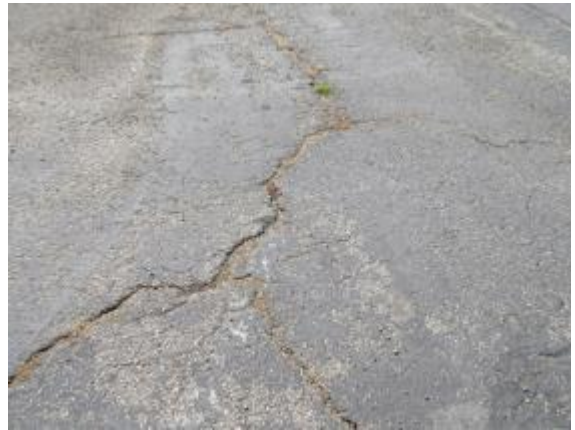
Photo #58: Basketball/volleyball court asphalt in poor condition

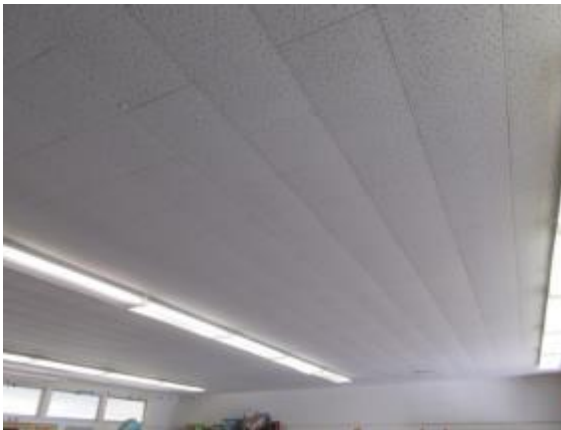
Photo #59: Ceiling in poor condition at classroom 17

8.1	Classrooms 17 & 18, MPR	487470	Interior Ceiling Finish, Acoustical Tile (ACT), Replace	6100	SF	\$3.11	\$18,977	<b>\$18,977</b>
<b>Immediate Repairs Total</b>								<b>\$193,834</b>

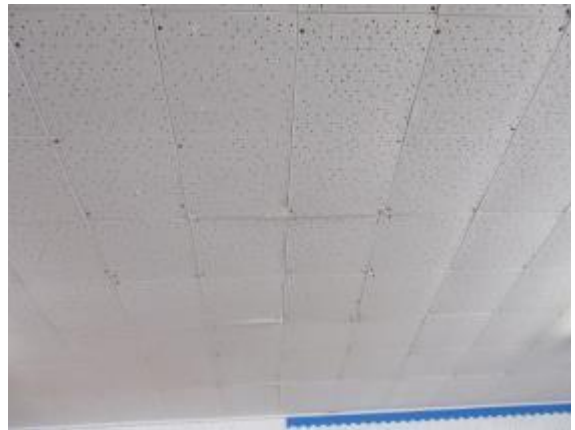
Photo #60: Ceiling in poor condition at classroom 18
