# FACILITY CONDITION ASSESSMENT

PALOS VERDES PENINSULA UNIFIED SCHOOL DISTRICT  
MIRA CATALINA ELEMENTARY  
30511 LUCANIA DRIVE  
RANCHO PALOS VERDES, CALIFORNIA 90275

119663.16R000-002.017

December 14, 2016

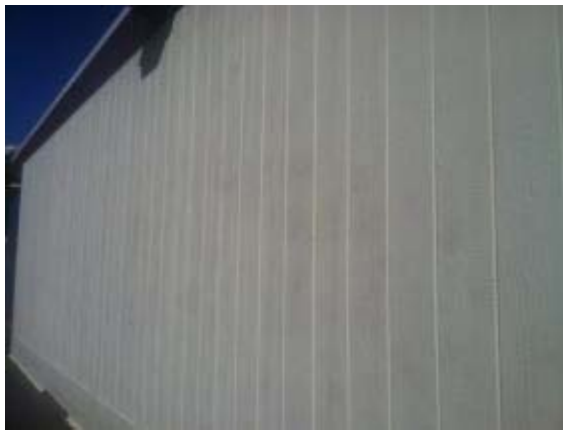
Photo #17: Modular classroom exterior siding

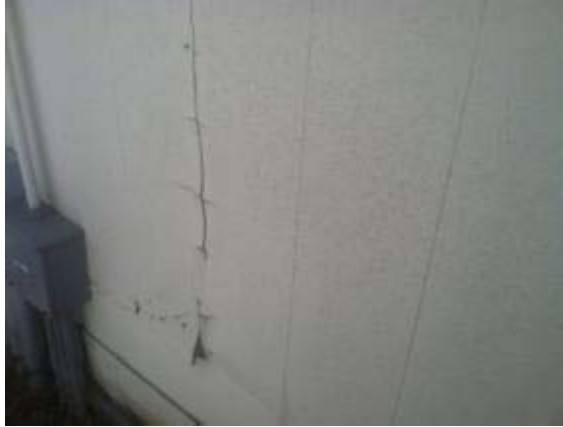
Photo #37: Deteriorated wood siding

6.4	Modular Classrooms		492818	Exterior Wall, Textured Plywood (T1-11), Repair	100	SF	\$11.50	\$1,150	<b>\$1,150</b>
6.6	Front office		492970	Storefront, Metal-Framed 3' x 7' Swinging Door Only, Replace	1	EA	\$2,106.57	\$2,107	<b>\$2,107</b>

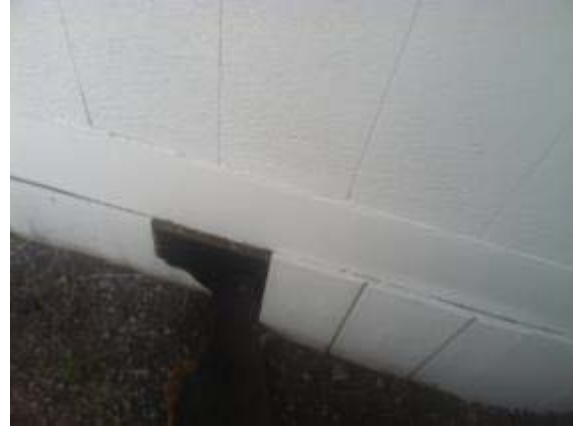
Photo #38: Deteriorated wood siding

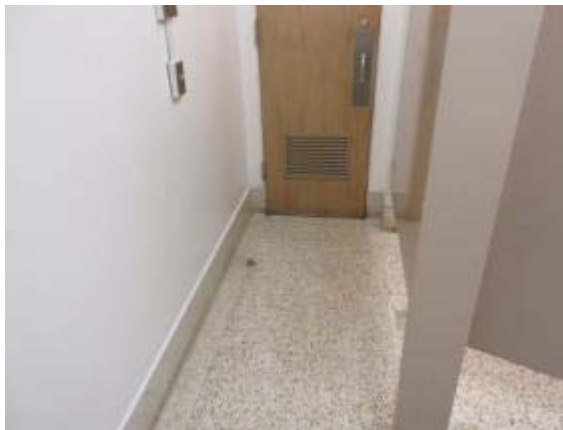
Photo #39: Non accessible restroom entrance

Report Section	Location	Description	ID	Cost Description	Quantity	Unit	Unit Cost	Subtotal	Deficiency Repair Estimate *
3.1	Restrooms		492043	ADA, Miscellaneous (Lump Sum Budgetary Allowance), Upgrade	1	EA	\$30,360.00	\$30,360	<b>\$30,360</b>

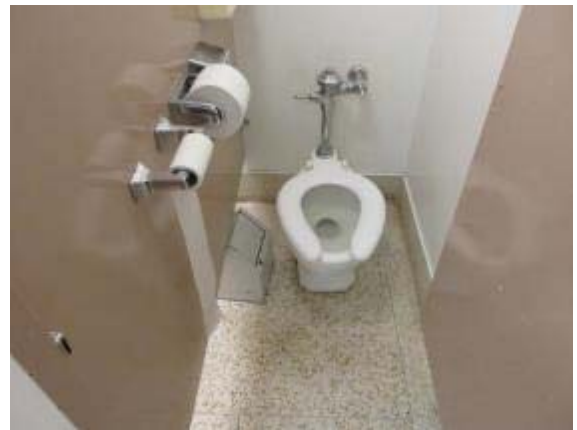
Photo #40: Non accessible restroom stall

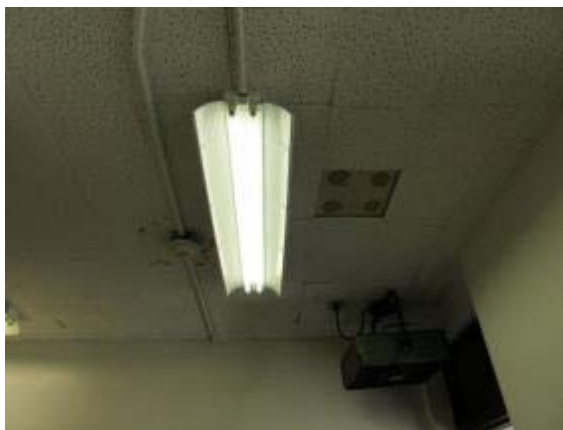
Photo #41: Deteriorated kitchen ceiling

6.6	Front office		492968	Storefront, Metal-Framed Windows w/out Door(s), Replace	81	SF	\$48.00	\$3,888	<b>\$3,888</b>
8.1	Kitchen		493359	Interior Ceiling Finish, Acoustical Tile (ACT), Replace	225	SF	\$3.11	\$700	<b>\$700</b>
<b>Immediate Repairs Total</b>									<b>\$58,886</b>

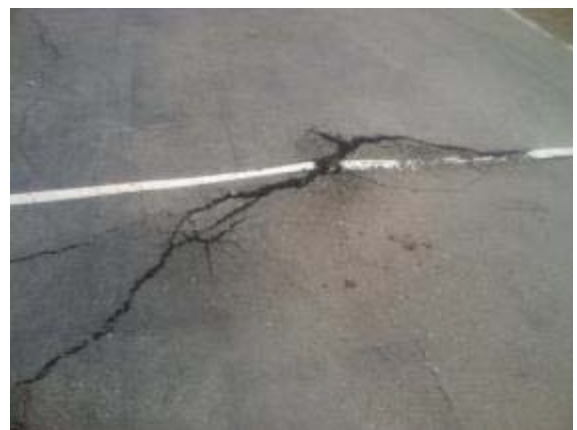
Photo #42: Damaged basketball court asphalt

5.3	Site		588365	Storm Water Drainage, Drainage Piping, Replace	200	LF	\$98.45	\$19,690	<b>\$19,690</b>
5.5	Basketball court		493368	Parking Lots, Asphalt Pavement, Cut & Patch	200	SF	\$4.96	\$992	<b>\$992</b>
