FACILITY CONDITION ASSESSMENT

MIRALESTE (MELA)

6245 VIA CANADA

December 21, 2016

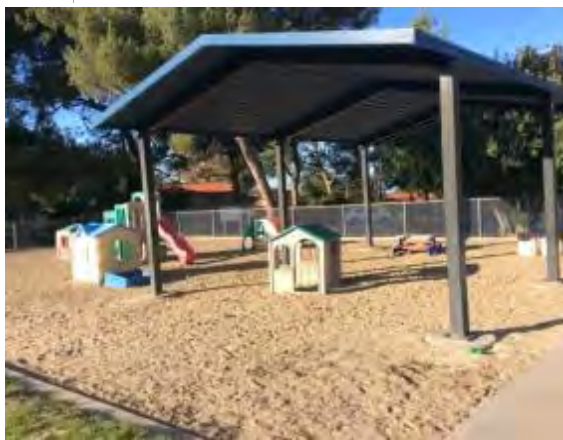
Photo #11: Sand box

- Install accessible rubber playground surface in place of sand
- Replace tile roofing substrate
- Replace galvanized iron supply plumbing infrastructure
- Replace wood windows
- Renovation of building storm water drains

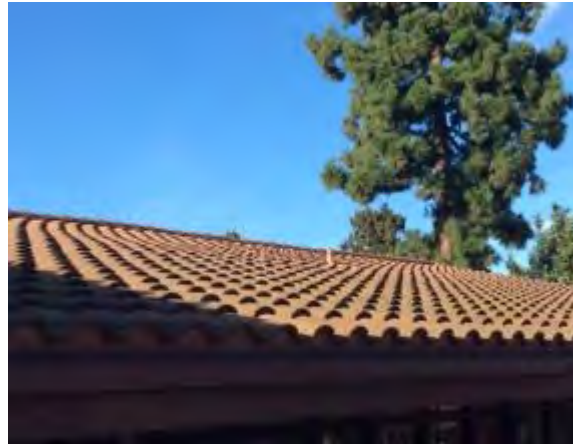
Photo #14: Clay tile roof

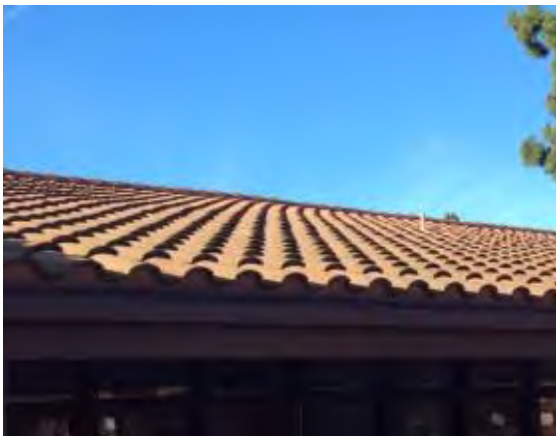
Photo #15: Clay tile roof

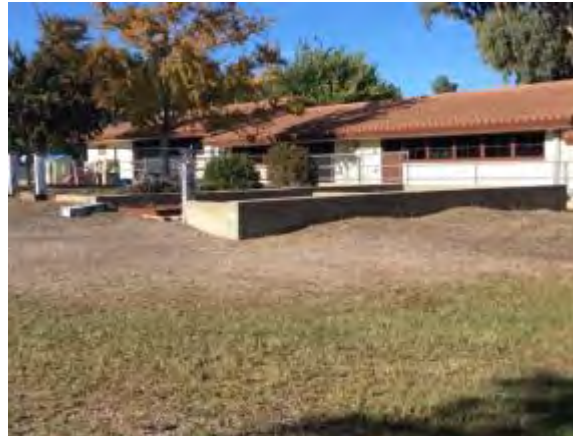
Photo #16: Clay tile roof

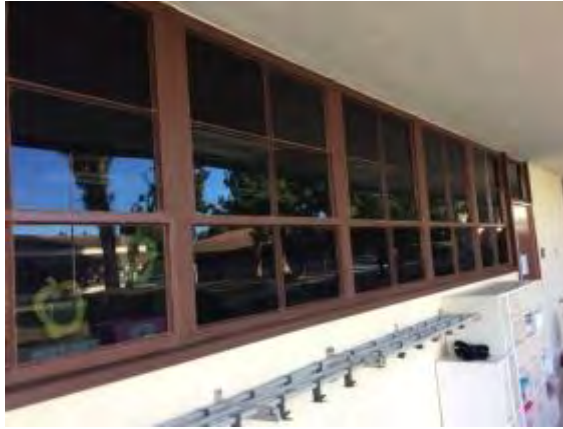
Photo #19: Windows

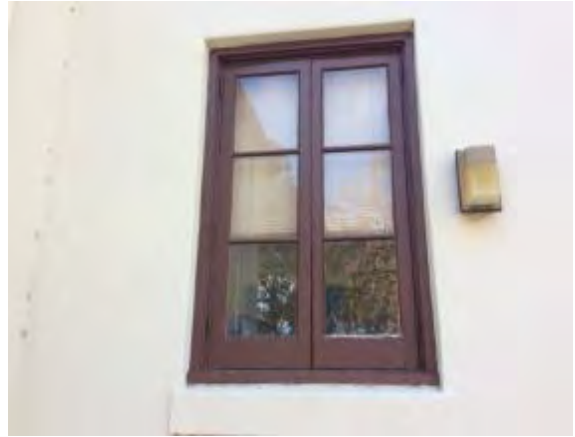
Photo #20: Window

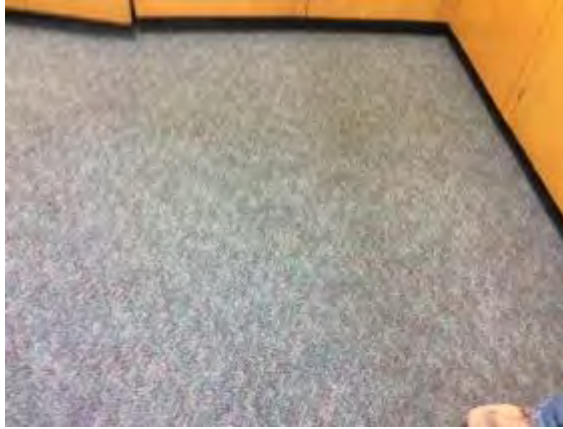
Photo
#31: Carpet

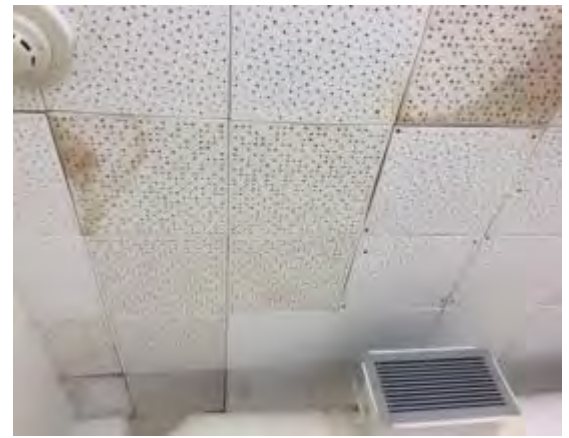
Photo
#34: Acoustical ceiling tiles (glued)

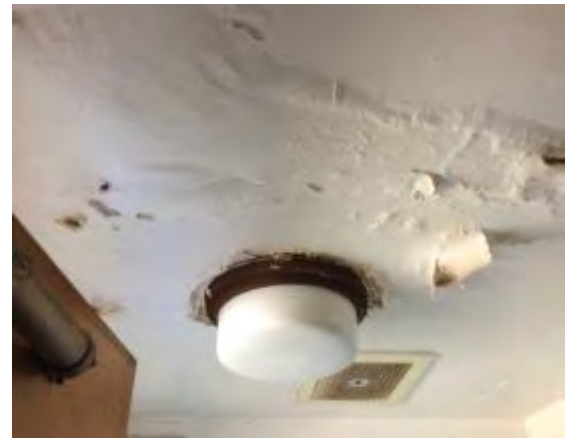
Areas of suspected fungal growth were found in an unused restroom adjacent to the Multi-Purpose Room. Approximately 10 square feet of plaster/drywall ceiling is affected.

The suspected fungal growth appears to be the result of repaired roof leaks. Exposure to suspected fungal growth can be hazardous and should be avoided. The presence of suspected fungal growth does not necessarily constitute an exposure. This assessment does not constitute a comprehensive moisture intrusion survey of the Project, and any conclusions are based solely on conditions readily observable in accessed areas.

Photo #40: Fungal growth (unused restroom at MPR)

Based on the apparent limited extent of suspected fungal growth (less than 30 square feet), the suspected fungal growth can be abated by the onsite maintenance staff as part of the property's routine maintenance program. Such persons should receive training in accordance with OSHA on proper clean up methods, personal protection, and potential health/safety hazards. The cost of this work is not included in the cost tables.
