FACILITY CONDITION ASSESSMENT

FACILITY CONDITION ASSESSMENT
OF
PALOS VERDES PENINSULA UNIFIED SCHOOL DISTRICT
MONTEMALAGA ELEMENTARY
1121 VIA NOGALES
PALOS VERDES ESTATES, CALIFORNIA 90274

119663.16R000-003.017

November 23, 2016

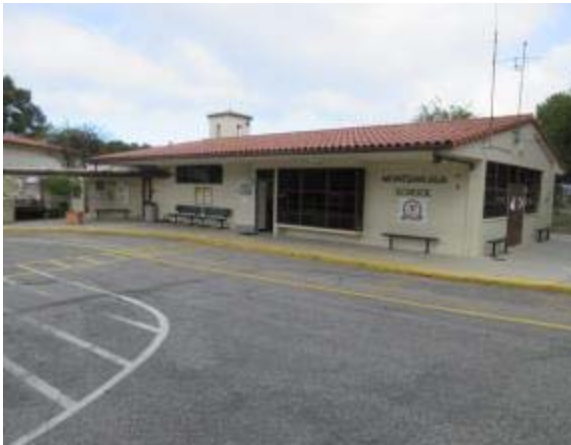
Photo #1: School office

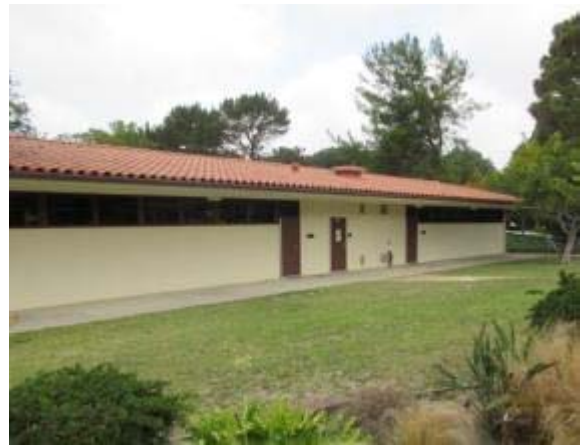
Photo #2: Classroom building

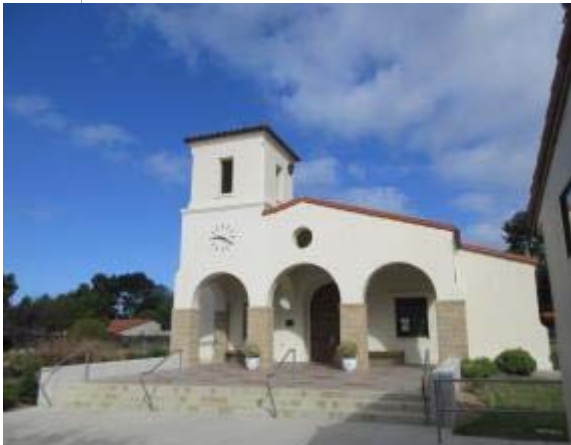
Photo #3: School library

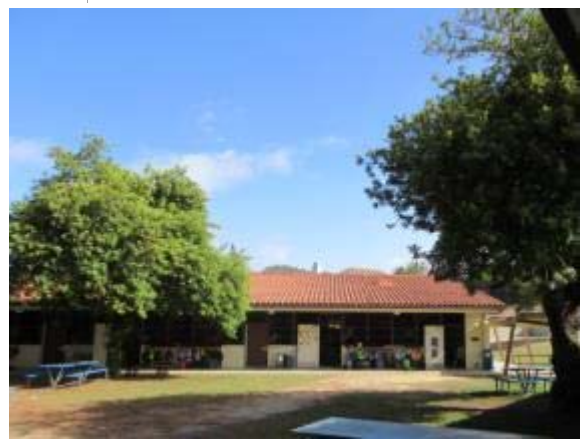
Photo #4: Classroom building

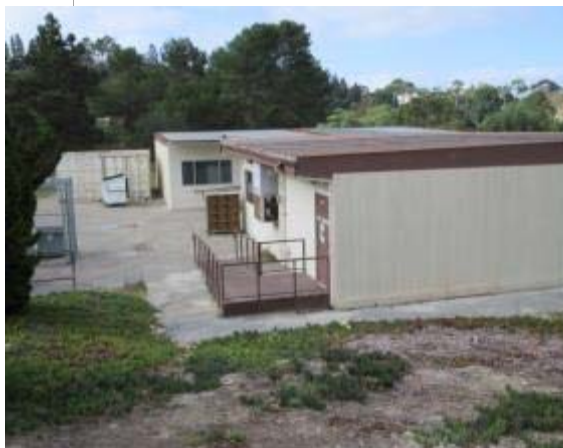
Photo #5: Portable classroom buildings

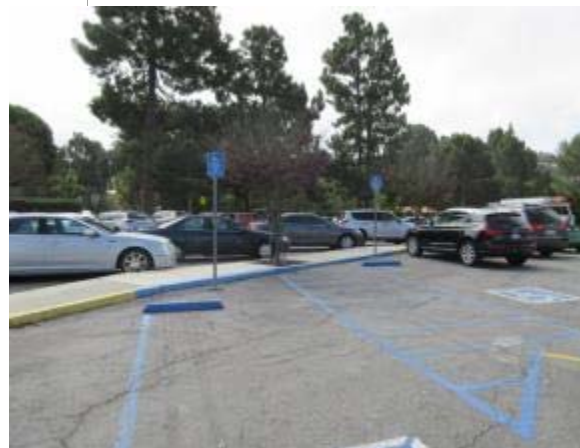
Photo #6: Parking lot

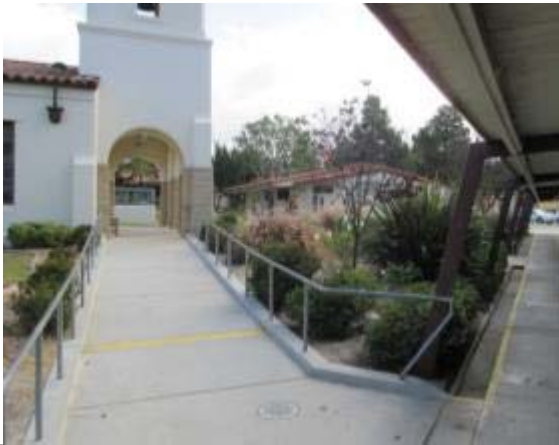
Photo #7: Walkway

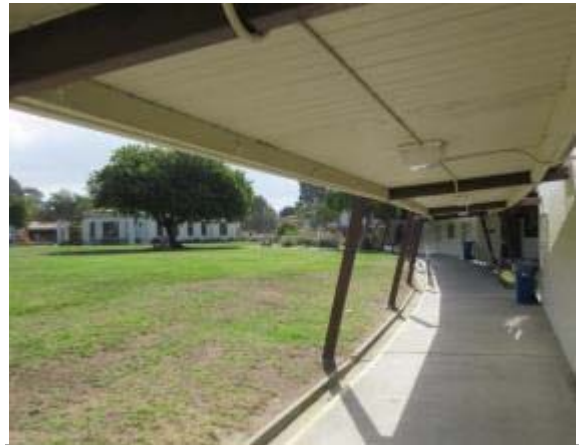
Photo #8: Covered walkway

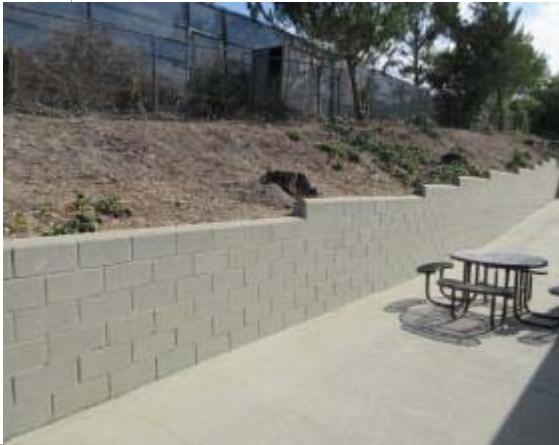
Photo #9: Retaining wall

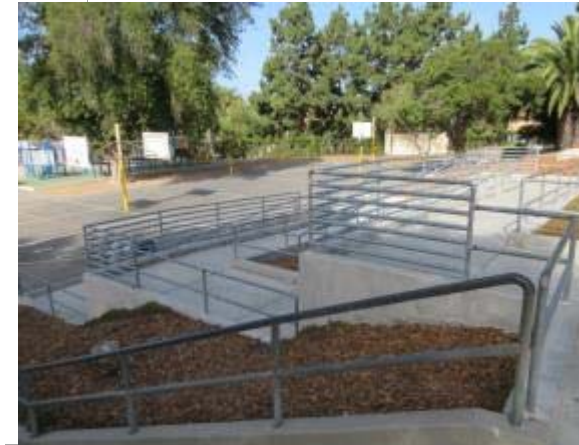
Photo #10: Ramp to playground

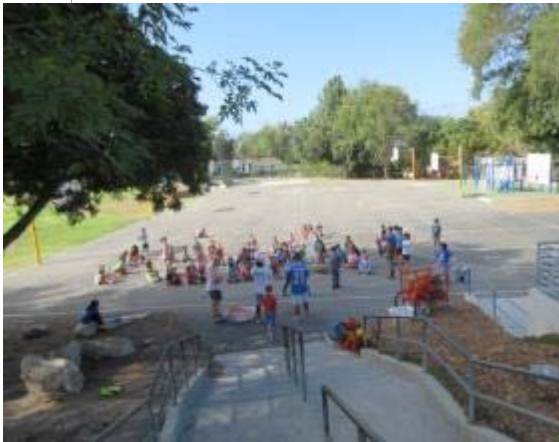
Photo #11: Stairway to playground

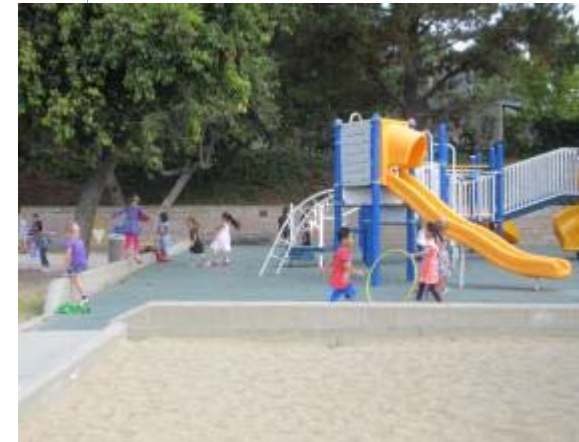
Photo #12: Kindergarten play structure

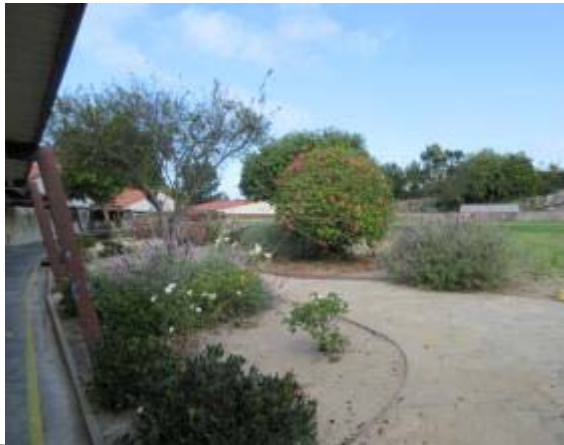
Photo #13: Landscape area

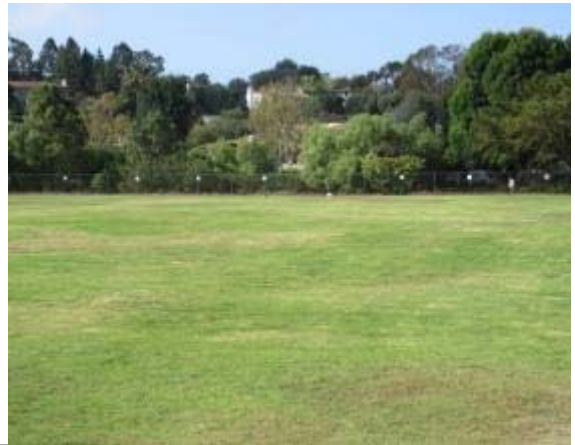
Photo #14: Playing fields

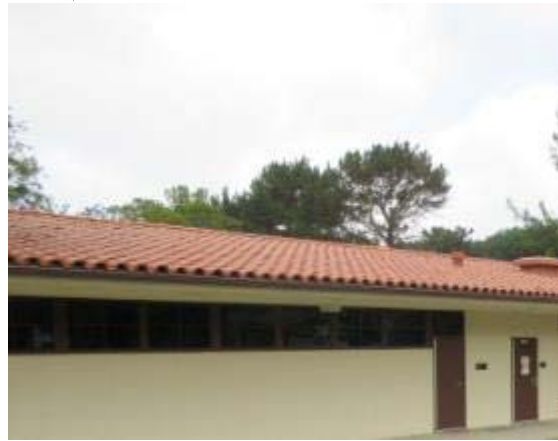
Photo #15: Tile roof at permanent buildings

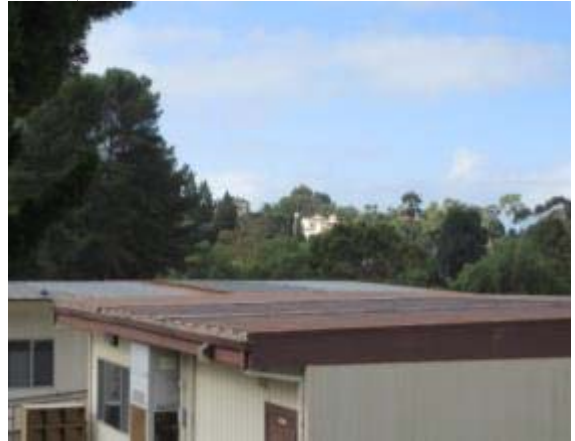
Photo #16: Metal roof at portable structures

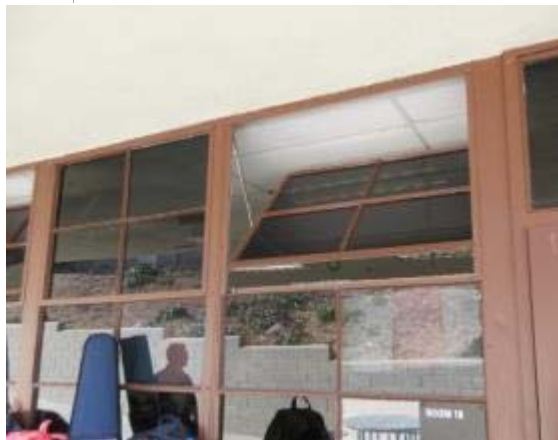
Photo #17: Windows at permanent buildings

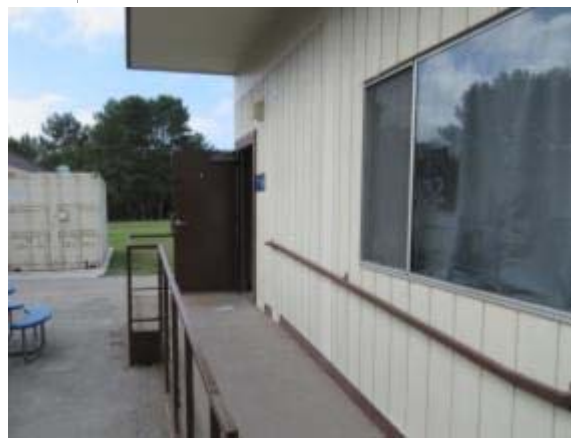
Photo #18: Window at portable structure

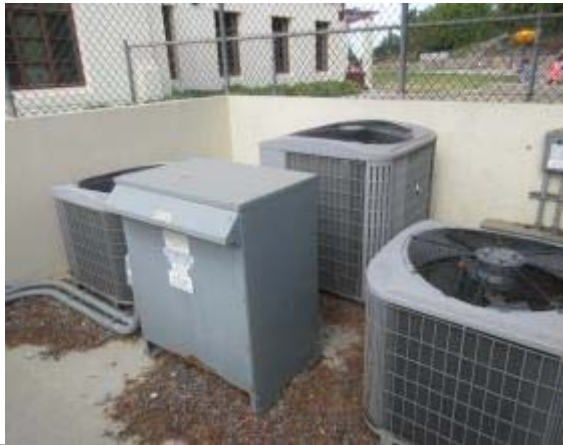
Photo #19: HVAC condensing units and transformer

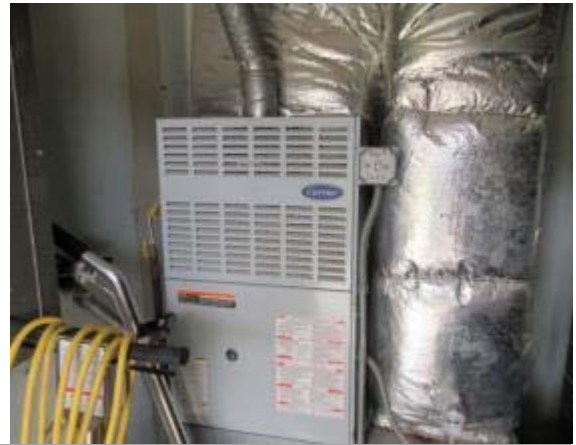
Photo #20: Furnace

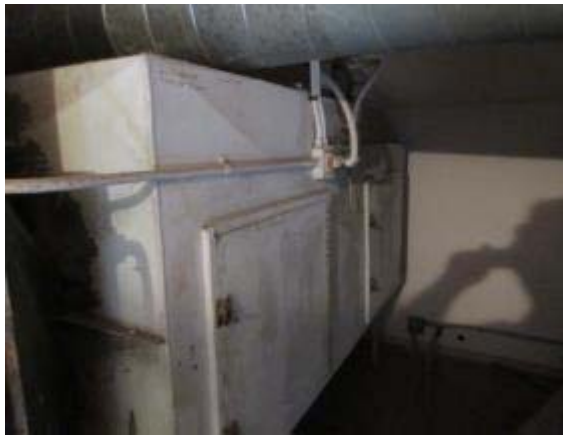
Photo #21: Duct heater

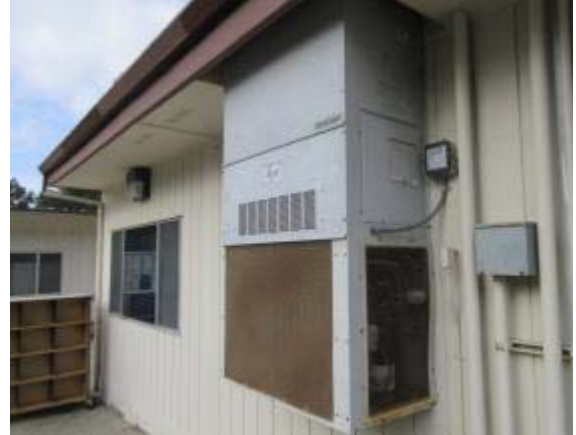
Photo #22: Package HVAC unit

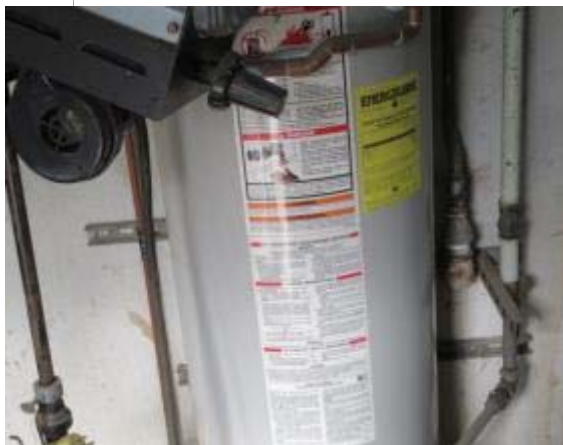
Photo #23: Water heater

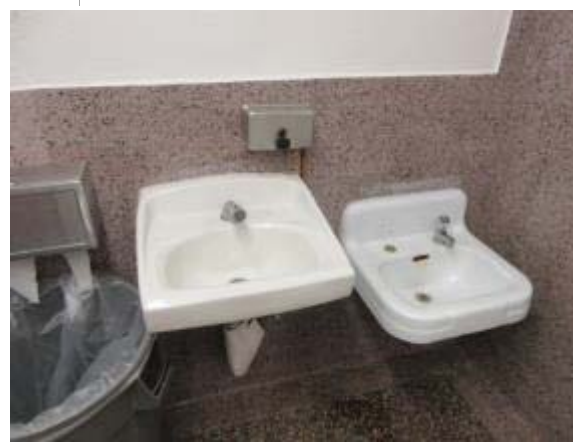
Photo #24: Bathroom sinks

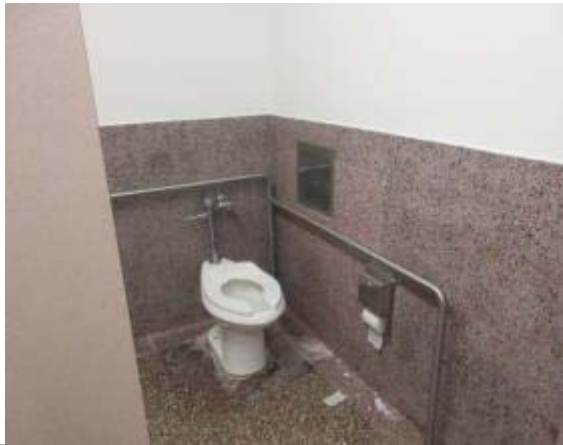
Photo #25: Accessible toilet

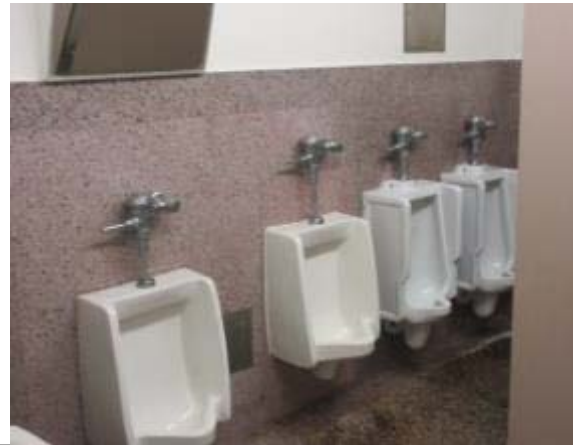
Photo #26: Urinals

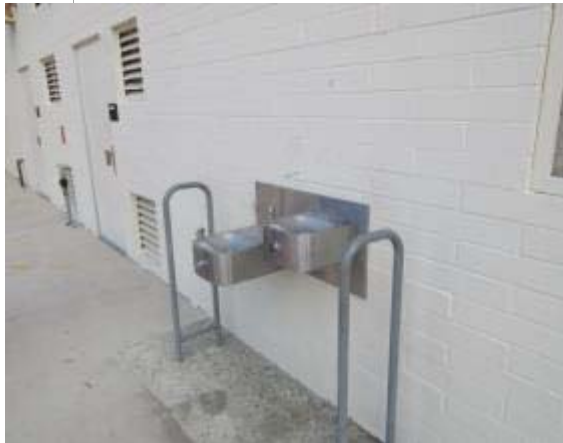
Photo #27: Drinking fountain

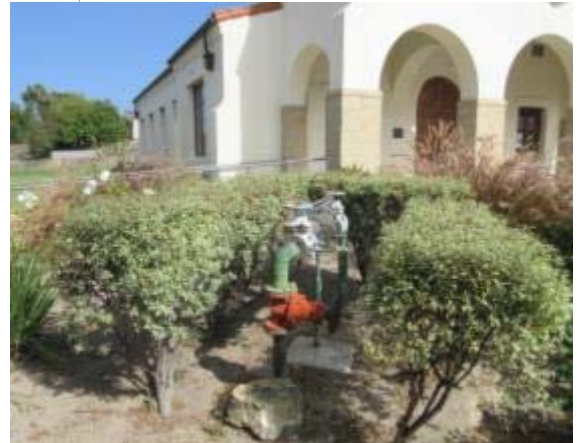
Photo #28: Backflow device

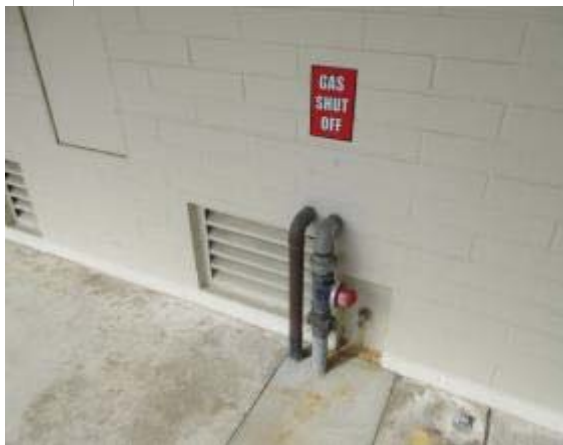
Photo #29: Gas service

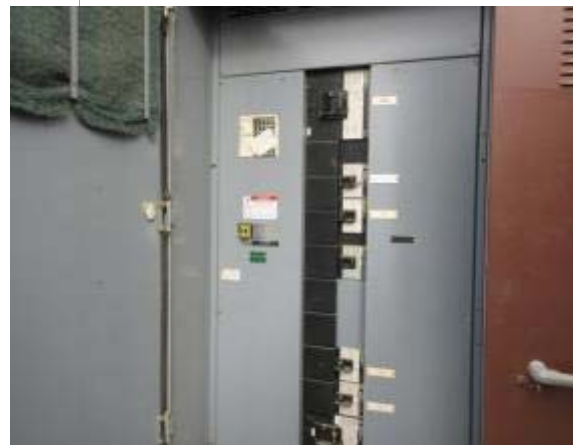
Photo #30: Main switchgear

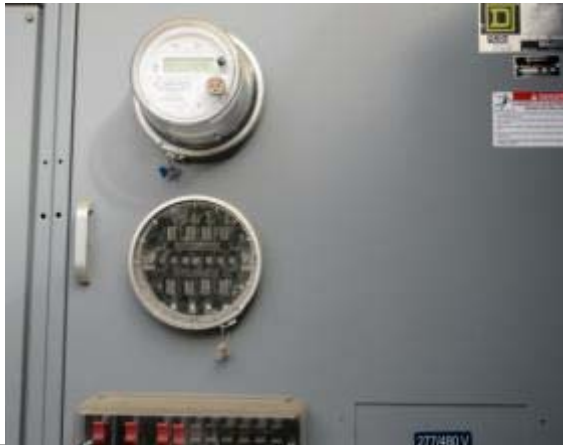
Photo #31: Electrical meter

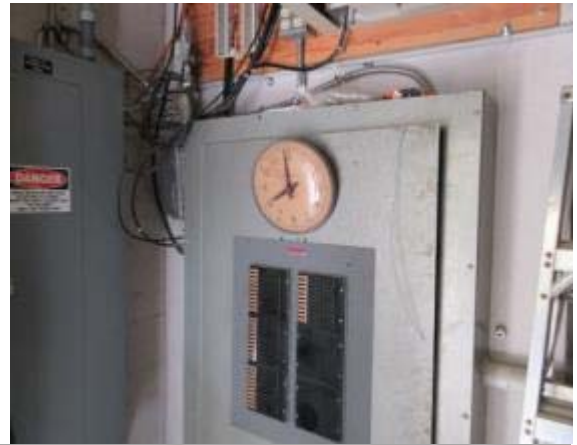
Photo #32: Distribution panel

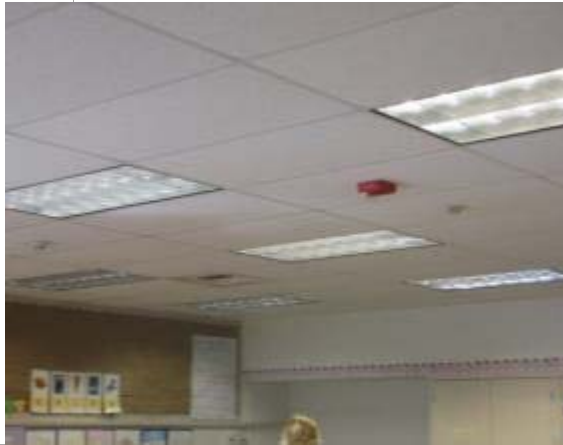
Photo #33: Classroom lighting

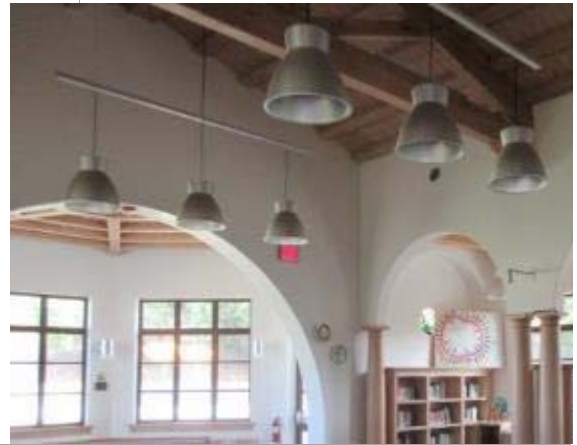
Photo #34: Library lighting

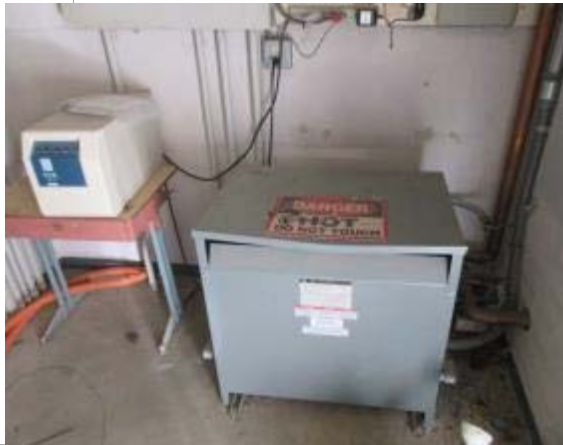
Photo #35: Interior transformer

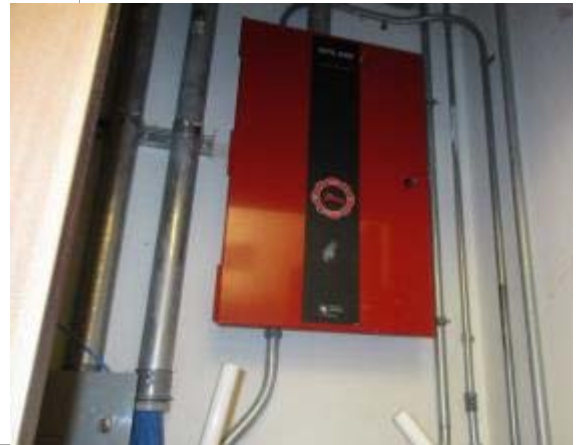
Photo #36: Fire alarm panel

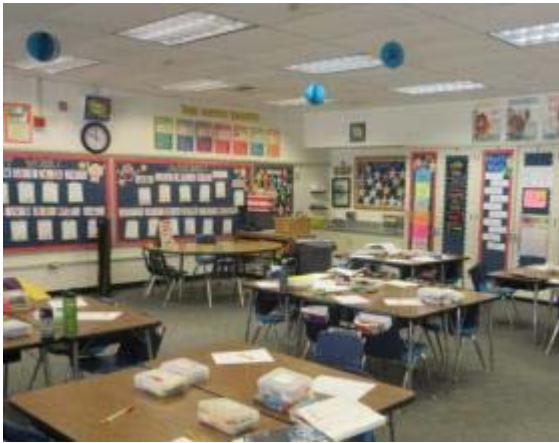
Photo #37: Classroom interior

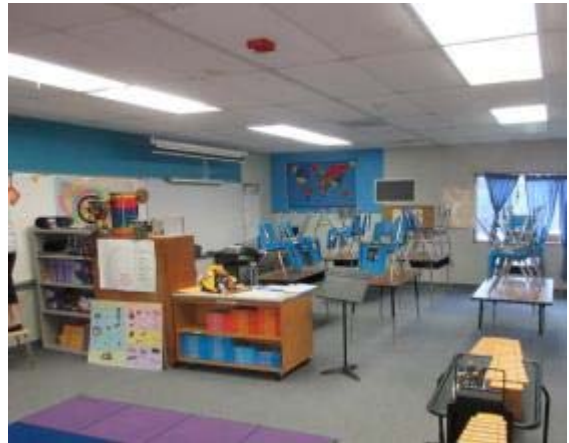
Photo #38: Classroom interior

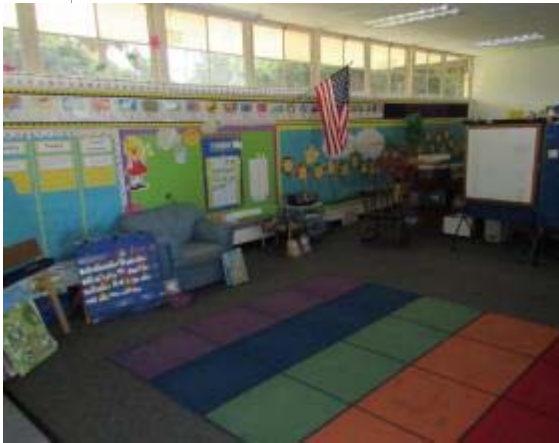
Photo #39: Kindergarten classroom interior

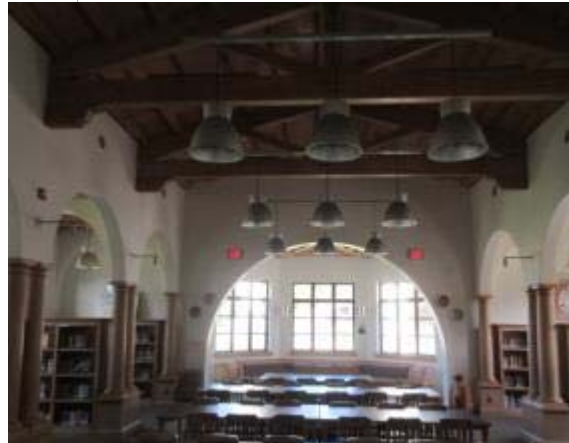
Photo #40: Library interior

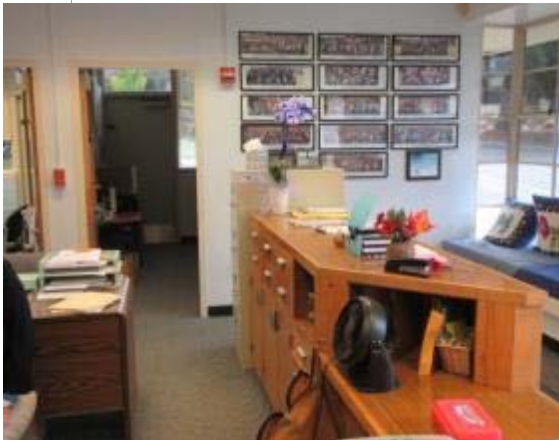
Photo #41: Admin office

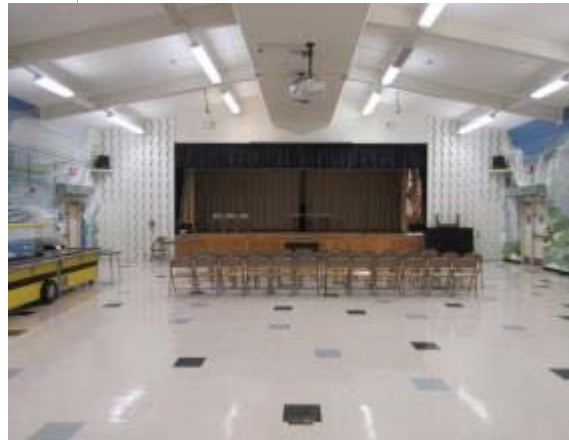
Photo #42: MPR interior

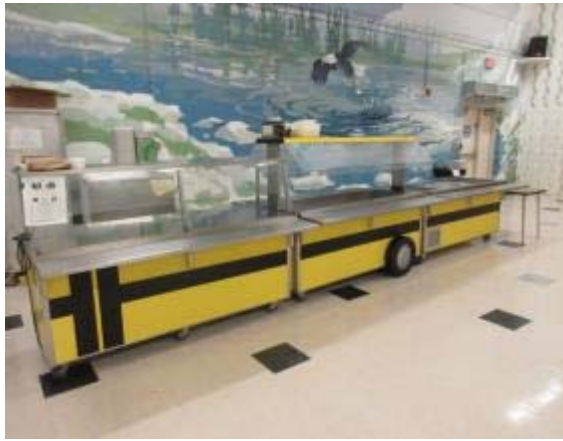
Photo #43: Food service line

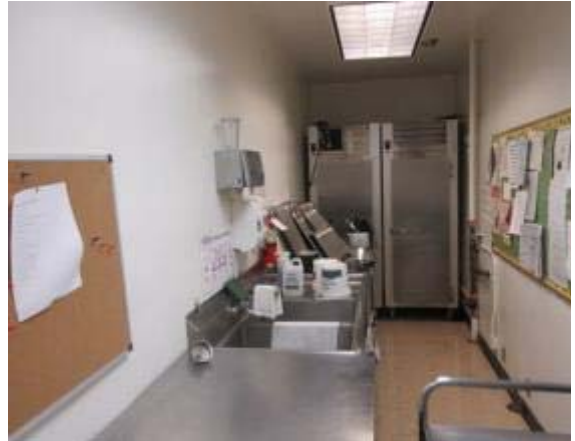
Photo #44: Kitchen area

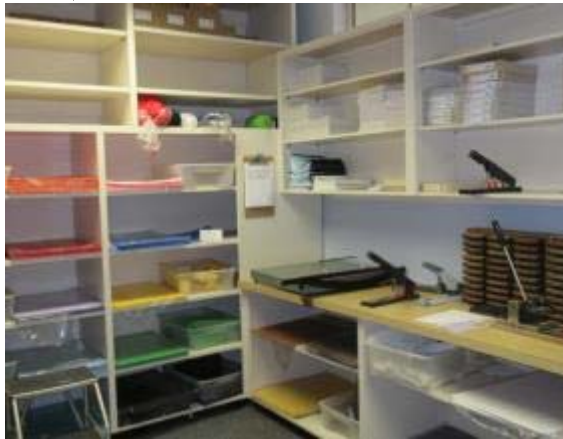
Photo #45: Teacher work room

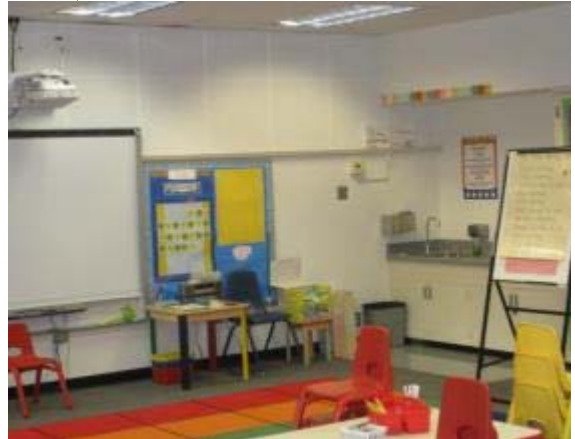
Photo #46: Classroom sink

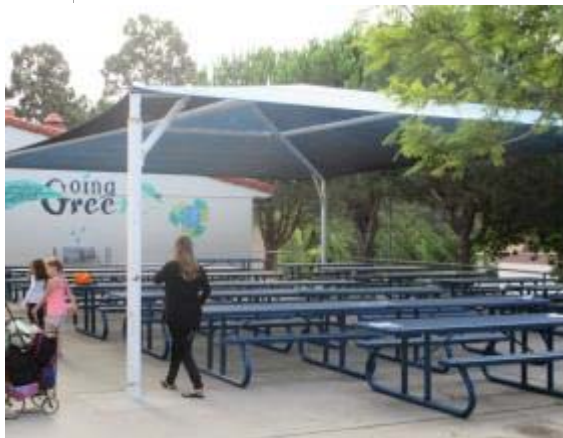
Photo #47: Shade structure

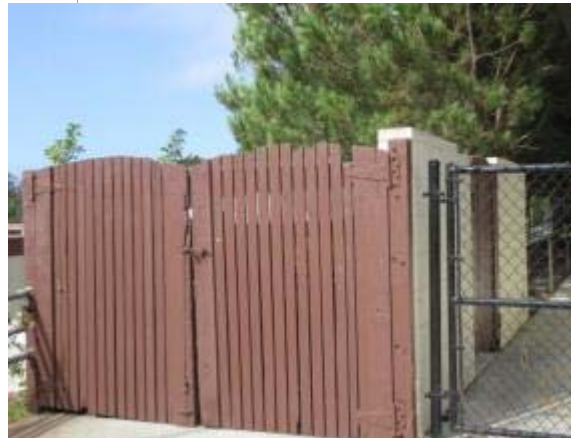
Photo #48: Trash enclosure
