# FACILITY CONDITION ASSESSMENT

119663.16R000-023.017

October 31, 2016

PALOS VERDES PENINSULA UNIFIED SCHOOL DISTRICT  
PORTUGUESE BEND  
32319-32323 FORRESTAL DRIVE  
RANCHO PALOS VERDES. CA. 90275

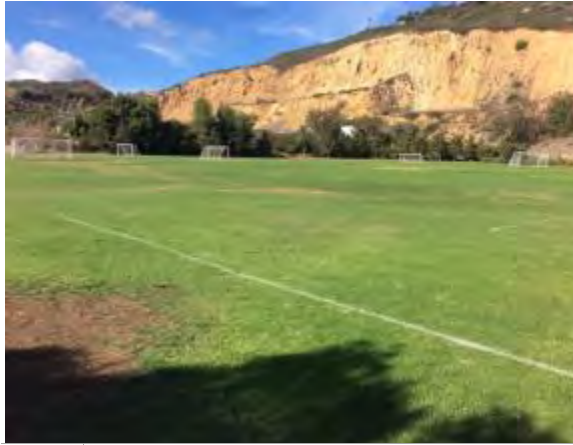
Photo #1: Soccer fields

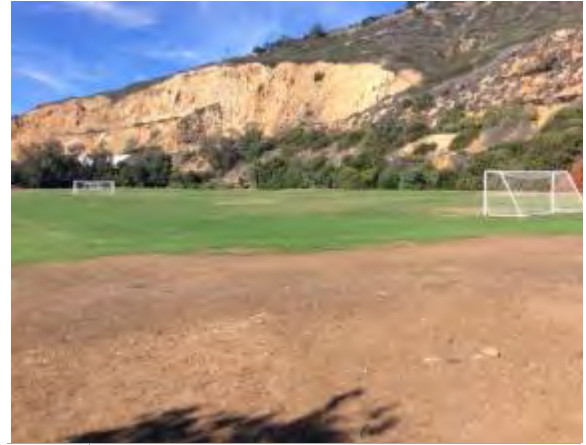
Photo #2: Soccer fields

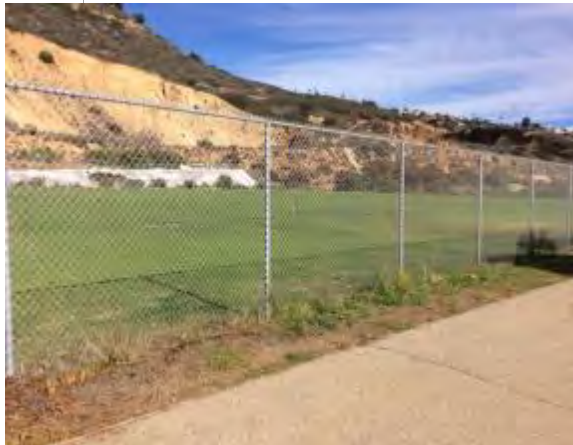
Photo #3: Chain link perimeter fence

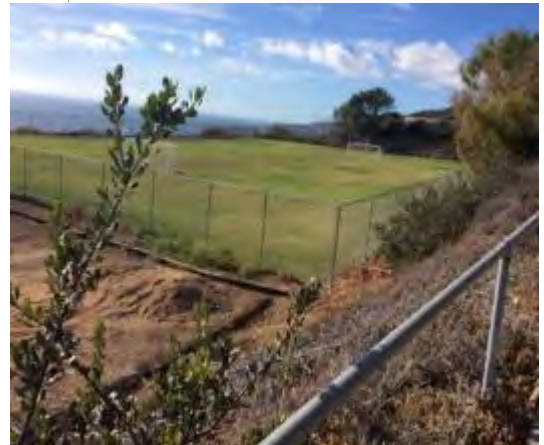
Photo #4: Soccer field

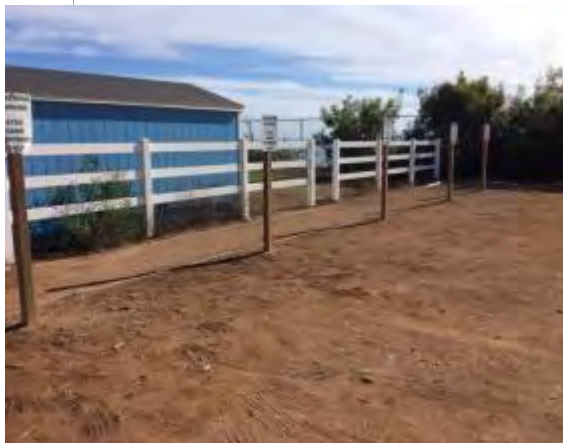
Photo #5: Gravel parking lot

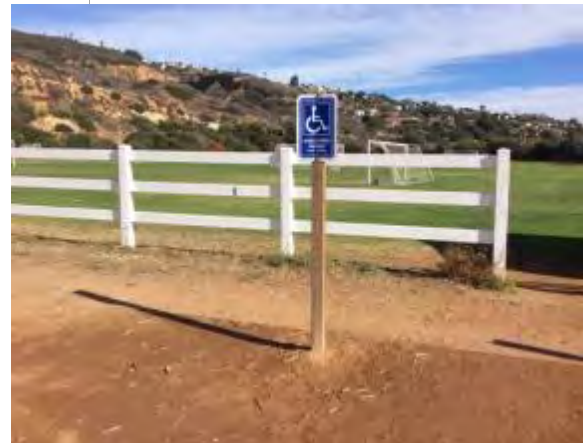
Photo #6: ADA parking signage
