# FACILITY CONDITION ASSESSMENT

PALOS VERDES PENINSULA UNIFIED SCHOOL DISTRICT  
PALOS VERDES PENINSULA HIGH SCHOOL  
27118 SILVER SPUR ROAD  
ROLLING HILLS ESTATES. CALIFORNIA 90274

119663.16R000-014.017

December 1, 2016

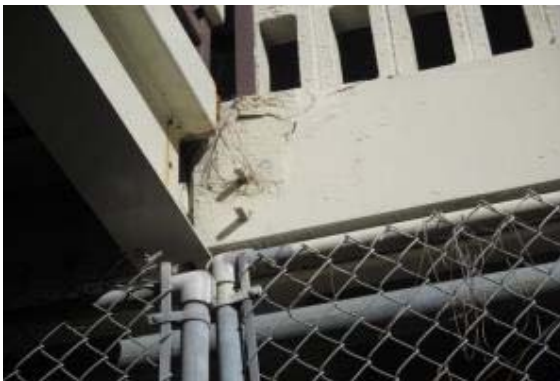
PHOTO  
#15: STEEL SUPPORT AT SECOND  
STORY WALKWAY IS RUSTING  
AND CAUSING SPALLING

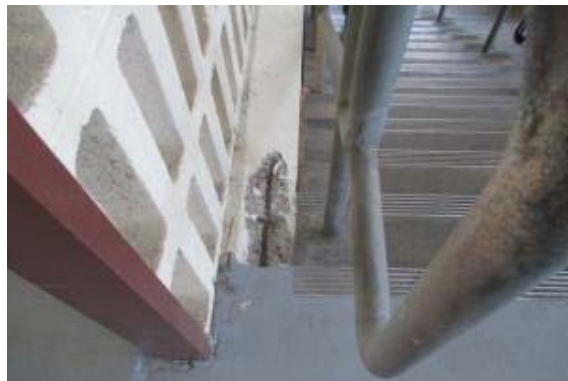
PHOTO  
#16: EXPOSED REBAR

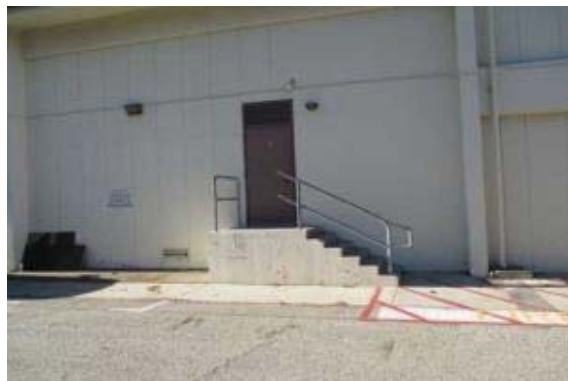
PHOTO  
#18: EXTERIOR STAIR/RAMP RAILS,  
METAL

5.2	East side of Hawthorne building	509820	Exterior Stair/Ramp Rails, Metal, Replace	6	LF	\$49.80	\$299	<b>\$299</b>
5.2	Throughout the 1963 part of the campus	509276	Pedestrian Pavement, Sidewalk, Concrete, Replace	9500	SF	\$19.82	\$188,307	<b>\$188,307</b>

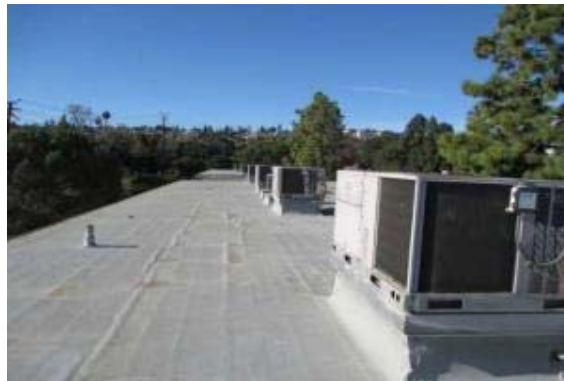
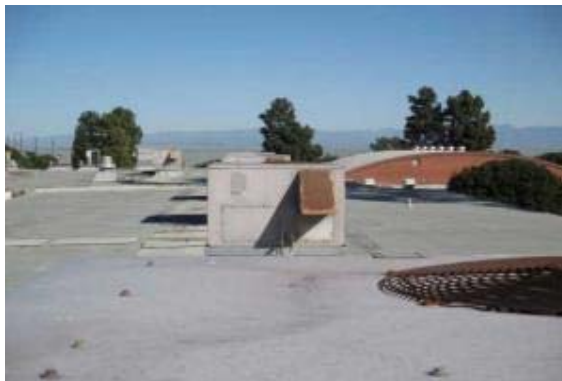
- During the walk through, significant dissatisfaction was expressed with the HVAC systems at the Hawthorne and Silver Spur buildings. Common complaints included lack of ventilation and extremely uneven dispersion of the conditioned air. Additionally, the POC reported that tenants have complained about potential odors that could relate to potential fungal growth or excess moisture within the HVAC delivery system. Because of the age of the system, 19 years, its unsatisfactory performance, and complete lack of roof or wall insulation a complete redesign of the HVAC system is recommended. A professional engineer must be retained to analyze the existing condition, provide recommendations and, if necessary, estimate the scope and cost of any required repairs. The cost of this study is included in the cost tables. A cost allowance to replace the HVAC system is also included in the cost tables.

PHOTO #32: HVAC SYSTEM, SCHOOL

PHOTO #33: HVAC SYSTEM, SCHOOL

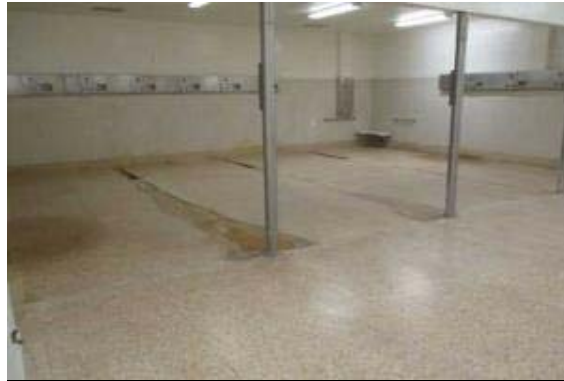
PHOTO #38: SHOWER HEAD, STATION OR COLUMN, COMMERCIAL GRADE

7.2	Both locker rooms	513677	Shower Head, Station or Column, Commercial Grade, Replace	50	EA	\$2,880.50	\$144,025	<b>\$144,025</b>
7.2	Kitchen	513345	Grease Trap/Interceptor, Underground, Provide	1	EA	\$10,850.00	\$10,850	<b>\$10,850</b>

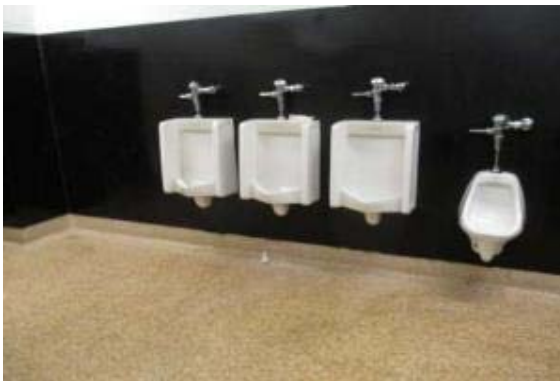
PHOTO #39: URINAL, VITREOUS CHINA

7.2	1963 buildings	513356	Urinal, Vitreous China, Replace	1	EA	\$1,193.44	\$1,193	<b>\$1,193</b>
7.2	1963 buildings	513357	Lavatory, Porcelain Enamel, Cast Iron, Replace	70	EA	\$795.35	\$55,675	<b>\$55,675</b>

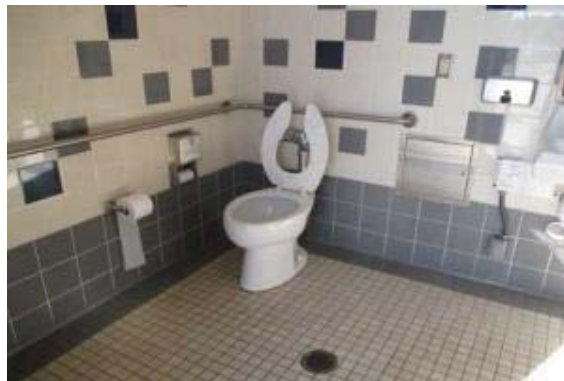
PHOTO #40: TOILET, TANKLESS (WATER CLOSET)

6.7	Hawthorne & Silver Spur	513057	Pedestrian Patios, Concrete, Repair	500	SF	\$28.94	\$14,472	<b>\$14,472</b>
7.2	1963 buildings	513355	Toilet, Tankless (Water Closet), Replace	51	EA	\$842.97	\$42,991	<b>\$42,991</b>

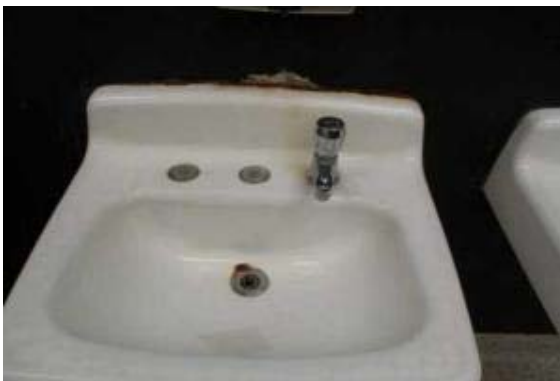
PHOTO #41: LAVATORY, PORCELAIN ENAMEL, CAST IRON

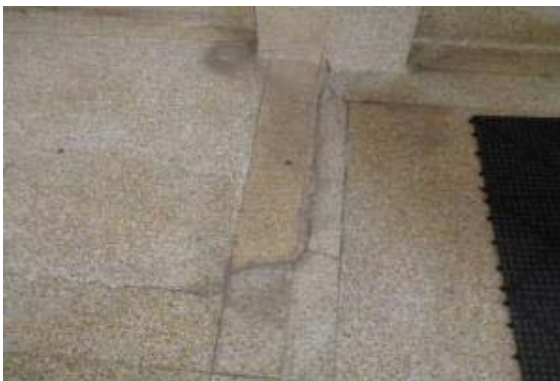
PHOTO #47: INTERIOR FLOOR FINISH, TERRAZZO

7.4	Throughout Building	589758	Electrical System, School, Upgrade	804	SF	\$49.78	\$40,019	<b>\$40,019</b>
8.1	Girls & Boys Showers	513632	Interior Floor Finish, Terrazzo, Replace	1500	SF	\$12.06	\$18,084	<b>\$18,084</b>

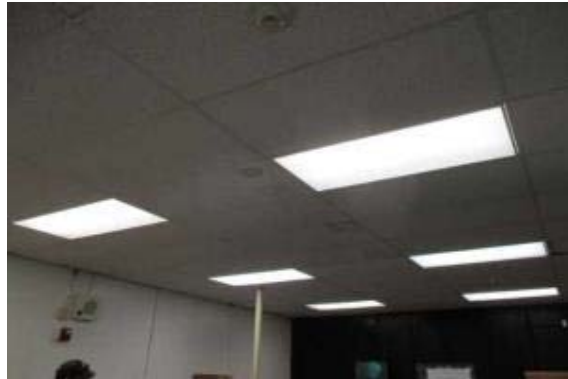
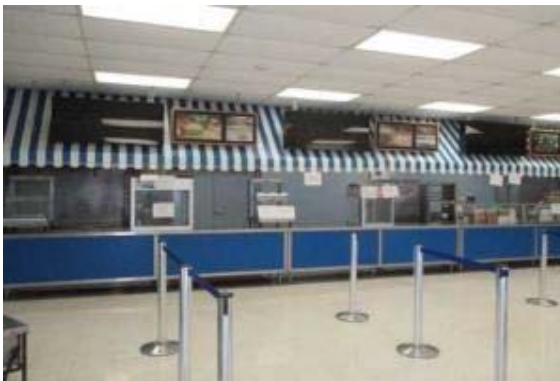
PHOTO #50: INTERIOR CEILING FINISH, ACOUSTICAL TILE (ACT)

PHOTO #51: INTERIOR CEILING FINISH, ACOUSTICAL TILE (ACT)

8.1	1963 buildings	513680	Interior Ceiling Finish, Acoustical Tile (ACT), Replace	61000	SF	\$3.11	\$189,771	<b>\$189,771</b>
8.3	Kitchen	507561	Commercial Kitchen, Steamer, Freestanding, Replace	1	EA	\$9,516.00	\$9,516	<b>\$9,516</b>

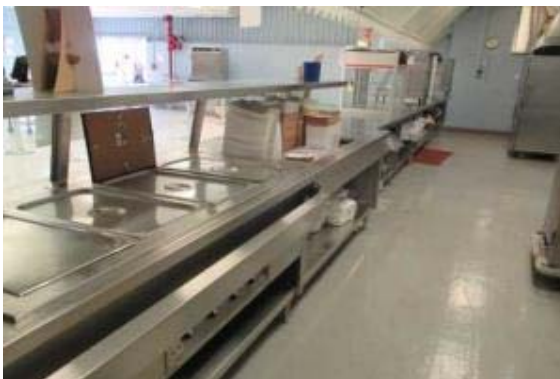
PHOTO #53: COMMERCIAL KITCHEN, STEAMER, FREESTANDING

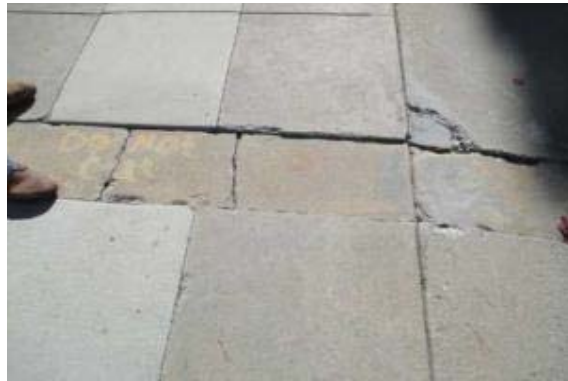
PHOTO  
#58: PEDESTRIAN PAVEMENT,  
SIDEWALK, CONCRETE
