FACILITY CONDITION ASSESSMENT

PALOS VERDES PENINSULA UNIFIED SCHOOL DISTRICT

POINT VICENTE ELEMENTARY

December 15, 2016

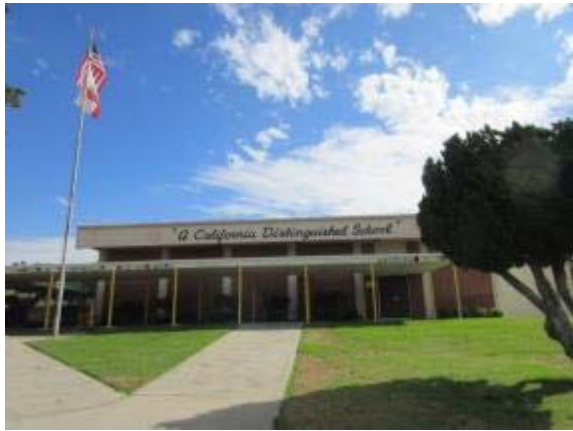
Photo #1: Main entrance

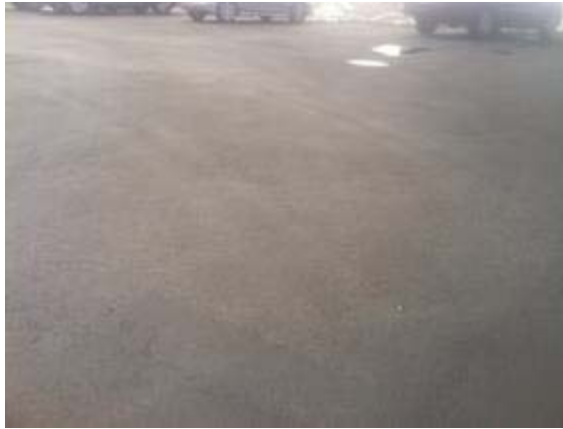
Photo #7: Parking lot pavement

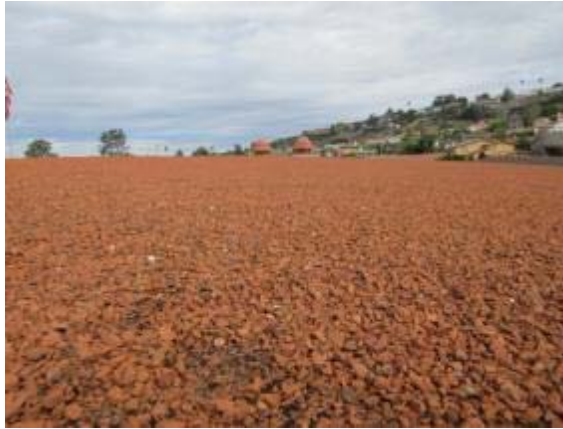
Photo #13: Multipurpose room roof

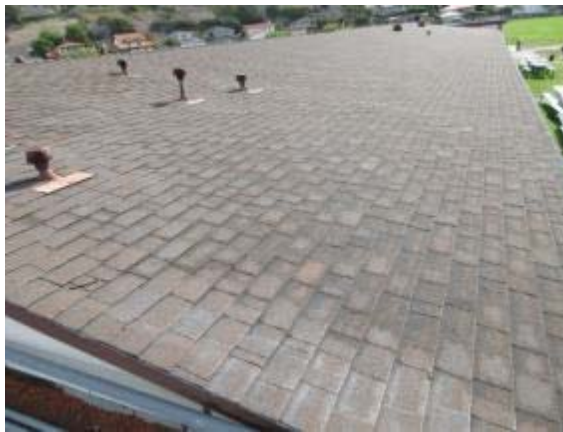
Photo #15: Permanent classroom roof finishes

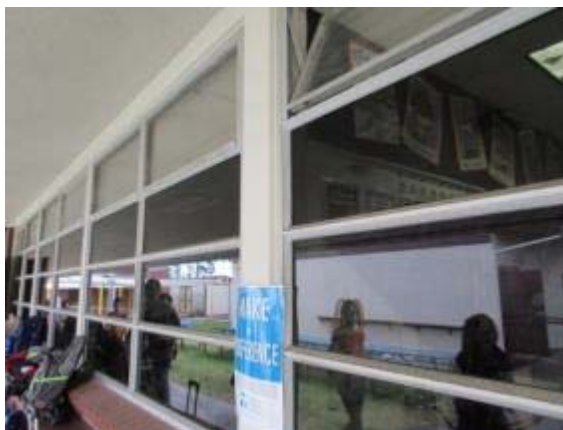
Photo #17: Permanent classroom windows

Report Section	Location	Description	ID	Cost Description	Quantity	Unit	Unit Cost	Subtotal	Deficiency Repair Estimate *
6.6	Permanent buildings	504417	Window, Steel, Repair	98	EA	\$33.50	\$3,283		\$3,283
Immediate Repairs Total									\$3,283

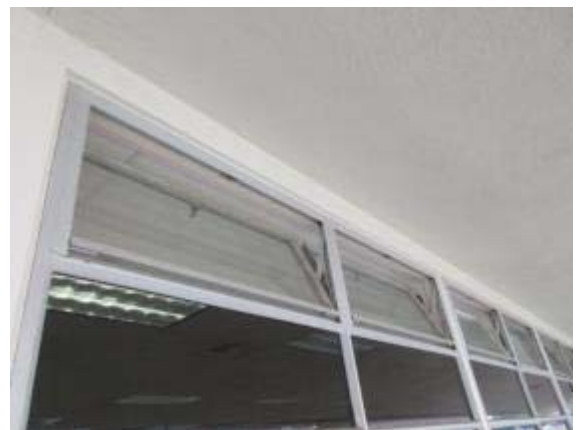
Photo #18: Permanent classroom windows

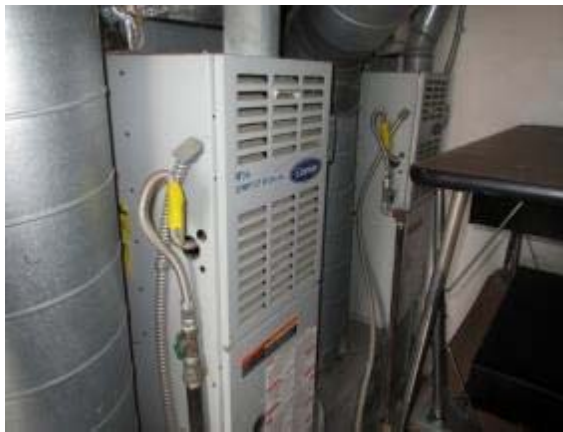
Photo #27: Forced-air furnace

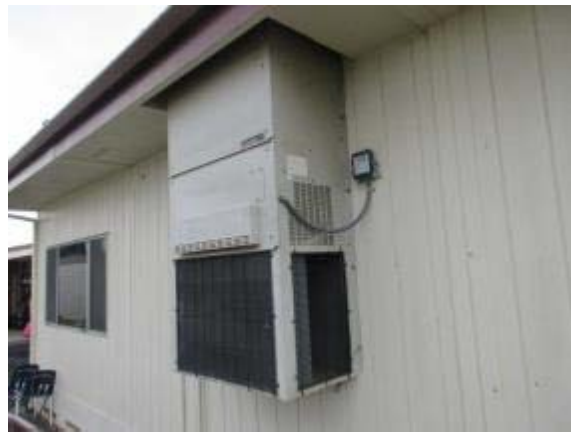
Photo #28: Package heat pump
