# FACILITY CONDITION ASSESSMENT

PALOS VERDES PENINSULA UNIFIED SCHOOL DISTRICT

PALOS VERDES HIGH SCHOOL

December 28, 2016

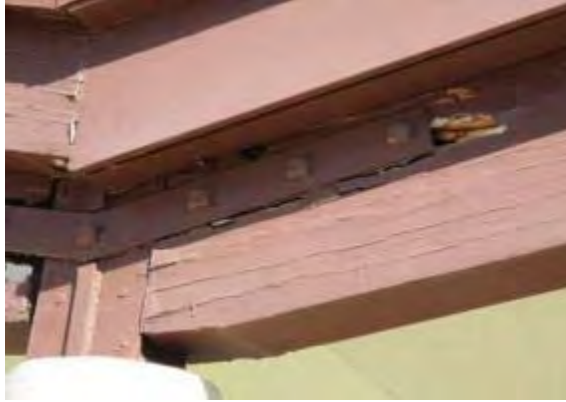
- There is evidence of termite damage. The exterior courtyard of the cafeteria shows significant areas of wood beam deterioration due to insect infestation. A local, licensed exterminator must be retained to inspect and treat the property as required to eliminate the pest and associated threat. The cost of this study is included in the cost tables. A cost allowance to treat the wood is also included in the cost tables.

Photo #7: *HEAVY TIMBER FRAMING*

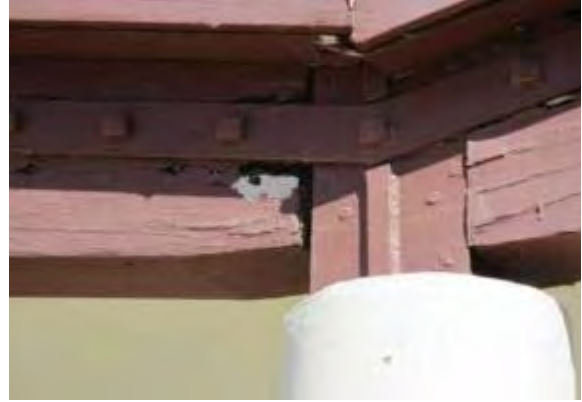
Photo #8: *HEAVY TIMBER FRAMING*

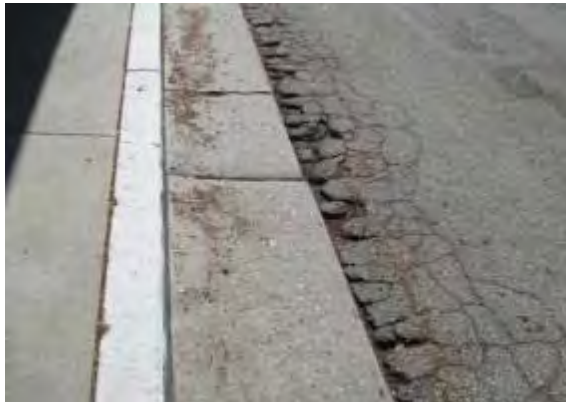
Photo #9: *ROADWAYS, ASPHALT PAVEMENT*

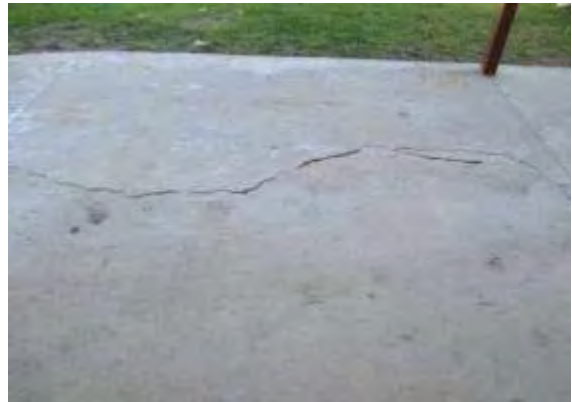
Photo #10: *PEDESTRIAN PAVEMENT, SIDEWALK, CONCRETE*

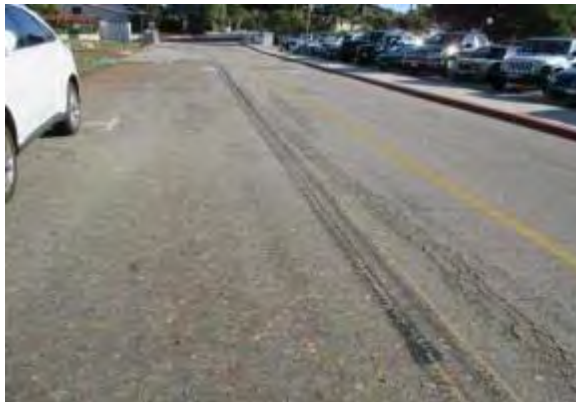
Photo #11: *PARKING LOTS, ASPHALT PAVEMENT*

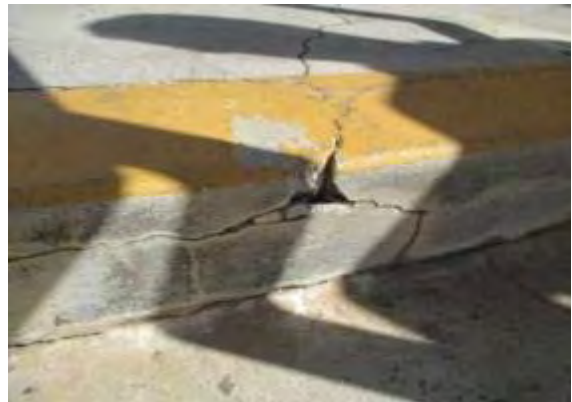
Photo #12: *CONCRETE STAIRS*

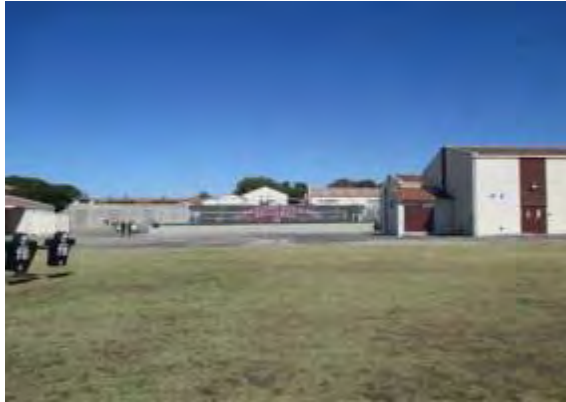
Photo #13: *LANDSCAPING, GROUND COVER*

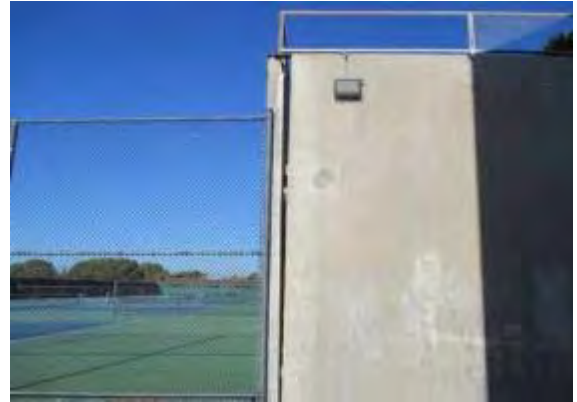
- Because of the extent of the damage, a review of the structural integrity of the damaged beams is required. In addition, several sections of the precast concrete panel retaining wall are showing movement, as is the floor in the 407-415 classrooms. A professional engineer, familiar with school structures and the geologic composition of the area must be retained to analyze the existing conditions, provide recommendations and, if necessary, estimate the scope and cost of any required repairs. The cost of this study is included in the cost tables. For further information see Sections 5.4 6.1 and 6.2.

Photo #14: *WALL SEPARATION*

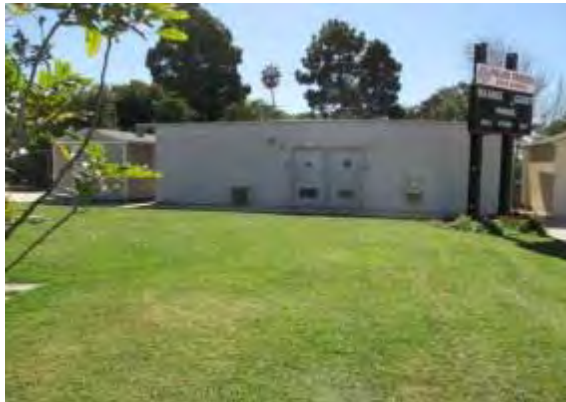
Photo #15: *LANDSCAPE AND IRRIGATION*

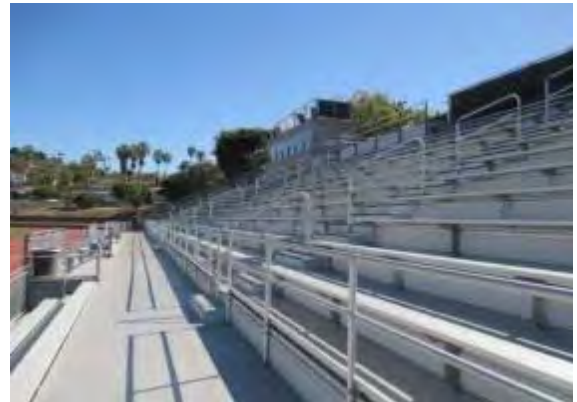
Photo #16: *SPORTS APPARATUS, BLEACHERS, STEEL FRAME W/ ALUMINUM SEATS*

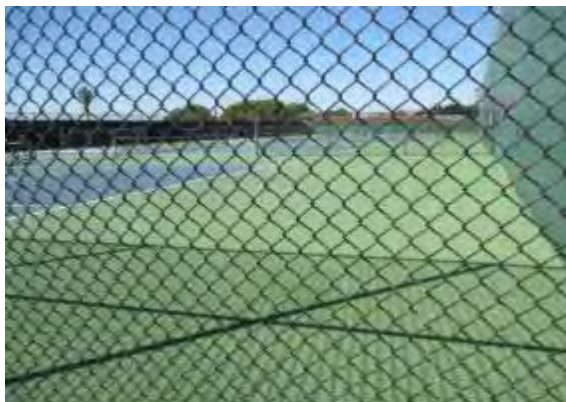
Photo #17: *FENCES AND GATES, CHAIN LINK, 8' HIGH*

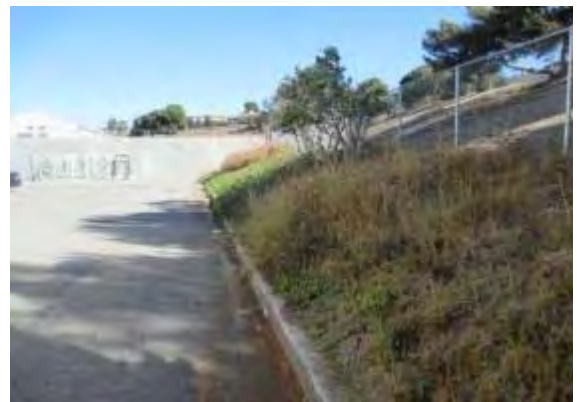
Photo #18: *FENCES AND GATES, CHAIN LINK, 6' HIGH*

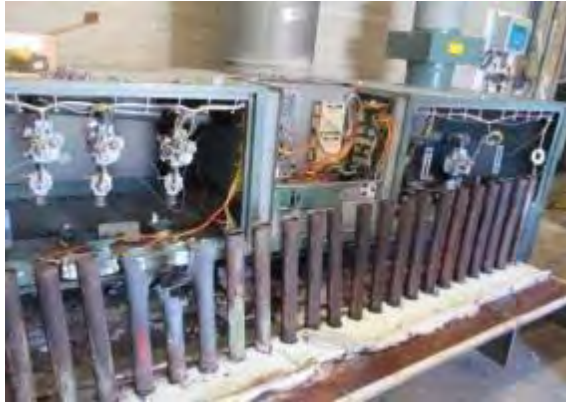
Photo #19: *SWIMMING POOL HEATER, GAS-FIRED, 300 MBH*

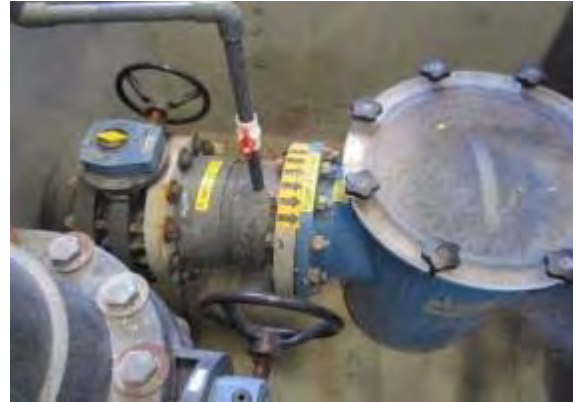
Photo #20: *SWIMMING POOL FILTRATION SYSTEM*

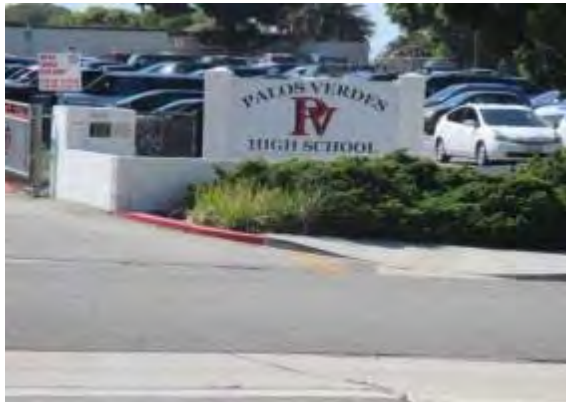
Photo #21: *SIGNAGE, PROPERTY, MONUMENT/PYLON*

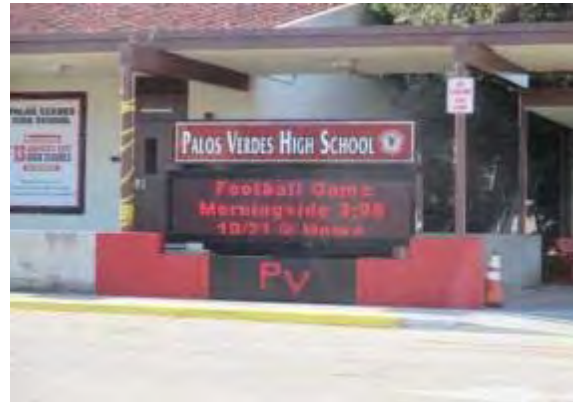
Photo #22: *SIGNAGE, PROPERTY, MONUMENT/PYLON*

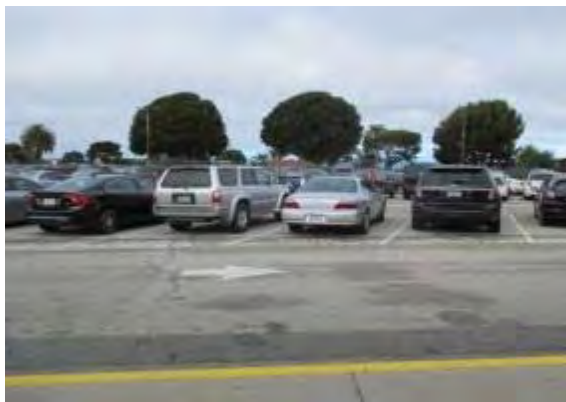
Photo #23: *POLE LIGHT, EXTERIOR, 80 TO 100 W LED (FIXTURE AND BRACKET ARM ONLY)*

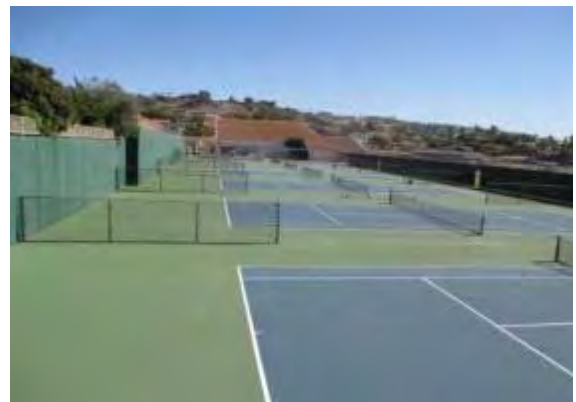
Photo #24: *PLAY SURFACES AND SPORTS COURTS, ASPHALT*

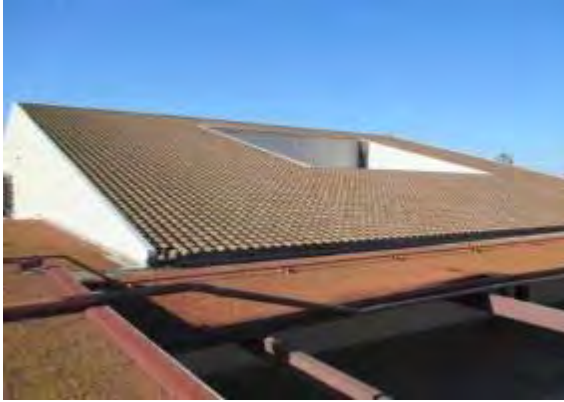
Photo #25: *ROOF, CLAY/CONCRETE TILE*

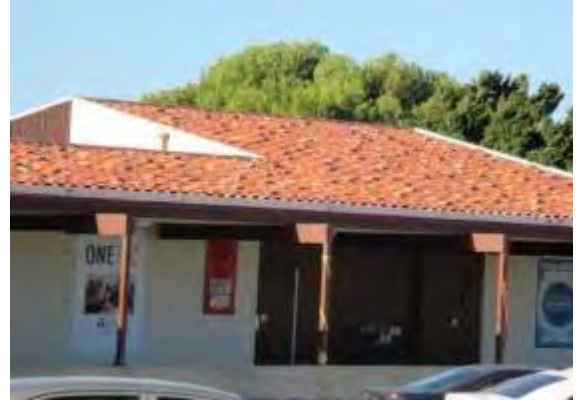
Photo #26: *ROOF, CLAY/CONCRETE TILE*

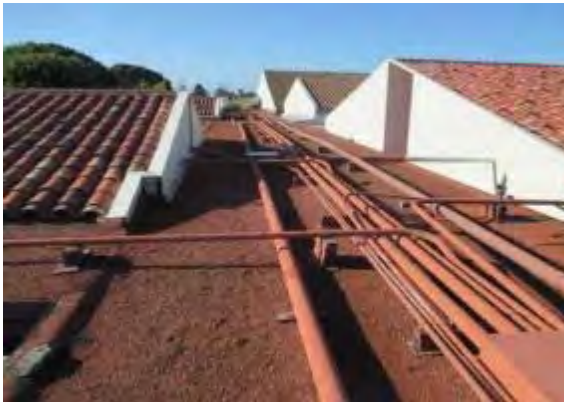
Photo #27: *ROOF, BUILT-UP*

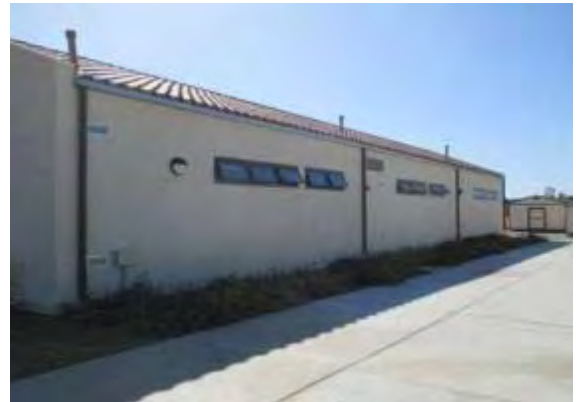
Photo #28: *EXTERIOR WALL, PAINTED SURFACE, 1-2 STORIES*

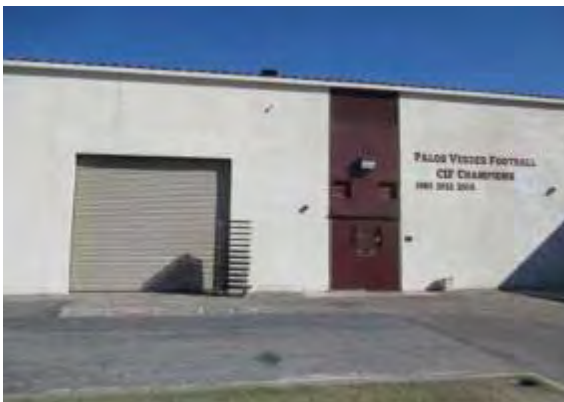
Photo #29: *EXTERIOR WALL, PAINTED SURFACE, 1-2 STORIES*

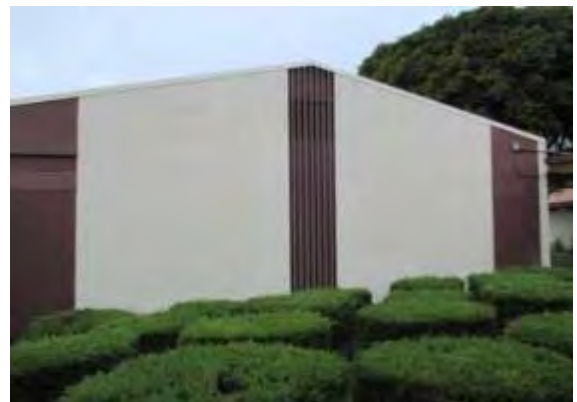
Photo #30: *LOUVER, WOOD, 1-2 STORIES*

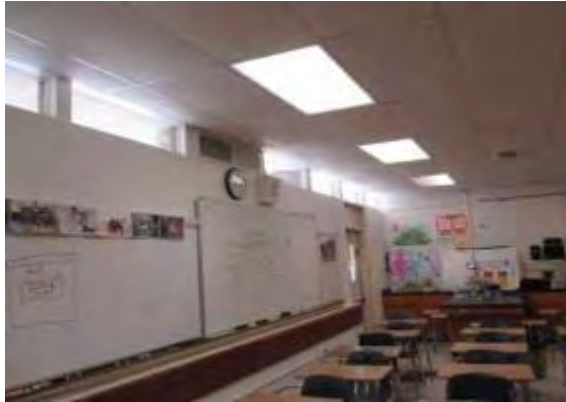
Photo #31: WINDOW, ALUMINUM DOUBLE-GLAZED

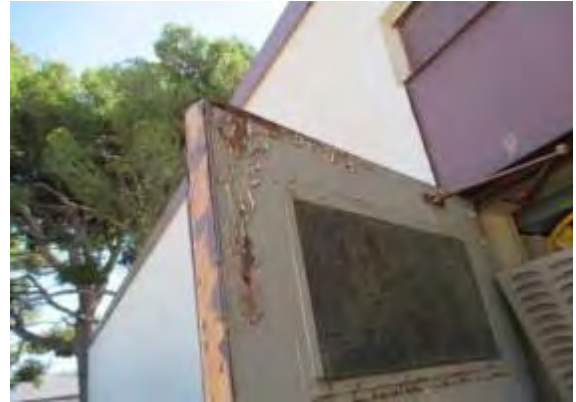
Photo #32: EXTERIOR DOOR, STEEL

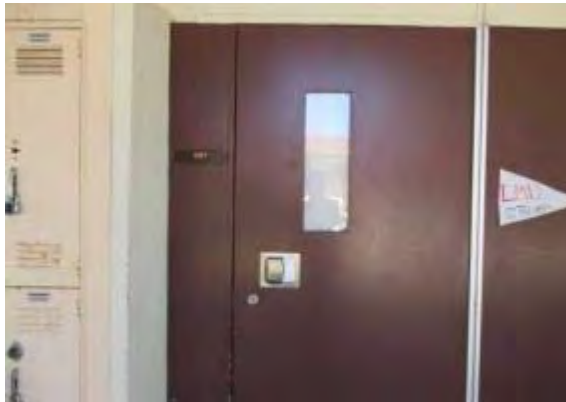
Photo #33: EXTERIOR DOOR, STEEL WITH SAFETY GLASS

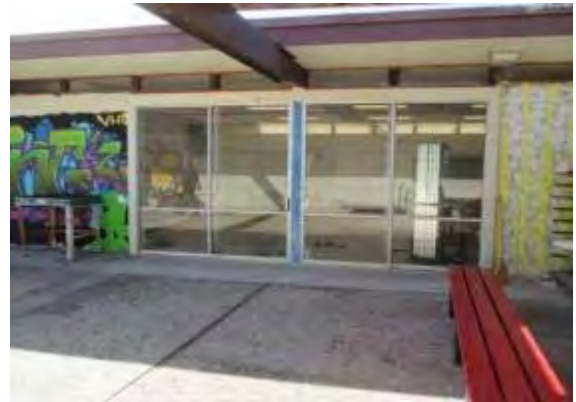
Photo #34: EXTERIOR DOOR, FULLY-GLAZED ALUMINUM-FRAMED SLIDING

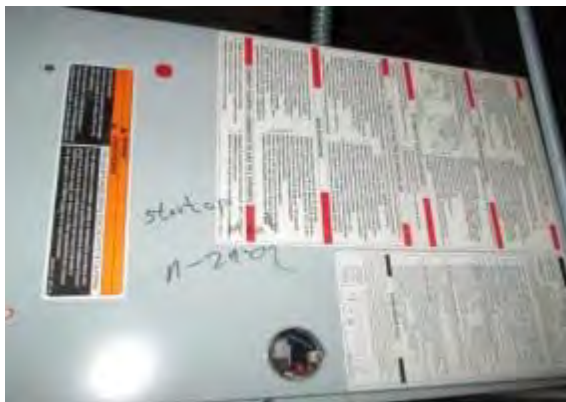
- HVAC systems are generally limited to heating. Due to the lack of openable windows, the classrooms appeared to be stuffy. Staff expressed concern about air circulation. A mechanical engineer must be retained to analyze the existing conditions, provide recommendations and, if necessary, estimate the scope and cost of any required repairs. The cost of this study is included in the cost tables. For further information see Section 7.1.

Photo #35: HVAC SYSTEM

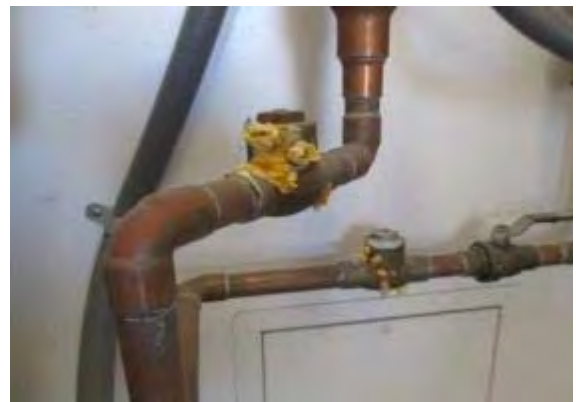
Photo #36: PLUMBING SYSTEM, DOMESTIC SUPPLY AND SANITARY, SCHOOL

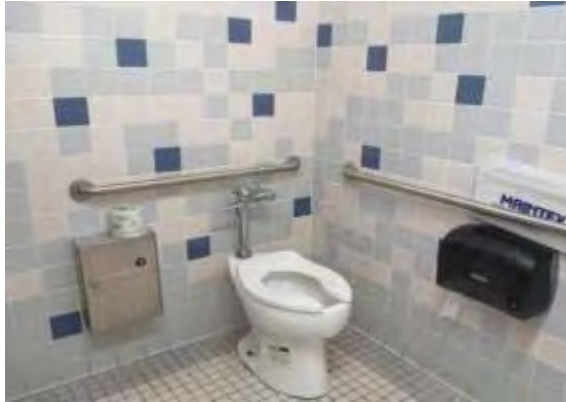
Photo #37: *TOILET, TANKLESS (WATER CLOSET)*

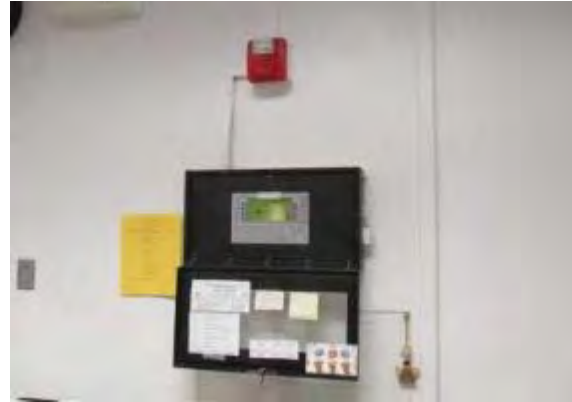
Photo #38: *FIRE ALARM SYSTEM, SCHOOL*

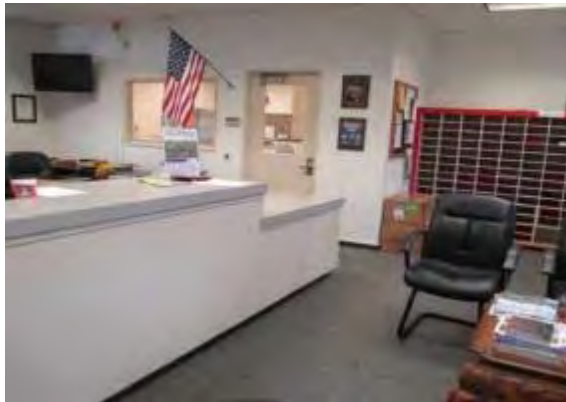
Photo #39: *INTERIOR FLOOR FINISH, CARPET STANDARD-COMMERCIAL MEDIUM-TRAFFIC*

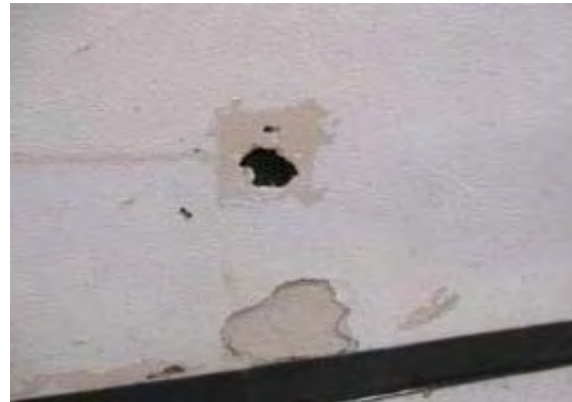
Photo #40: *INTERIOR WALL FINISH, GYPSUM BOARD/PLASTER*

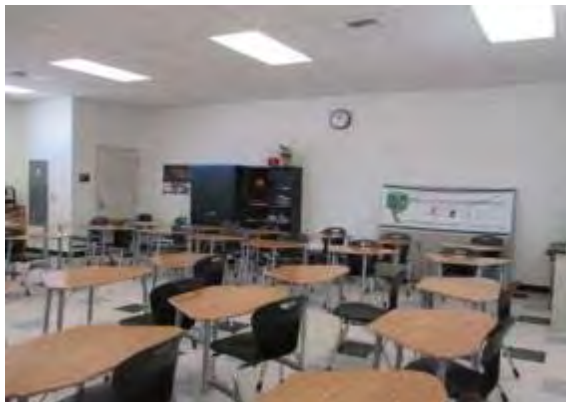
Photo #41: *INTERIOR WALL FINISH, GYPSUM BOARD/PLASTER/METAL*

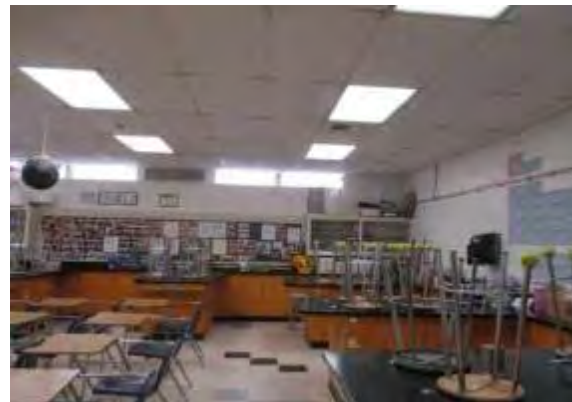
Photo #42: *INTERIOR FLOOR FINISH, VINYL TILE (VCT)*

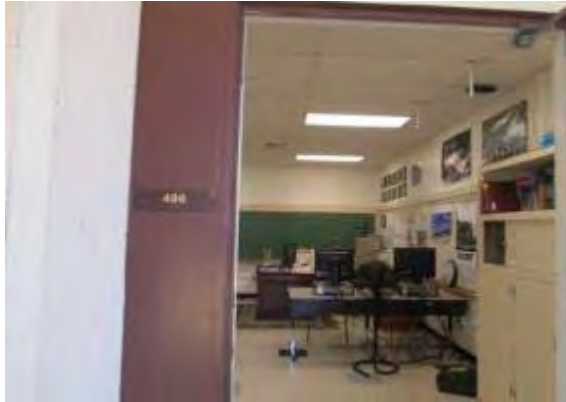
Photo #43: *INTERIOR WALL FINISH, GYPSUM BOARD/PLASTER/METAL*

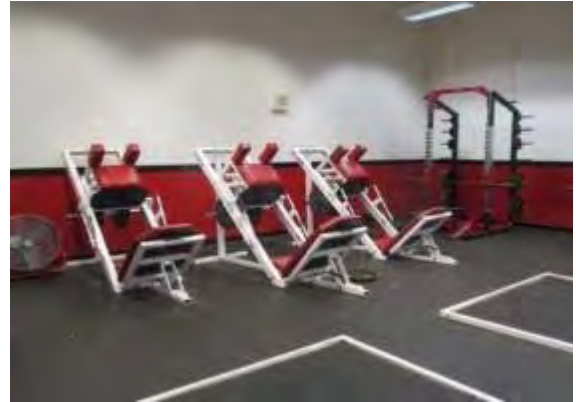
Photo #44: *INTERIOR FLOOR FINISH, RUBBER TILE*

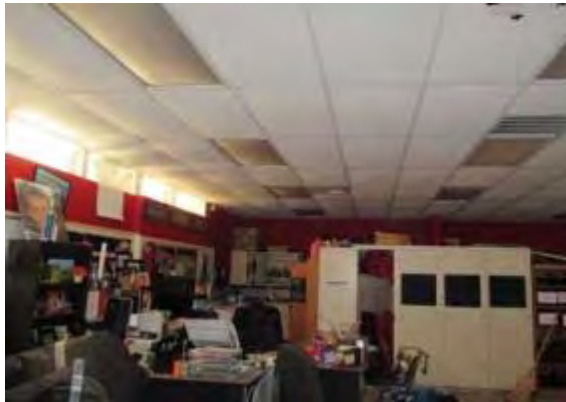
Photo #45: *INTERIOR CEILING FINISH, ACOUSTICAL TILE (ACT)*

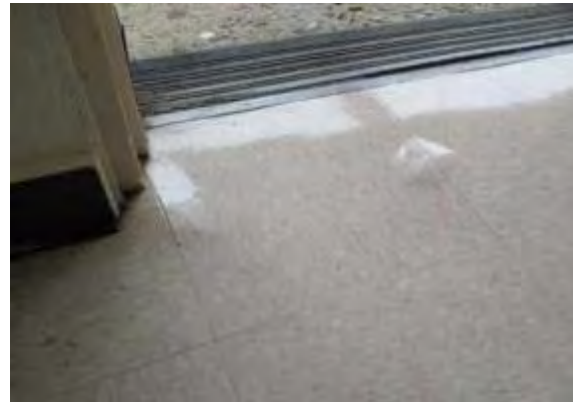
Photo #46: *INTERIOR FLOOR FINISH, VINYL TILE (VCT)*

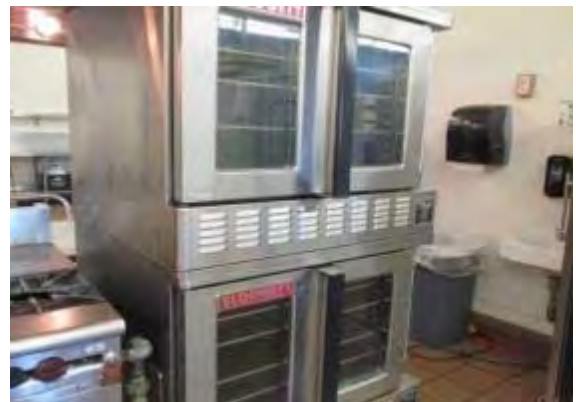
Photo #48: *COMMERCIAL KITCHEN, CONVECTION OVEN, DOUBLE*

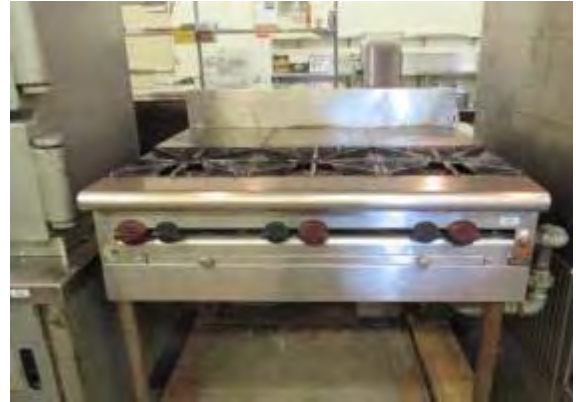
Photo #50: *COMMERCIAL KITCHEN, RANGE/OVEN, 4-BURNER WITH GRIDDLE*

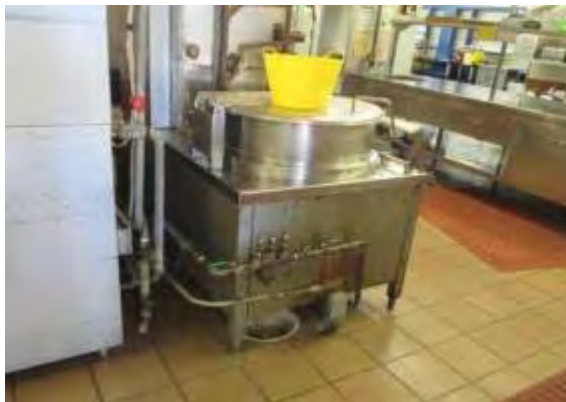
Photo #51: *COMMERCIAL KITCHEN, STEAM KETTLE*

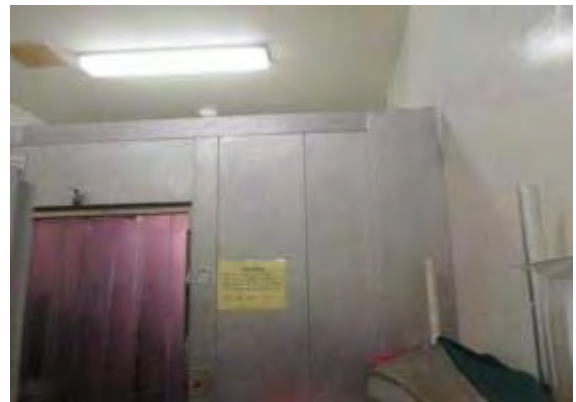
Photo #52: *COMMERCIAL KITCHEN, WALK-IN REFRIGERATOR*
