FACILITY CONDITION ASSESSMENT

PALOS VERDES MIDDLE SCHOOL

2161 VIA OLIVERA

January 17, 2017

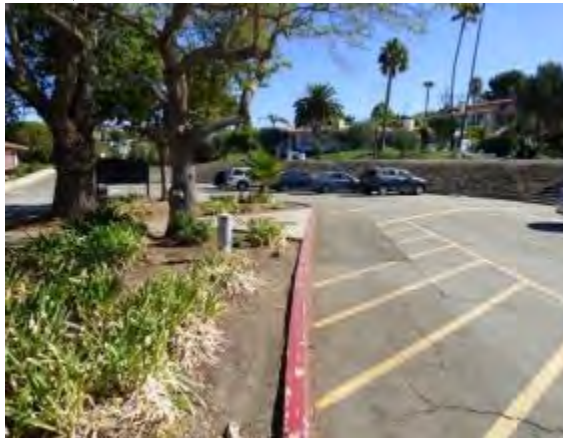
Photo #9: Front parking lot

- Mechanical engineer to analyze HVAC system and air quality
- Seal and stripe asphalt pavement
- Recommended pole lighting for parking areas
- Partial sewer line replacement

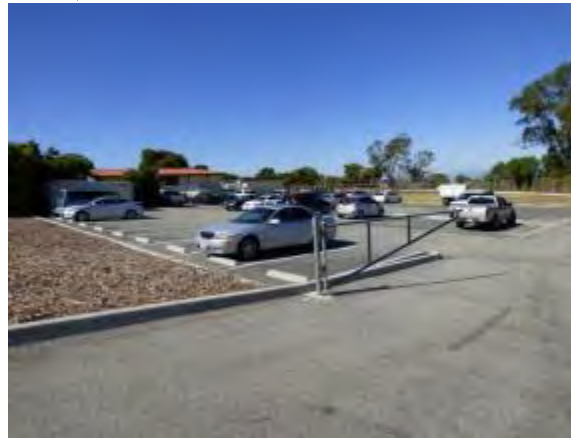
Photo #10: North parking lot

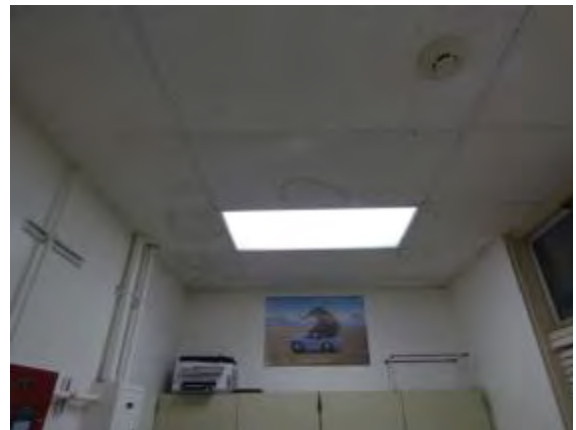
Photo #28: Isolated stained ceiling tiles throughout buildings (due to past leaks)

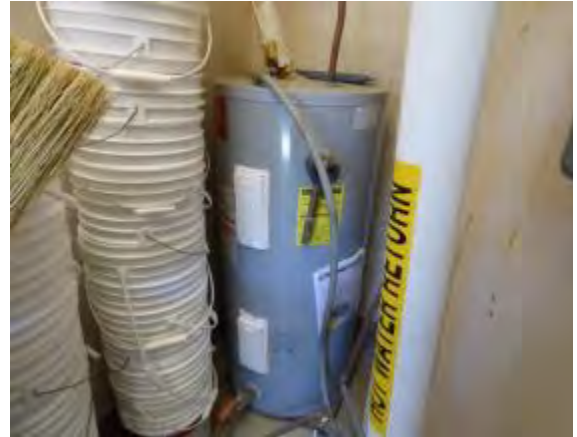
Photo #32: Hot water heater

7.2	533910	Water Heater, Gas, Residential, 15 GAL, Replace	10	6	* 4	6	EA	\$2,349.48	\$14,097						\$14,097										\$14,097				\$28,194		
7.2	533922	Circulator Pump, 3 HP, Replace	15	6	9	2	EA	\$8,839.12	\$17,678										\$17,678										\$17,678

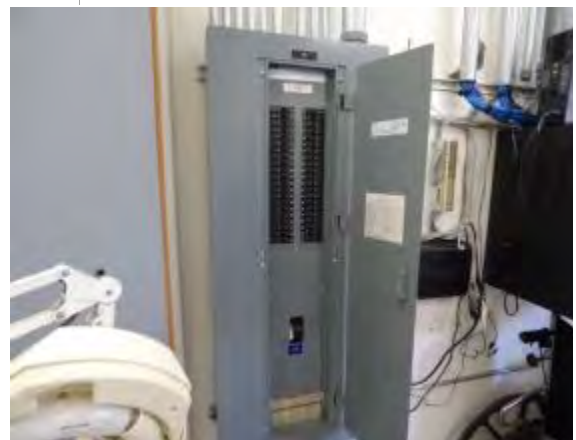
Photo #40: Electrical panels throughout buildings

7.2	589737	Pipe, Drain & Sewage, Vitrified Clay, 8", Replace	50	50	0	65	LF	\$33.43	\$2,173	\$2,173																			\$2,173		
7.4	589735	Electrical System, School, Upgrade	40	37	3	63336	SF	\$49.78	\$3,152,549				\$3,152,549																\$3,152,549

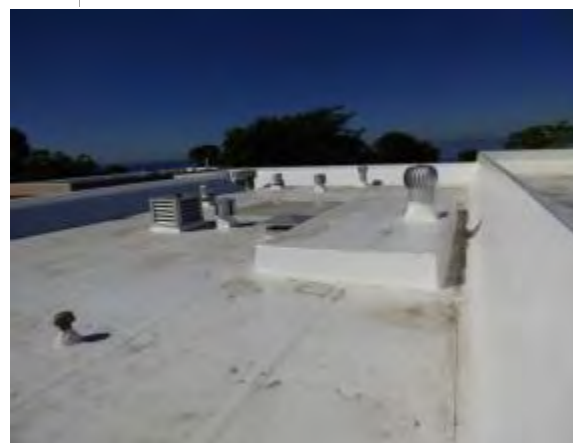
Photo #42: TPO single ply membrane roof

5.5	539859	Pole Light w/Concrete Base, Exterior, 105 to 200 W LED, Install new	20	20	0	4	EA	\$8,803.00	\$35,212	\$35,212																			\$35,212		
6.3	529603	Roof, Single-Ply TPO/PVC Membrane, Replace	20	3	17	22500	SF	\$15.93	\$358,445																	\$358,445			\$358,445

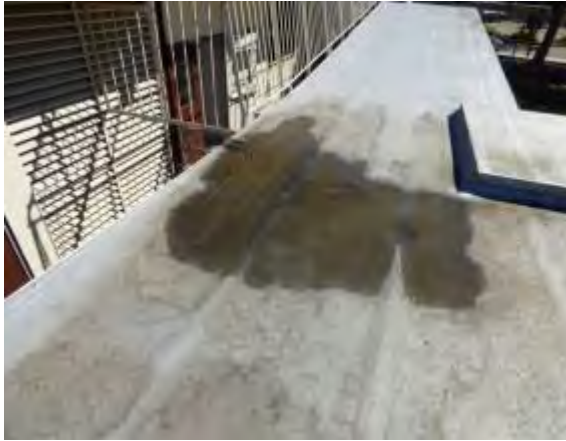
Photo #44: TPO single ply membrane roof (viewed at minor isolated ponding)

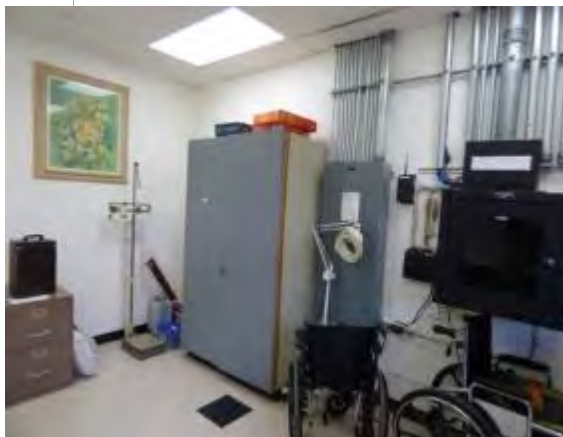
Photo #59: Fire Control Main Panel in office building

7.6	533887	Fire Alarm Control Panel, Multiplex, Replace	15	13	2	6	EA	\$4,284.35	\$25,706			\$25,706														\$25,706			\$51,412		
7.6	529593	Fire Alarm Control Panel, Addressable, Replace	15	13	2	1	EA	\$20,297.59	\$20,298			\$20,298														\$20,298			\$40,595

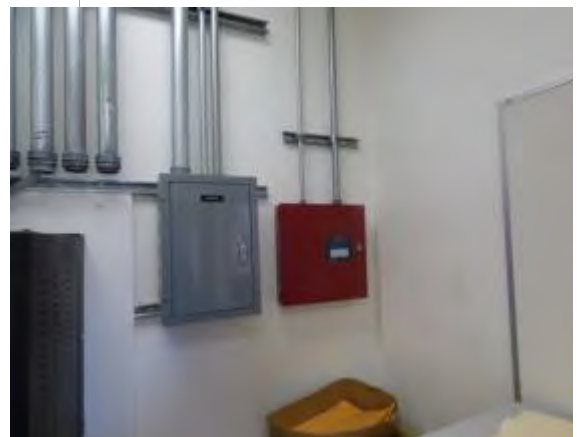
Photo #60: Fire Control Sub-Panels throughout all buildings
