FACILITY CONDITION ASSESSMENT

119663.16R000-016.017

November 29, 2016

PALOS VERDES PENINSULA UNIFIED SCHOOL DISTRICT
RANCHO DEL MAR HIGH SCHOOL, AND
ADULT EDUCATION & CHILD CARE
38 CREST ROAD WEST
ROLLING HILLS, CALIFORNIA 90274

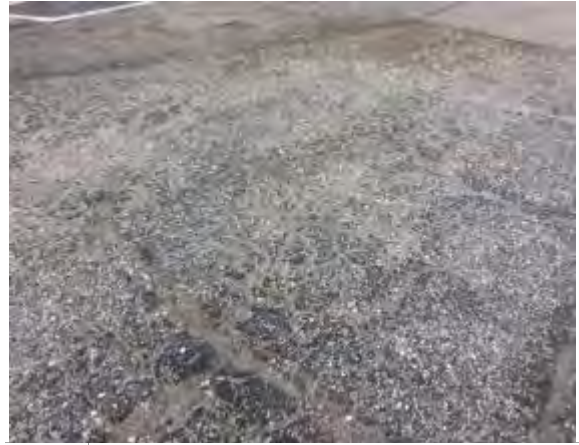
Photo #8: Parking lot with damaged asphalt

5.2	480411	Asphalt Pavement Overlay, Parking Lot, Mill & Overlay	25	25	0	22000	SF	\$3.28	\$72,169	\$72,169																				\$72,169						
5.2	481330	Pedestrian Pavement, Sidewalk, Concrete, Repair	0	0	*0	300	SF	\$28.94	\$8,683		\$8,683																			\$8,683

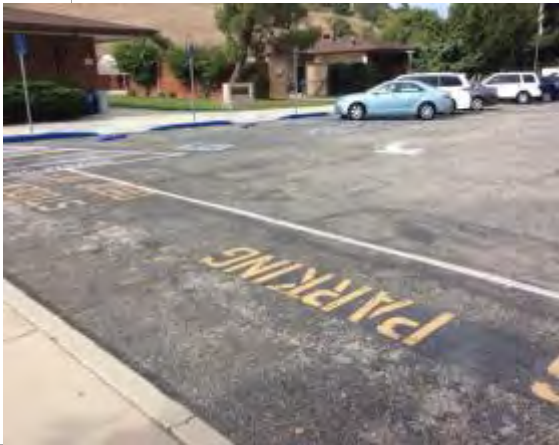
Photo #9: Parking lot with ADA parking spaces

3.1	514338	ADA, Door, Lever Handle Hardware, Install	0	0	0	4	EA	\$202.40	\$810	\$810																				\$810						
3.1	514339	ADA, Parking, Designated Stall with Pavement Markings & Signage, Install	0	0	0	1	EA	\$834.90	\$835	\$835																				\$835

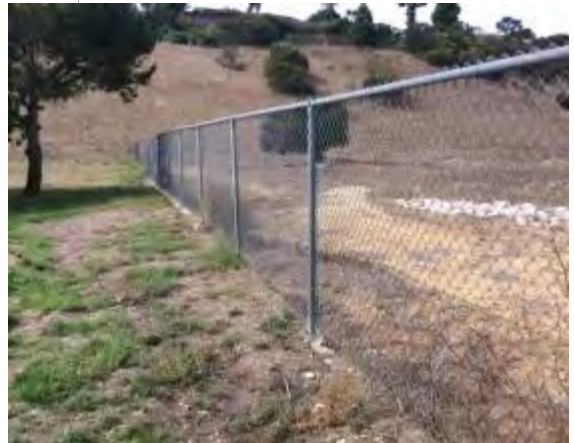
Photo #16: Chain link perimeter fence

5.5	480417	Chain Link Fence, 6' High (per LF), Replace	30	16	14	1400	LF	\$37.54	\$52,553															\$52,553						\$52,553						
5.5	514340	Play Surfaces & Sports Courts, Asphalt, Seal & Stripe	5	5	0	8300	SF	\$0.38	\$3,158	\$3,158				\$3,158						\$3,158					\$3,158					\$12,633

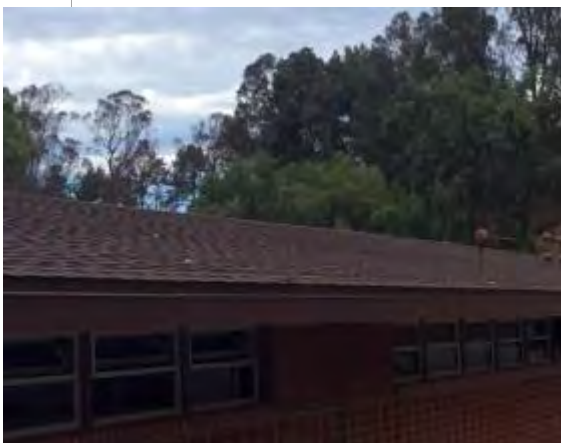
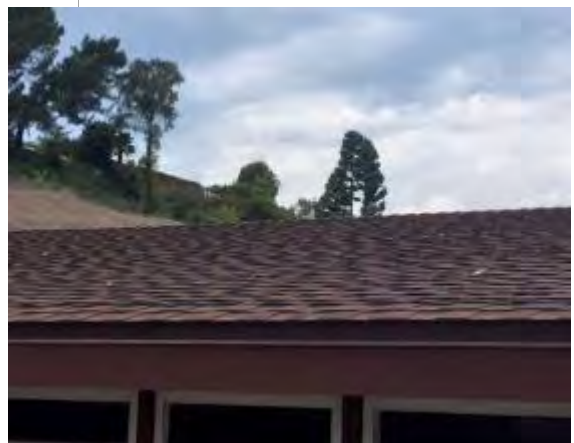
Photo #17: Asphalt shingles roof

Photo #18: Asphalt shingles roof

6.3	480659	Asphalt Shingle Roof, Asphalt Shingle, Replace	20	11	9	26600	SF	\$3.42	\$90,985										\$90,985											\$90,985						
6.3	480420	Gutters & Downspouts, Aluminum w/ Fittings, Replace	10	10	0	1300	LF	\$8.37	\$10,883	\$10,883										\$10,883										\$21,767
