# FACILITY CONDITION ASSESSMENT

PALOS VERDES PENINSULA UNIFIED SCHOOL DISTRICT  
RANCHO VISTA ELEMENTARY  
4323 PALOS VERDES DRIVE NORTH  
ROLLING HILLS ESTATES, CALIFORNIA 90274

119663.16R000-006.017

November 29, 2016

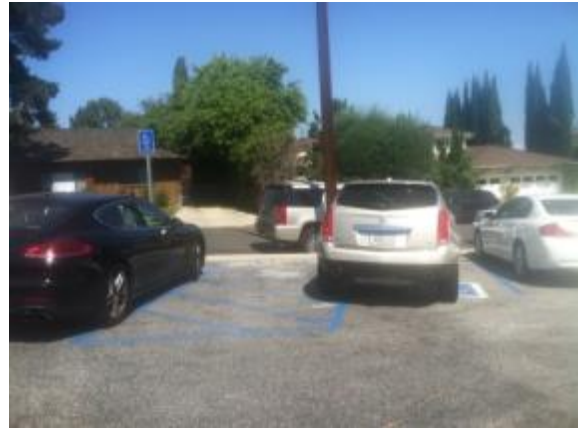
Photo #8: Missing sign at accessible parking space

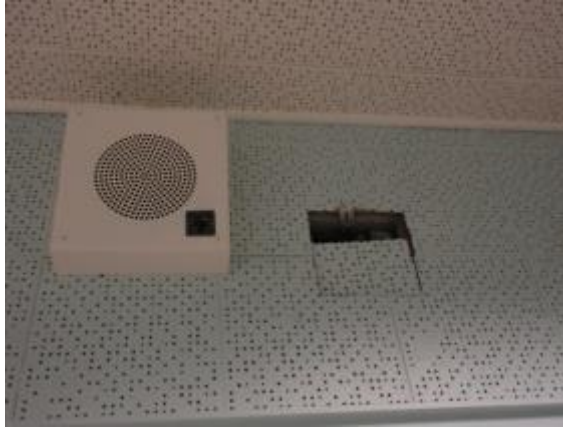
Photo #37: Damaged hard tile at office wall

8.1	Office Building	482008	Interior Wall Finish, Wood Paneling, Replace	500	SF	\$23.73	\$11,865	<b>\$11,865</b>
<b>Immediate Repairs Total</b>								<b>\$176,878</b>

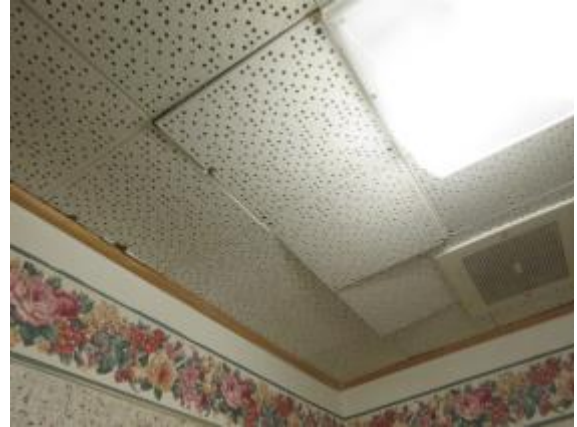
Photo #38: Damaged tiles at office ceiling

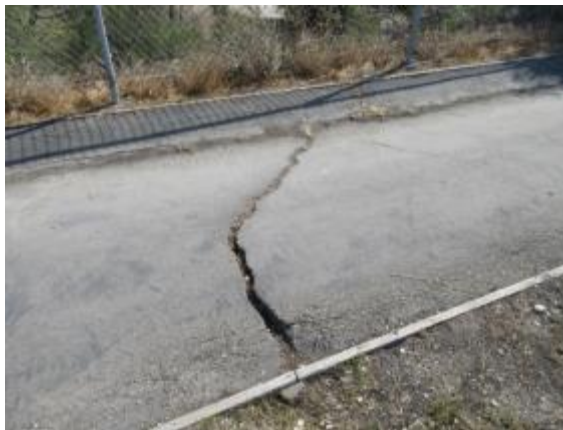
- The asphalt pavement exhibits significant areas of failure and deterioration, such as alligator cracking and transverse cracking at the west parking lot, the north parking lot, and the paved walkway on the east edge of the property. All of the paving must be overlaid with new asphalt paving in order to maintain the integrity of the overall pavement system. Milling is recommended as part of the overall repair work.

Photo #39: Damaged asphalt at east walkway

5.2	North and West Parking Lots	481775	Parking Lots, Asphalt Pavement, Mill & Overlay	23500	SF	\$3.28	\$77,089	<b>\$77,089</b>
5.2	East Property Line	481778	Pedestrian Pavement, Sidewalk, Asphalt, Replace	8700	SF	\$1.60	\$13,955	<b>\$13,955</b>

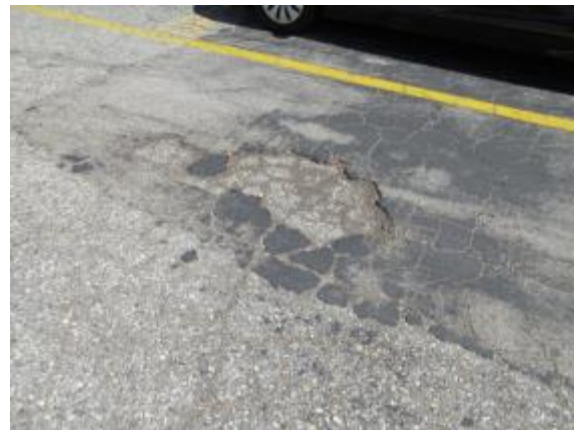
Photo #40: Damaged asphalt at west parking lot

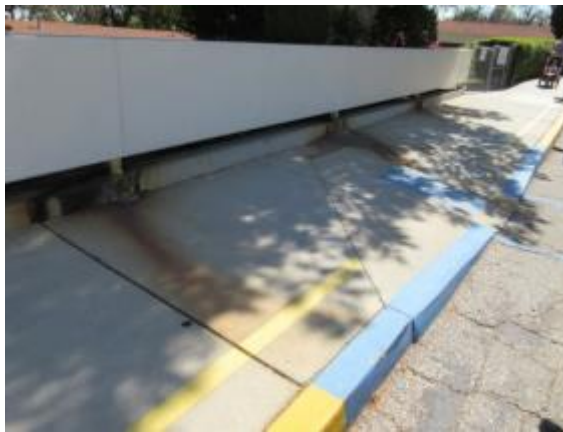
Photo #41: Rusty tube-steel supports at west entrance

5.5	Exterior Walls	588657	High Intensity Discharge Light Fixture, Exterior, Wall Mounted, 150-250 W, Replace	15	EA	\$719.95	\$10,799	<b>\$10,799</b>
5.5	West Entrance	481783	Fences & Gates, Metal Tube, 4' High, Repair post base	120	LF	\$55.20	\$6,624	<b>\$6,624</b>

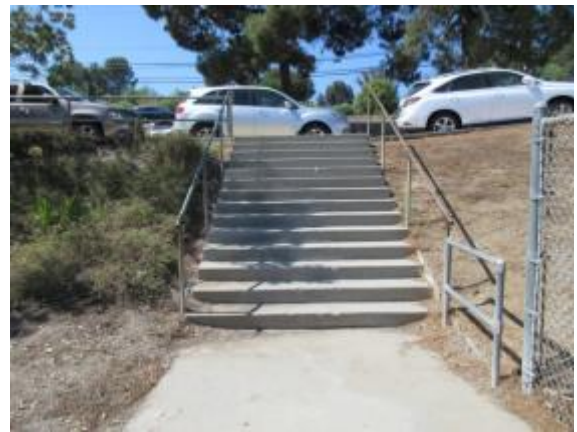
Photo #42: Handrails do not extend beyond stairs at northwest stairs

Report Section	Location Description	ID	Cost Description	Quantity	Unit	Unit Cost	Subtotal	Deficiency Repair Estimate *
3.1	Office Restroom, Northwest Stairs, and North Parking Lot	482361	ADA, Miscellaneous (Lump Sum Budgetary Allowance), Upgrade	1	EA	\$1,230.00	\$1,230	<b>\$1,230</b>
