FACILITY CONDITION ASSESSMENT

PALOS VERDES PENINSULA UNIFIED SCHOOL DISTRICT

VALMONTE (VELA)

November 29, 2016

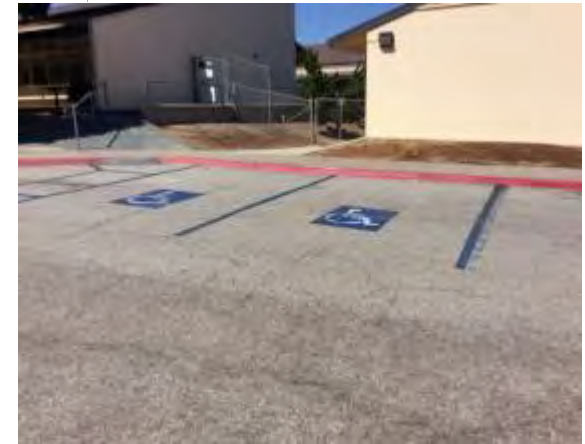
- Signage missing for two parking stalls at south parking area (adjacent Buildings 4 & 5)
Estimated Cost: 2 at \$480.70 each = \$961.40
- Lever action hardware is not provided at classroom doors.
Estimated Cost: 24 at \$202.40 each = \$4,858.00

Photo #10: ADA Parking Stalls

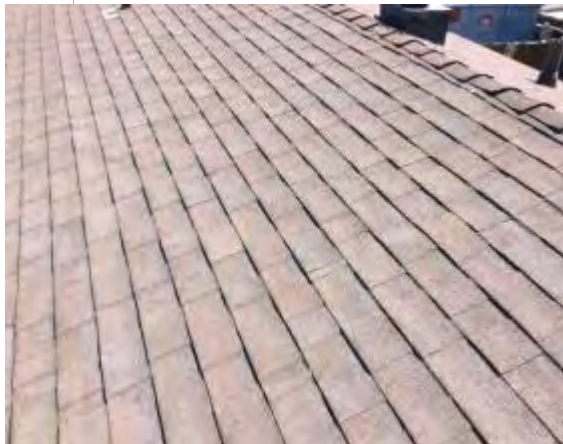
Photo #23: Asphalt Shingles Roof

6.3	485578	Asphalt Shingles Roof, Asphalt Shingle, Replace	20	19	1	37500	SF	\$5.04	\$189,000		\$189,000																			\$189,000
6.3	486730	Gutters & Downspouts, Aluminum w/ Fittings, Replace	10	9	1	1500	LF	\$8.37	\$12,558		\$12,558									\$12,558										\$25,115

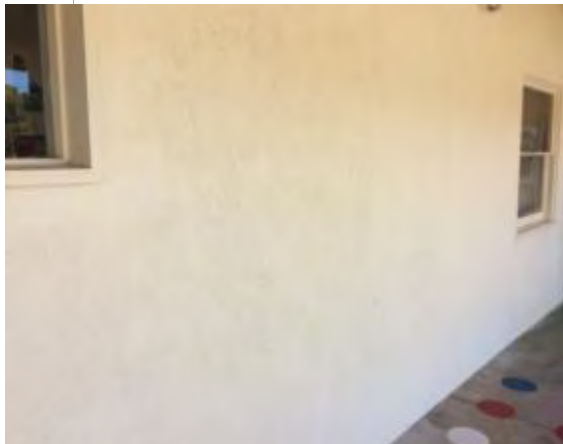
Photo #27: Stucco Exterior Wall

6.4	486713	Exterior Column, Brick or Brick Veneer, 1-2 Stories, Repair	0	78	* 0	144	SF	\$48.56	\$6,992	\$6,992																				\$6,992
6.4	486841	Exterior Wall, Stucco, Remove Clerestory Windows and Infill Openings	0	78	* 0	1500	SF	\$18.20	\$27,294	\$27,294																				\$27,294

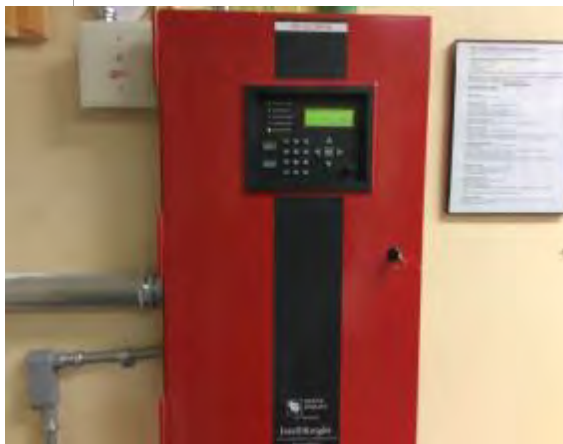
Photo #29: Fire Alarm Control Panel

7.6	485582	Fire Alarm Control Panel, Multiplex, Replace	15	8	7	5	EA	\$4,284.35	\$21,422							\$21,422														\$21,422
8.1	485855	Interior Wall Painting, Gypsum Board/Plaster/Metal, Prep & Paint	8	3	5	35000	SF	\$1.42	\$49,812					\$49,812								\$49,812								\$99,624
