FACILITY CONDITION ASSESSMENT

FACILITY CONDITION ASSESSMENT
OF
VISTA GRANDE ELEMENTARY
7032 PURPLE RIDGE DRIVE
RANCHO PALOS VERDES, CALIFORNIA 90275

119663.16R000-009.017

December 20, 2016

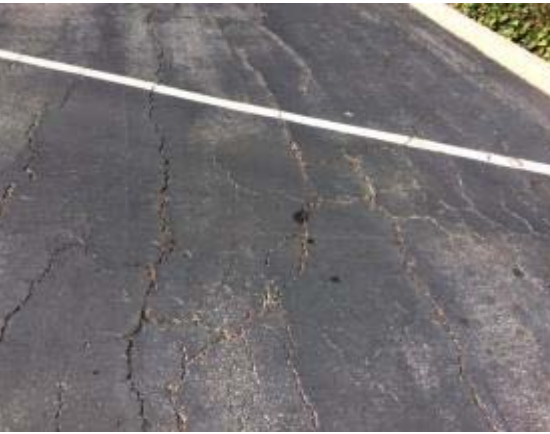
- The asphalt pavement exhibits significant areas of failure and deterioration, such as alligator cracking, transverse cracking, extensive raveling, heavy overall surface wear and localized depressions at the service entrance northeast of the facility. All of the paving must be overlaid with new asphalt paving in order to maintain the integrity of the overall pavement system. Milling is recommended as part of the overall repair work.

Photo #11: Asphalt roadway pavement

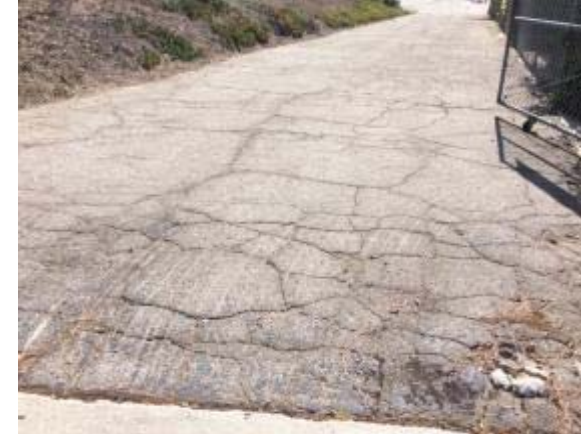
Photo #12: Asphalt roadway pavement

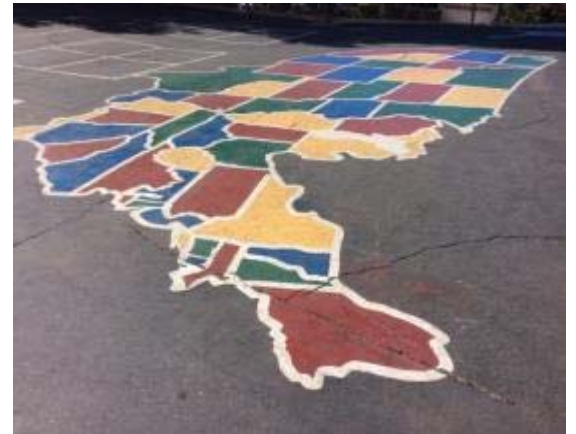
- The asphalt pavement exhibits significant areas of failure and deterioration throughout the courtyard, including around tree stems. The damaged areas need to be cut and patched in order to restore an effective and usable pavement system.

Photo #18: Asphalt pavement play area

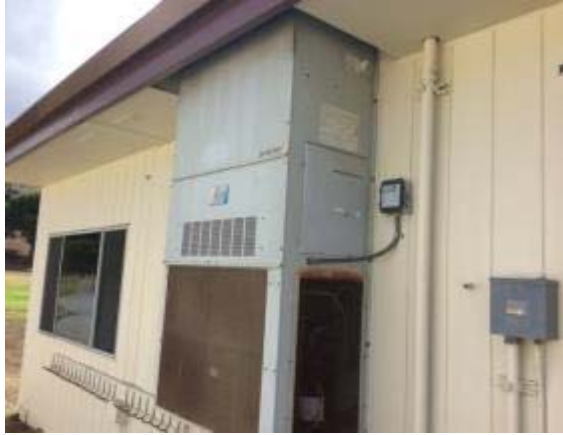
Photo #37: Wall-mounted Heat Pump

7.1	Portables	507643	Wall-Mounted Heat Pump, Split System, 5 Ton, Replace	8	EA	\$6,439.81	\$51,519	\$51,519
7.2	19-20	507645	Drinking Fountain, Exterior, Porcelain Stell, Replace	2	EA	\$2,972.00	\$5,944	\$5,944

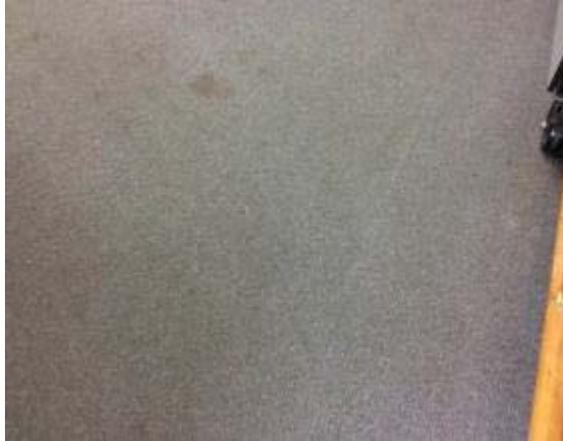
Photo #43: Carpet Flooring

8.1	Throughout Facility	508370	Carpet Floor Finishing, Carpet Standard-Commercial Medium-Traffic, Replace	20500	SF	\$7.26	\$148,754	\$148,754
Immediate Repairs Total								\$239,825
