FACILITY CONDITION ASSESSMENT

119663.16R000-016.017

November 29, 2016

PALOS VERDES PENINSULA UNIFIED SCHOOL DISTRICT
RANCHO DEL MAR HIGH SCHOOL, AND
ADULT EDUCATION & CHILD CARE
38 CREST ROAD WEST
ROLLING HILLS, CALIFORNIA 90274

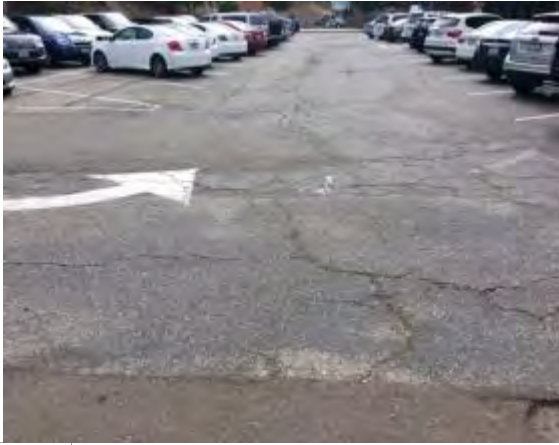
Photo #7: Lower parking lot

5.2	480411	Asphalt Pavement Overlay, Parking Lot, Mill & Overlay	25	25	0	22000	SF	\$3.28	\$72,169	\$72,169																				\$72,169						
5.2	481330	Pedestrian Pavement, Sidewalk, Concrete, Repair	0	0	*0	300	SF	\$28.94	\$8,683		\$8,683																			\$8,683

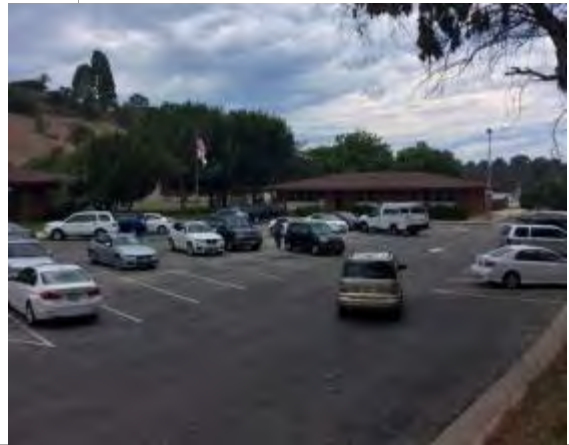
Photo #10: Overview of parking lot

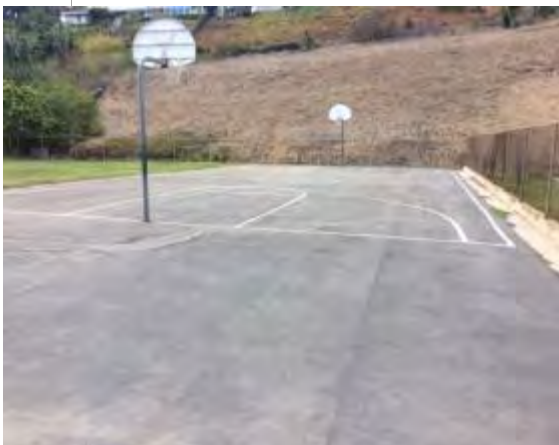
Photo #11: Basketball court

5.5	480417	Chain Link Fence, 6' High (per LF), Replace	30	16	14	1400	LF	\$37.54	\$52,553															\$52,553						\$52,553						
5.5	514340	Play Surfaces & Sports Courts, Asphalt, Seal & Stripe	5	5	0	8300	SF	\$0.38	\$3,158	\$3,158				\$3,158						\$3,158					\$3,158					\$12,633

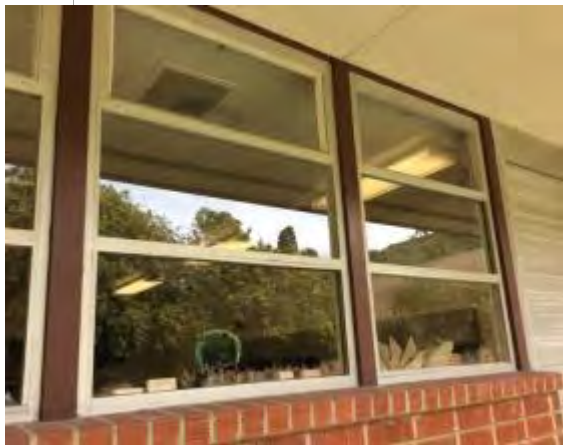
Photo #21: Aluminum-framed windows

6.6	481273	Window, Aluminum Double-Glazed 24 SF, 1-2 Stories, Replace	30	21	9	70	EA	\$870.45	\$60,931										\$60,931											\$60,931						
6.6	481279	Window, Aluminum Double-Glazed 12 SF, 1-2 Stories, Replace	30	16	14	40	EA	\$584.21	\$23,368														\$23,368							\$23,368

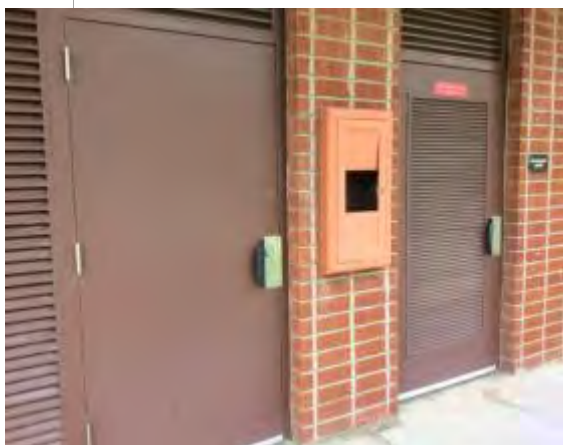
Photo #23: Exterior doors

6.6	481282	Exterior Door, Steel, Replace	25	23	2	1	EA	\$950.12	\$950			\$950																		\$950						
7.1	480676	Condensing Unit, 2.5 Ton, Replace	15	9	6	2	EA	\$3,366.36	\$6,733						\$6,733															\$6,733

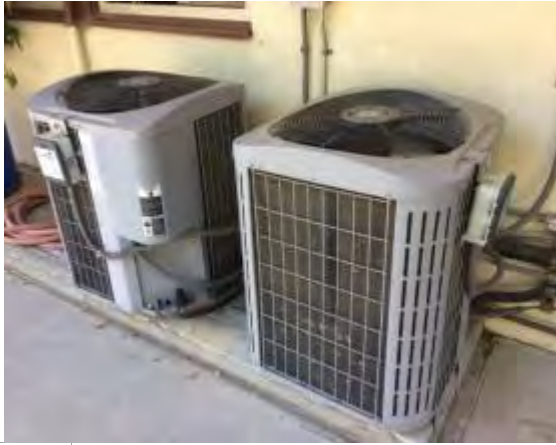
Photo #25: Condensing units

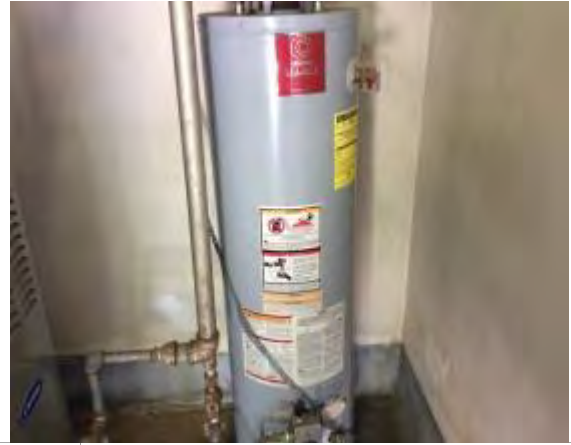
Photo #26: Water heater

7.2	481018	Backflow Preventer, 2", Replace	15	9	6	1	EA	\$2,603.17	\$2,603						\$2,603															\$2,603						
7.2	480673	Water Heater, 30 GAL, Replace	10	9	1	1	EA	\$2,349.48	\$2,349		\$2,349									\$2,349										\$4,699

7.2	480670	Water Heater, 28 GAL, Replace	10	7	3	1	EA	\$2,349.48	\$2,349			\$2,349										\$2,349								\$4,699						
7.4	480671	Switchboard, 400 Amp, Replace	30	28	2	1	EA	\$24,768.06	\$24,768			\$24,768																		\$24,768

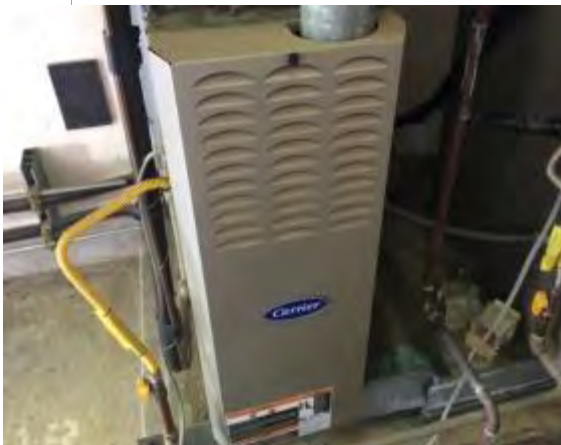
Photo #27: Gas furnace

7.1	480677	Furnace, 120 MBH, Replace	20	11	9	2	EA	\$5,644.27	\$11,289										\$11,289											\$11,289						
7.1	480675	Furnace, 66 MBH, Replace	20	11	9	2	EA	\$3,801.45	\$7,603										\$7,603											\$7,603

7.1	480679	Furnace, 80 MBH, Replace	20	11	9	8	EA	\$3,801.45	\$30,412										\$30,412											\$30,412						
7.2	480681	Water Closet, Tankless (Water Closet), Replace	20	1	19	7	EA	\$842.97	\$5,901																				\$5,901	\$5,901

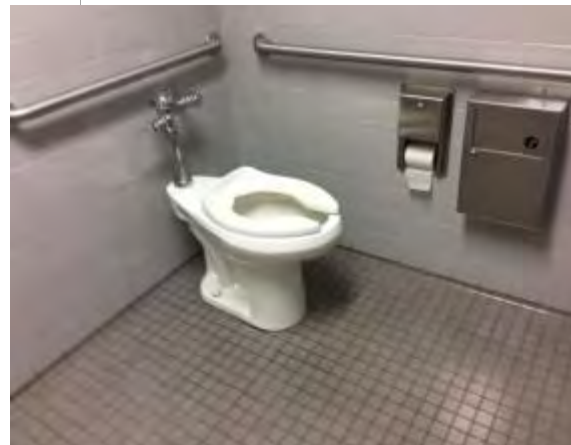
Photo #28: Water closet

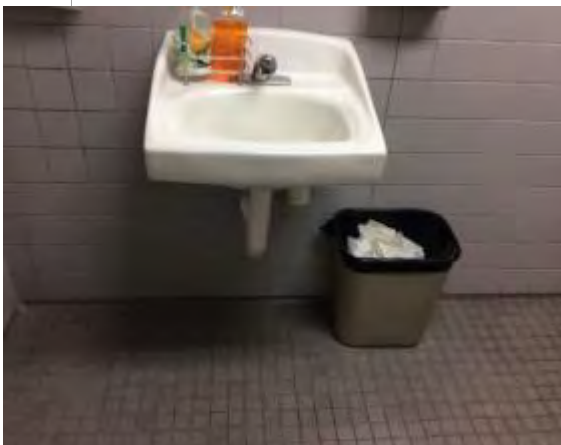
Photo #29: Lavatory

7.2	480683	Urinal, Vitreous China, Replace	20	1	19	5	EA	\$1,193.44	\$5,967																				\$5,967	\$5,967						
7.2	480682	Lavatory, Vitreous China, Replace	20	1	19	9	EA	\$572.66	\$5,154																				\$5,154	\$5,154

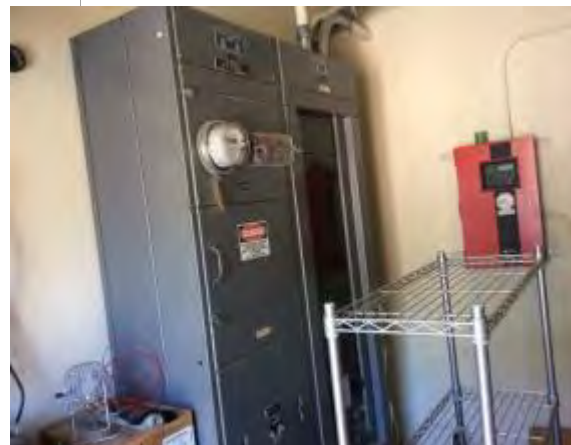
Photo #30: Main switchboard

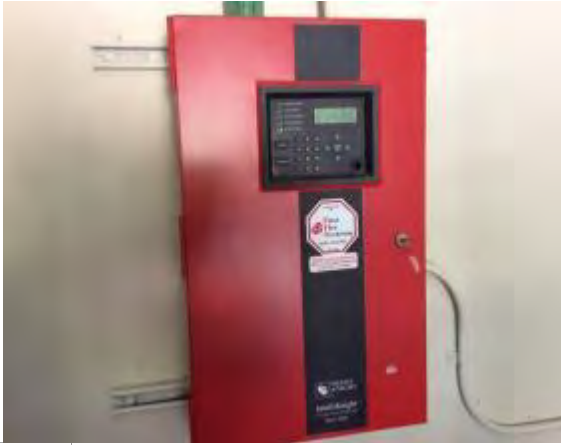
Photo #31: Fire alarm control panel

7.6	480672	Fire Alarm Control Panel, Multiplex, Replace	15	9	6	1	EA	\$4,284.35	\$4,284						\$4,284															\$4,284						
8.1	481295	Interior Wall Paint, Gypsum Board/Plaster/Metal, Prep & Paint	8	6	2	24000	SF	\$1.42	\$34,157			\$34,157								\$34,157							\$34,157			\$102,470

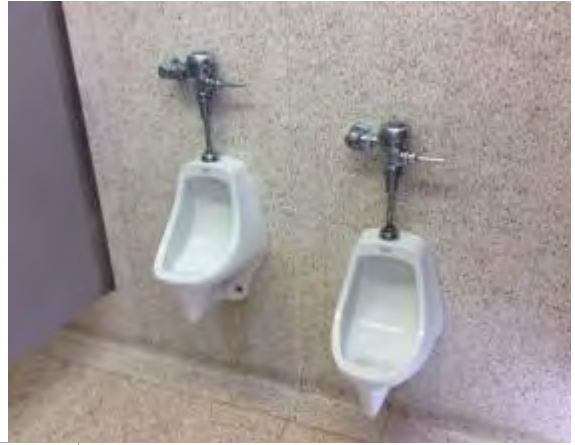
Photo #32: Urinals

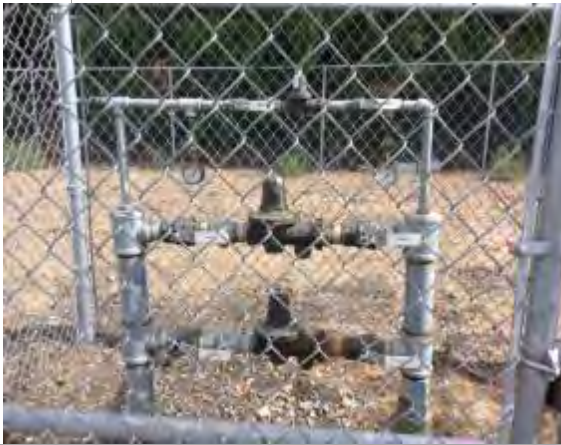
Photo #33: Backflow preventer

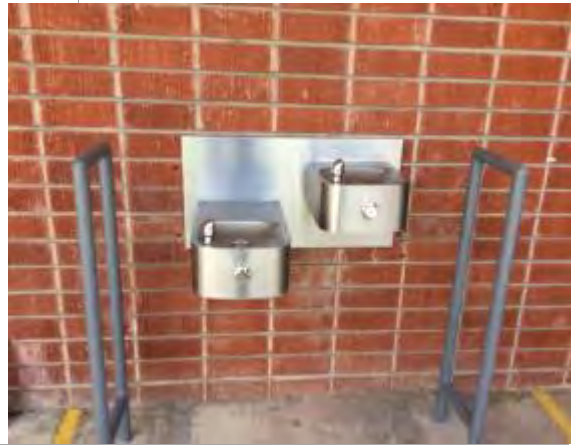
Photo #34: Drinking fountains

7.2	480680	Drinking Fountain, Stainless Steel, Dual, Accessible, Replace	10	3	7	2	EA	\$2,457.51	\$4,915							\$4,915									\$4,915					\$9,830

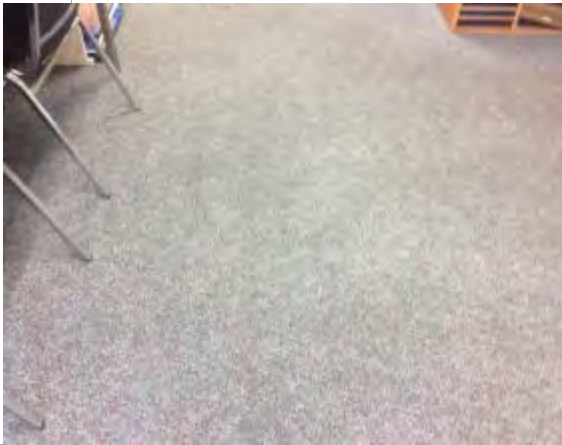
Photo #39: Carpet

8.1	514341	Interior Floor Finish, Vinyl Tile (VCT), Replace	15	13	2	2500	SF	\$4.80	\$12,002			\$12,002													\$12,002					\$24,003						
8.1	481294	Interior Floor Finish, Carpet Standard-Commercial Medium-Traffic, Replace	10	8	2	16000	SF	\$7.26	\$116,101			\$116,101								\$116,101										\$232,202

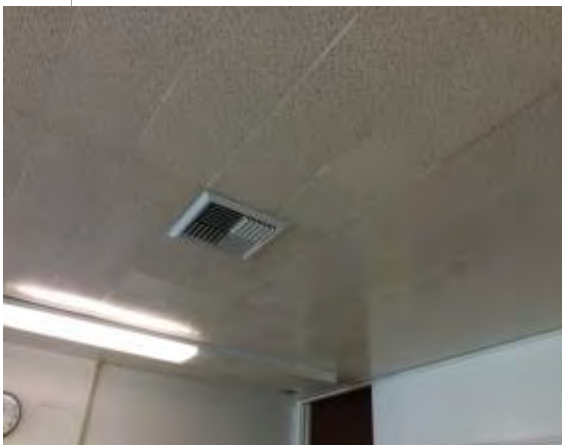
Photo #41: Glued ceiling tiles

8.1	481292	Interior Ceiling Finish, Glued ceiling tiles, Replace	20	15	5	17500	SF	\$3.11	\$54,443					\$54,443																\$54,443						
8.2	480674	Sink, Sink, Replace	30	21	9	8	LF	\$1,262.50	\$10,100										\$10,100											\$10,100						
	589959	Electrical System, School, Upgrade	40	37	3	20000	SF	\$49.78	\$995,500				\$995,500																	\$995,500						
Totals, Unescalated										\$105,189	\$11,033	\$187,977	\$997,849	\$0	\$106,256	\$13,620	\$4,915	\$0	\$211,320	\$65,532	\$2,349	\$116,101	\$2,349	\$75,921	\$51,813	\$0	\$16,917	\$34,157	\$17,022	\$2,020,321						
Location Factor (1.00)										\$0	\$0	\$0	\$0	\$0	\$0	\$0	\$0	\$0	\$0	\$0	\$0	\$0	\$0	\$0	\$0	\$0	\$0	\$0	\$0	\$0	\$0	\$0	\$0	\$0	\$0	\$0
Totals, Escalated (3.0% inflation, compounded annually)										\$105,189	\$11,364	\$199,425	\$1,090,377	\$0	\$123,180	\$16,263	\$6,045	\$0	\$275,724	\$88,070	\$3,252	\$165,532	\$3,450	\$114,838	\$80,724	\$0	\$27,960	\$58,150	\$29,848	\$2,399,391
